PAPER REF: 3899

## CONSERVATION OF WOODEN CHURCH IN THE VILLAGE TRNOVE

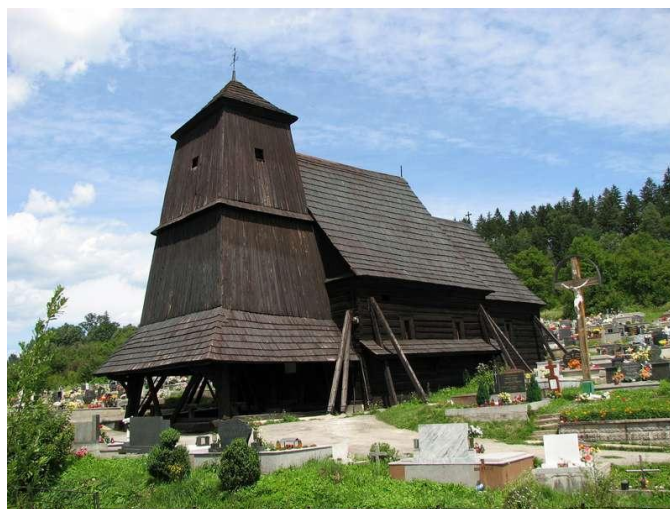
Fig. 1 Church of St. George in Zilina prior to reconstruction works

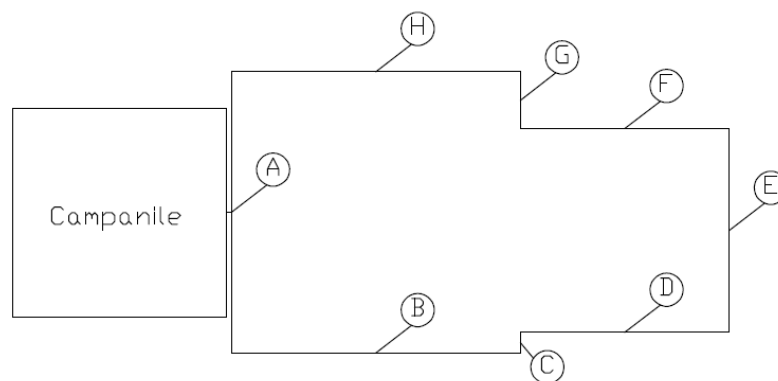
Fig. 2 Church ground plan scheme with identification of walls

Tab. 1 Remedying proposal

| Part: | Replacement | Damaged part replacement | Grouting | Chemical wood protection * |
| Wall A | 5 beams | 2 beams | 2 beams | 4 beams |
| Wall B | 6 beams | 3 beams | 1 beam | 3 beams |
| Wall C | 4 beams | 1 beam | 2 beams | 6 beams |
| Wall D | 6 beams | 2 beams | 3 beams | 2 beams |
| Wall E | 4 beams | 1 beam | 5 beams | 3 beams |
| Wall F | 7 beams | 2 beams | 4 beams | 0 |
| Wall G | 3 beams | 0 | 1 beam | 8 beams |
| Wall H | 6 beams | 2 beams | 3 beams | 2 beams |
| Bell tower | 6 spurs, 40 m <sup>2</sup> shingle and 72 wooden boards | 4 spurs, 4 columns, 70 ceiling wooden plates | | 80 wooden boards, 2 spurs |
| Roof frame | 8 rafters | 23 pillars, 8 tie beams, 6 bonding ties, 18 rafters | 4 wall beams | 12 pillars, 4 tie beams, 5 bonding ties |
| Shingle | 128 m <sup>2</sup> | | | |
| Ceiling boarding | 198 wooden boards | | | |

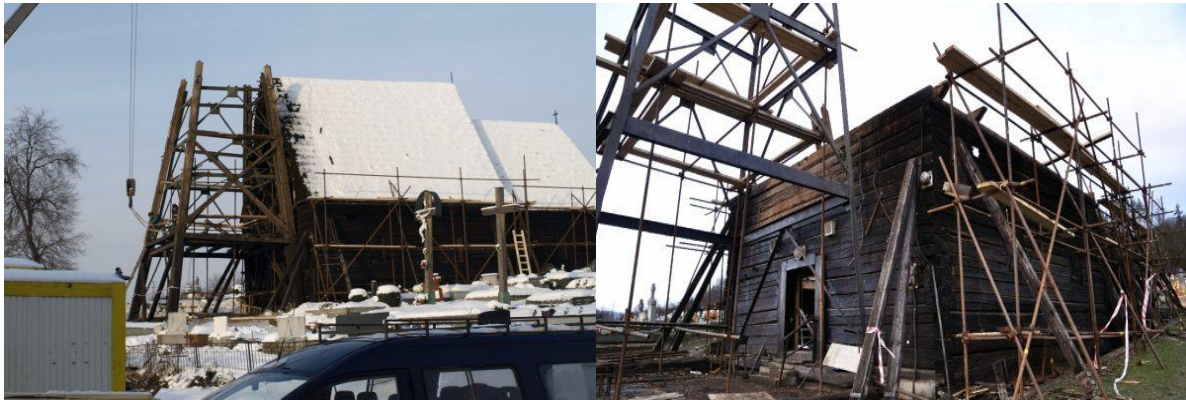
Fig. 3 Dismantling the wooden church

Before the church was dismantled it was measured, documented and each part was marked. On 25th of November 2010 began the dismantling of the church (Fig. 3). Parts of the church were transported to the Eastern part of Slovakia, where was performed remediation. Companies from Eastern Slovakia which specialize in remediation of wooden structures have many experiences with repairs of historical objects. Therefore it was decided to transport the church.

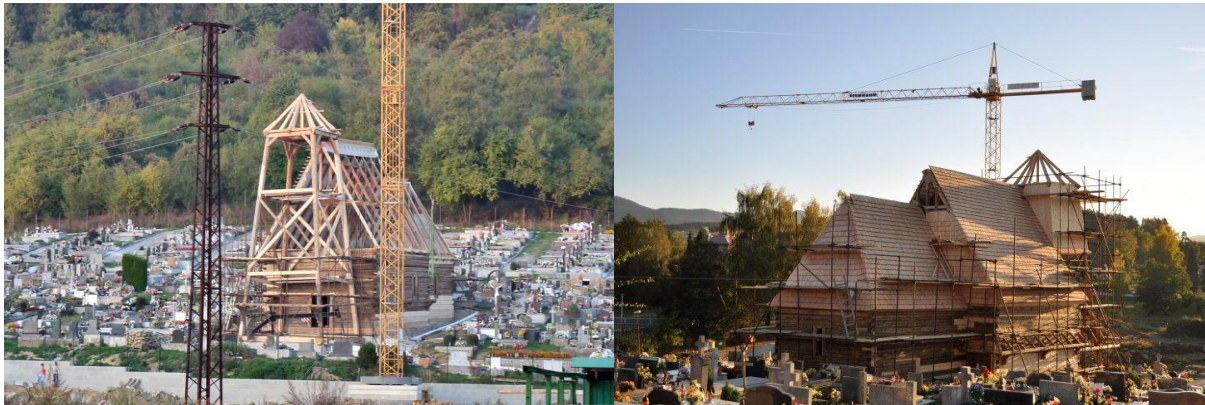
Fig. 4 Assembling the church

Following successful remediation process the church was transported back to its original location and built up (Fig. 4). Opening ceremony of the church was held on 29th of April 2012. Total reconstruction took about 17 months.

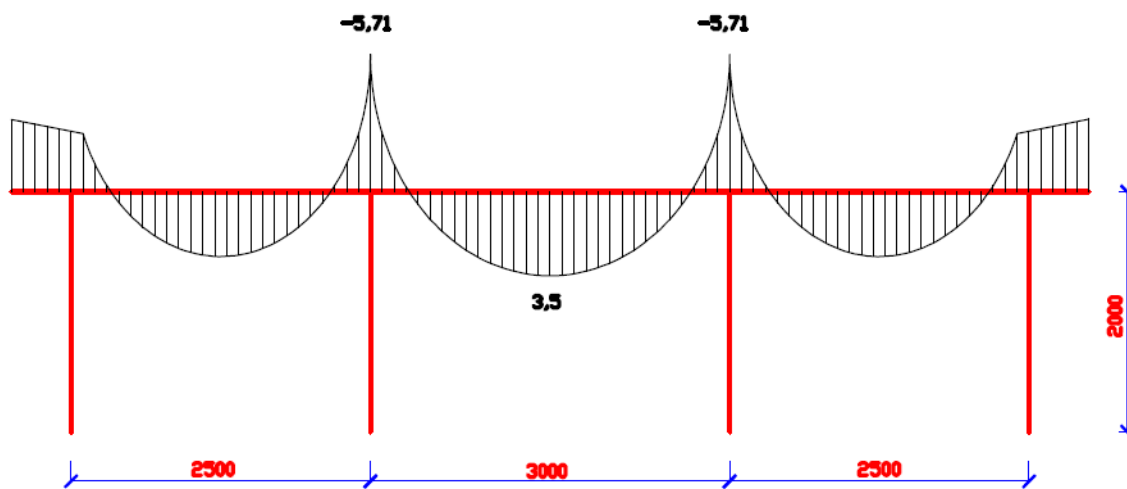
The aim of static assessment calculation is to demonstrate the ability of the wooden building to withstand the load (Fig. 5 shows bending moments at the church choir) caused by its own weight, the random natural loads (snow, wind) and the load of people, equipment or special loads (seismic zone). Static assessment is necessary not only due to legislation requirements (Building Permit Design), but also due to the warranty. Static reliability of the structure recognizes two limit states:

Fig. 5 Bending moments at the church choir

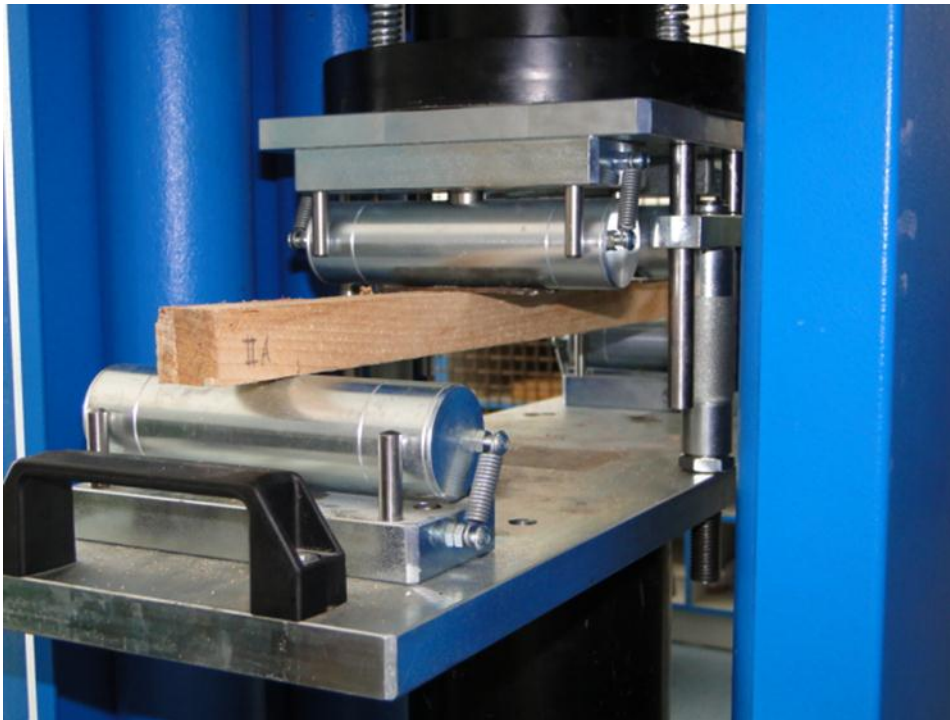
Figure 6 - Testing the bending strength

The table shows that grouted wood has higher resistance (approximately by 31%) at the static bending than non-grouted wood.

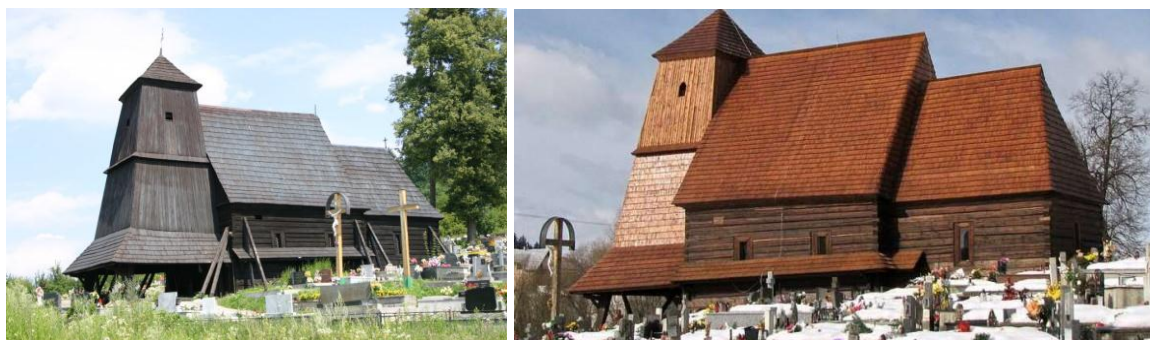
Fig. 9 Wooden church in Trnove On the left prior to reconstruction, on the right after reconstruction
