A REVIEW ON CONSTRUCTION DETAILS THAT INFLUENCE THE STABILITY OF BRICK FAÇADES

Tiago Teixeira Martins^{1(*)}, Borja Jiménez Salado¹, Suyapa Dávila Sánchez-Toscano¹, Ramón Álvarez Cabal¹⁻²

¹Instituto Técnico de Materiales y Construcciones (INTEMAC)

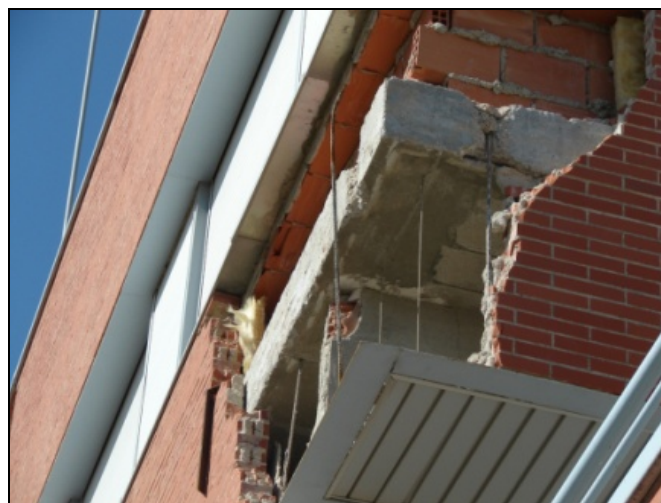
Traditionally this configuration was admitted as valid given that the support is not less than $\frac{2}{3}$ of the thickness of the partition, in a condition that, although not strictly stable, appear to be supported by practice. Thus, if the exterior panel is formed by header bond metric brick, the effective support in the slab is reduced to about 8 cm. That circumstance, questionable in itself, worsens considering the following aspects:

- The order of magnitude of the tolerance allowed by the standards during construction of the structure, in particular slabs, is unaffordable for the façade enclosures. The CTE considers deviations of up to 20 mm (25 mm according to PIET-70) between the edges of two consecutive slabs in the vertical plane and 50 mm in the total structure. If we also take into account that, after removal of the formwork of the floor, the support surface of the enclosure cannot be completely horizontal neither vertical the front of the slab, the execution of the outer brick panel is complex (Fig. 2 and 3 below).

Fig. 2 Half thickness support of the enclosure façade outer panel

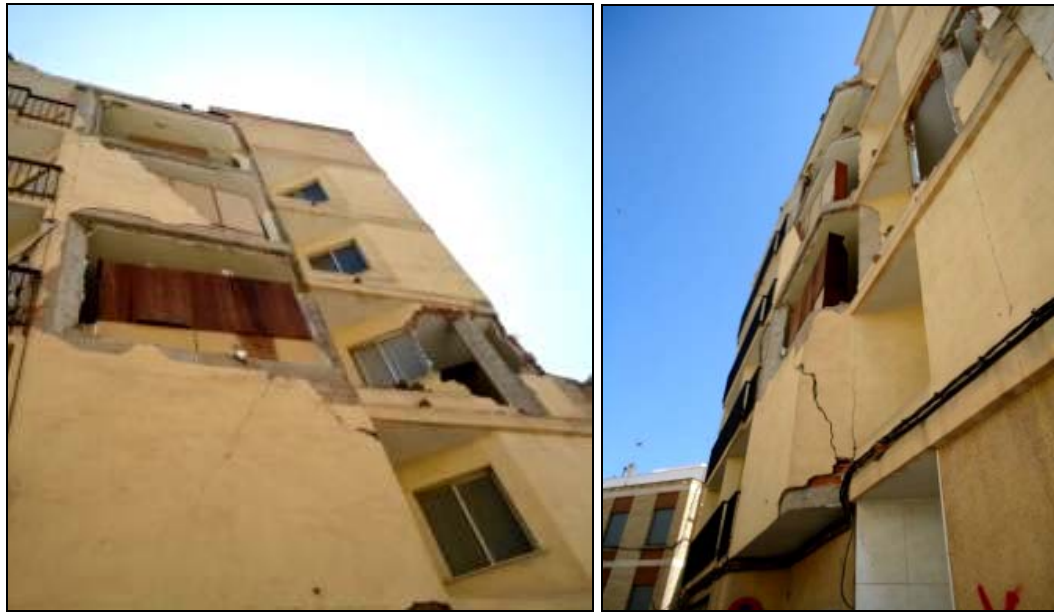
Fig. 3 Progressive loss of support as a function of height

Undoubtedly, the stability of a masonry wall depends very determinately of adequate support from its base.

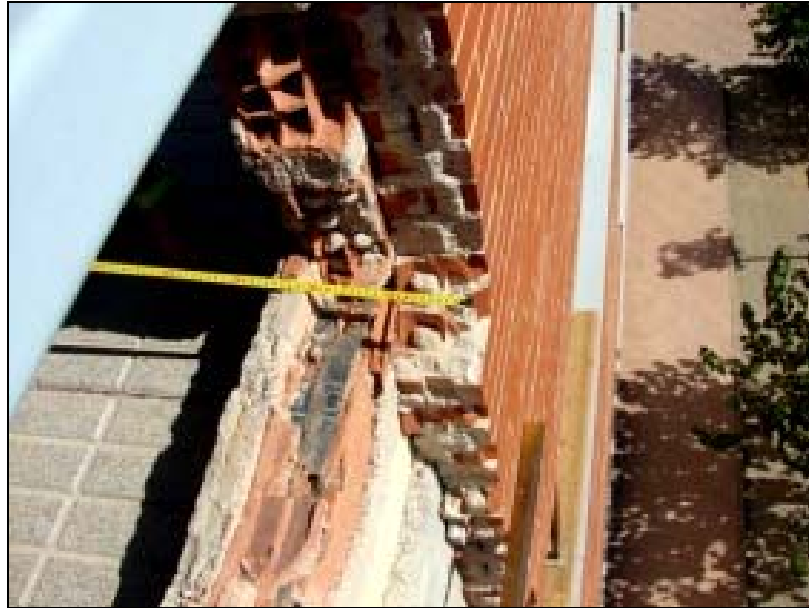
- To improve waterproofing and drainage conditions, standards recommend using a waterproof sheet to collect and evacuate outside water leaked in through the wall and condensation that may exist in the air chamber, extending foil in the blade support brick exterior with horizontal structure. This leads to friction reduction between building enclosure and framework, compromising the stability of the façade, especially if the sheet has slope as it is recommended by standards (Fig.4 and 5).

Fig. 5 Support on waterproof membrane

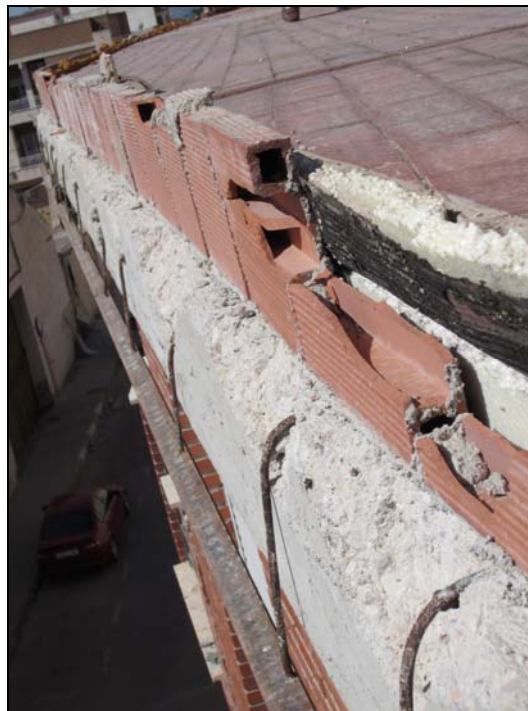
In order to improve the conditions of the aforesaid support, often resort to placing auxiliary metal profiles fixed in the frame. These profiles should allow supporting enclosure walls placed directly on them. However, the adhesion between the metal profile and the grout is at least questionable. Furthermore, deviations between plants also influence the placement of these profiles, which are not in the front of the floor flatness sufficient for proper anchorage, causing gaps between profile and floor structure.

Fig. 6 Support on metal profile

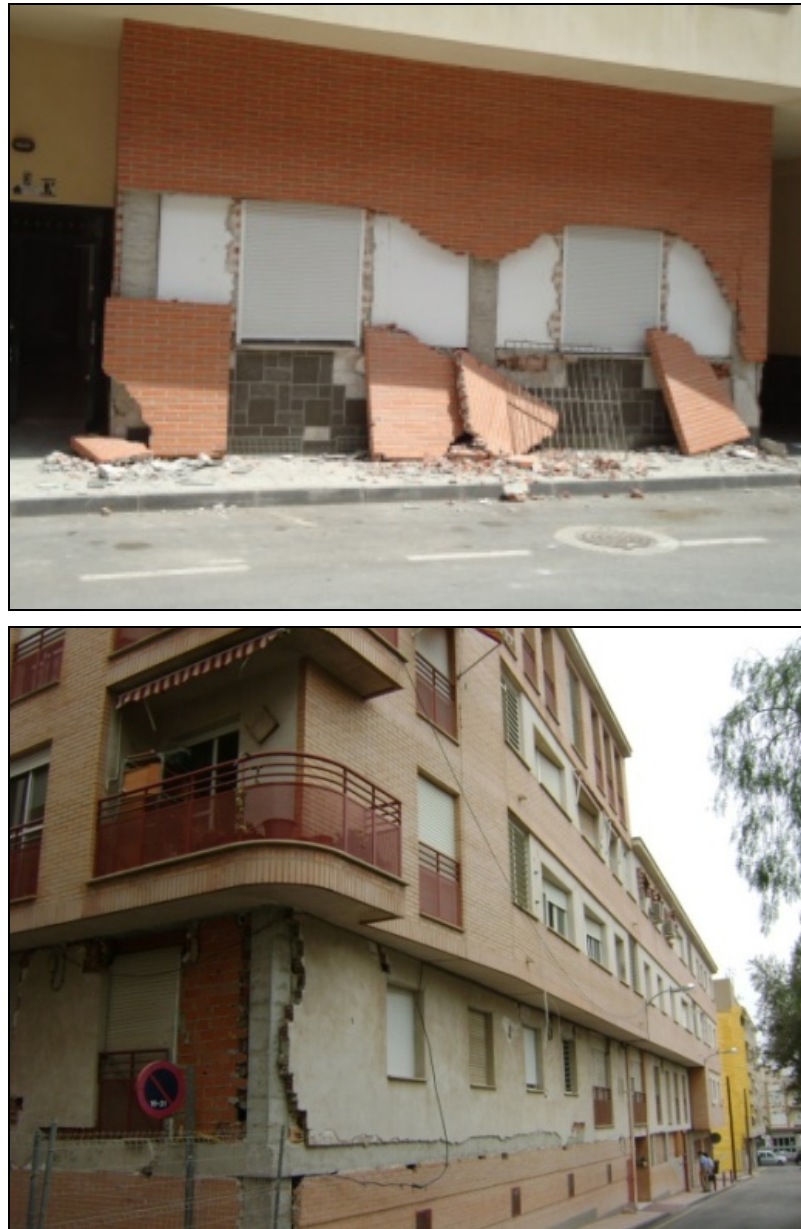
Fig. 7 Drop façade by an inadequate support

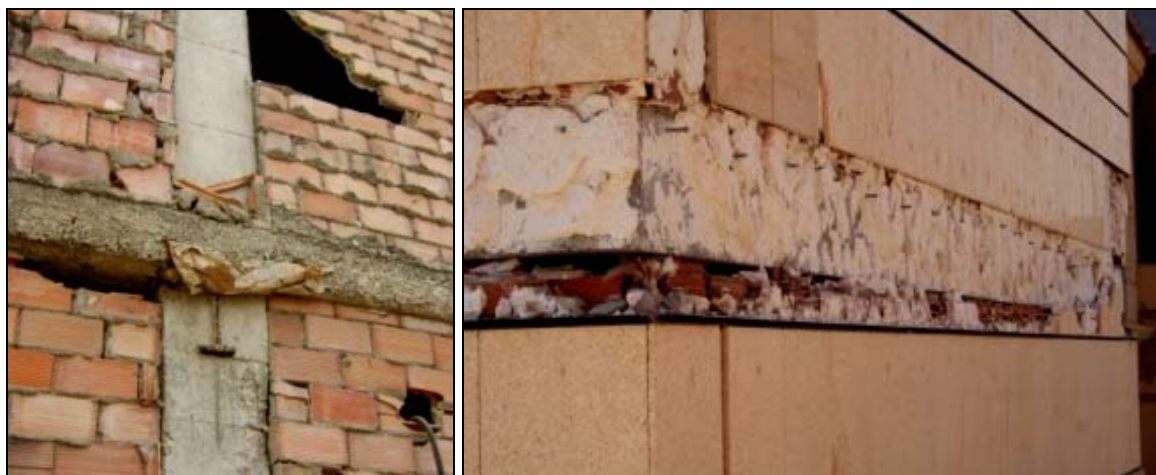
However, it is common that layout lack and / or errors related to the bed joint thickness of the brick masonry, result in much higher or lower gaps than indicated. With gaps of less than 2 cm, it is hard to run a cement mortar filling. In the second case, it is common to fill the joint with rubble masonry and mortar solution that ultimately prevents the formation of the patched joint (Fig. 8).

Fig. 8 Caulking without seal, left, and caulking with rubble, right

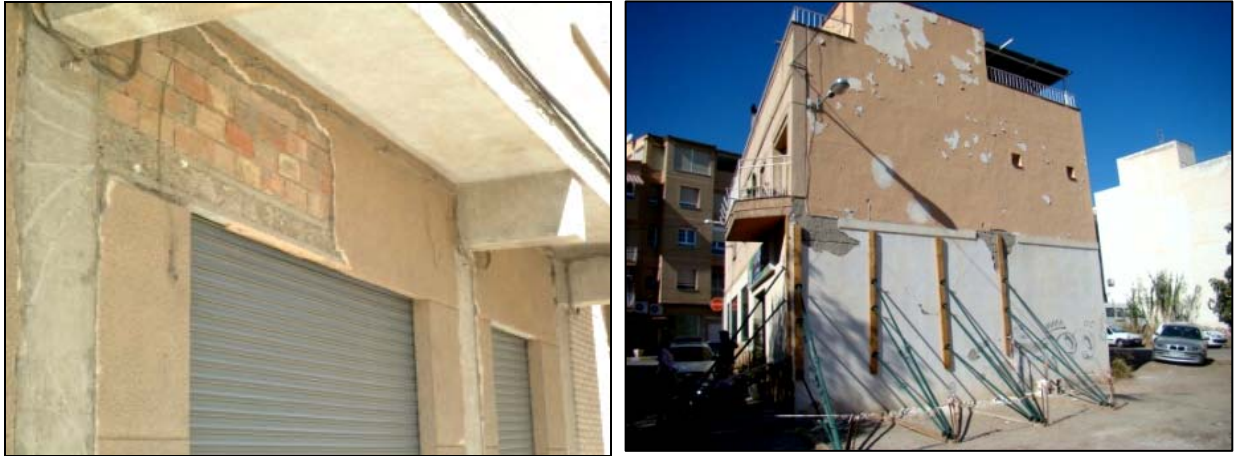
At this point, we could make a reflection which is especially important in case of seismic action. Many authors have studied how enclosure increases the stiffness of the structure, which so significantly changes its behaviour and response actions that request. In Lorca we confirmed that this circumstance was decisive. The connection of the panels to the structure, Fig. 10, has caused that horizontal actions due to the earthquake were resisted by the collaboration of non-structural masonries in many buildings with structural deficiencies. Furthermore, it has been the main cause of the damage observed in numerous enclosures and interior partitions.

Fig. 10 Examples of enclosures executed without gaps

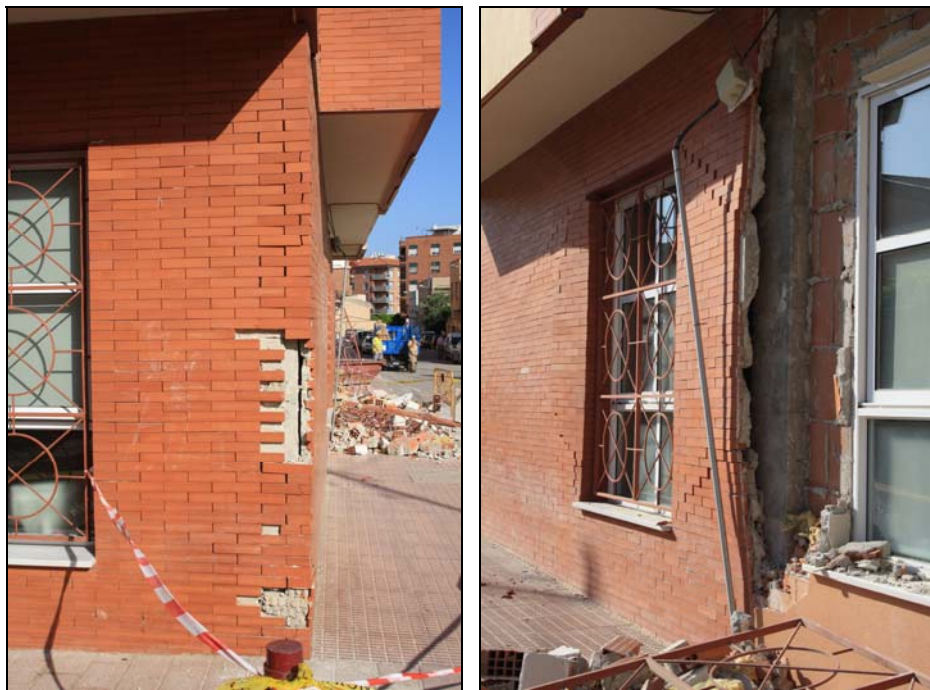
The transmission of gravity loads collected by floors through enclosures, produced by the rigidity of the masonries and their connection to the framework, has been studied by many authors. This accumulation of charges on the ground floors could justify the observed buckling panels brought to lateral earthquake in Lorca (Fig. 11).

Fig. 11 Ground floor buckling panels

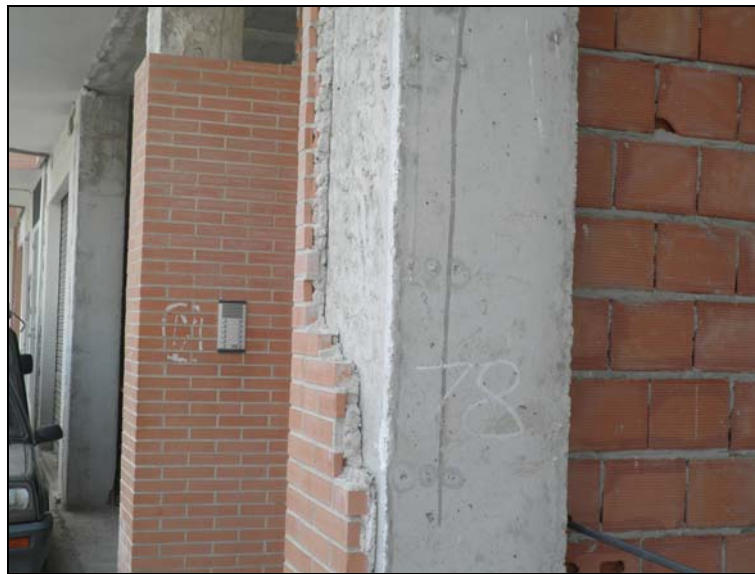
Fig. 12 Damage at pillar meeting

The most common solution is one in which the enclosure's head is placed against the pillar. Brick walls execution begins at the tops, ensuring that their head is, as said, placed against the pillar. Prior to the enclosure execution, it is usual to place a plastic panel around the pillar, which allows separating the movements between pillar and façade and, at the same time, prevents the adhesion of the pieces that cover the pillar in order to give continuity to the façade. The pillar coating is executed with brick bits cut *in situ*, which inevitably weakens the masonry, causing cracking due to differential movements between the two elements, originated by both thermo hygrometric causes and the pillar's own structural movements. In order to avoid that kind of problems, the bed joints are sometimes reinforced.

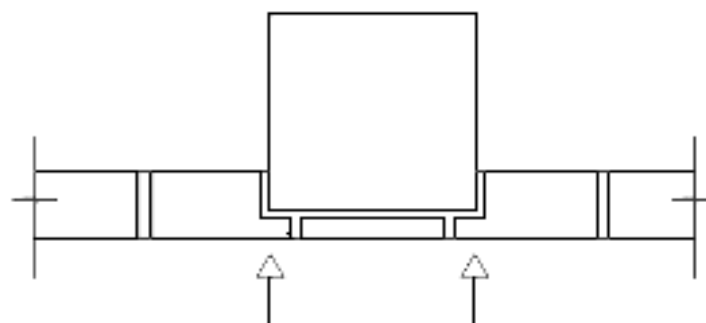
If vertical joints are insufficient, movement's restrictions caused by the pillar meeting to the wall would cause cracks in veneer pieces, particularly in those colloquially called "guns", obtained from cutting bricks (Fig. 14).

Fig. 14 Susceptible cracking points

These points favor the entry of water from outside, not only through the aforementioned cracks, but from the plating capillary filtration itself. To avoid these problems, one alternative is to place the whole outer panel in front of the pillars, making it independent by one

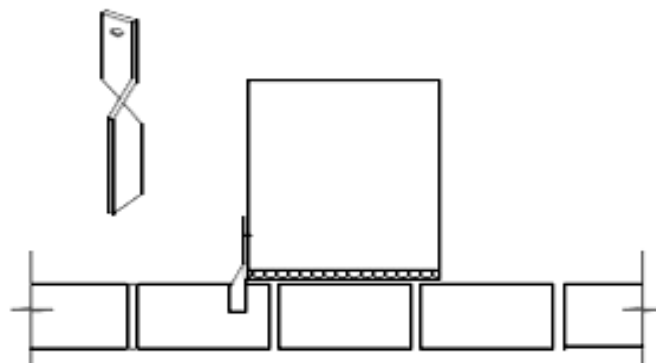
separating element such as a compressible insulation panel of low density or even a polyethylene panel. Although this solution would be complete with the placement of connecting keys between pillar and masonry, Fig. 15, this would represent a significant loss in the panel's stability. In most cases, anchoring elements consist of low rigidity metal strips. These elements are criticized in part of the literature available.

Fig. 15 Metal strips anchoring elements

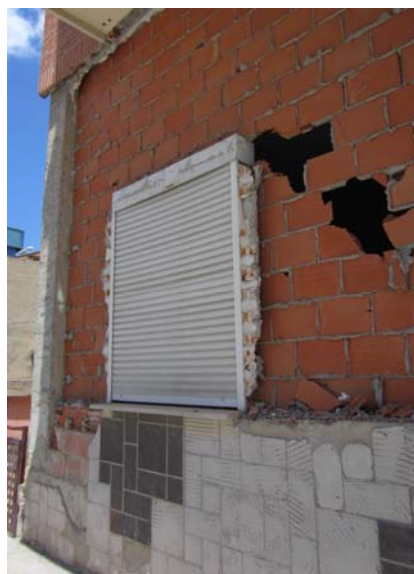
However, we can affirm that carpentries behaviour in Lorca has been surprisingly good and not quite coincident with the reasoning set out above. Through inspections, we observed only carpentry disjointed from their original position. There have been even cases where brick from outer leaf has fallen, and the inner, supposedly weaker, has stood holding the windows (Fig. 17).

Fig. 17 Carpentry behavior after Lorca's earthquake
