PAPER REF: 4023

CONDITION MONITORING OF HEAVY DUTY GAS TURBINE STATIONARY AND ROTARY BLADES

MAPNA Turbine Blade Engineering & Manufacturing Co. (PARTO), Iran

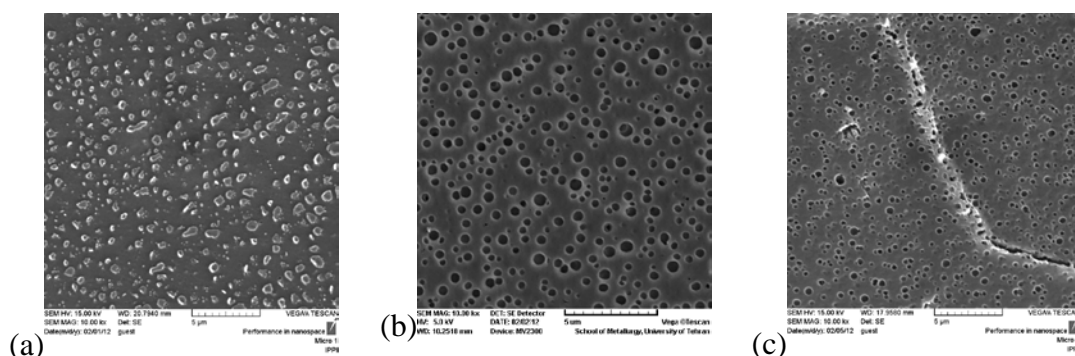
Replication was taken from the selected blades; although, third stage rotary blades were not considered because of the coating which had been applied on the airfoils. Fig.1 shows typical SEM images of one blade from each turbine stage. In all the three alloys, dissolution of fine gamma prime precipitates and coarsening of primary precipitates were observed. In addition, replica images displayed continuous carbide layers along grain boundaries in IN738LC and an unknown coarse phase located along grain boundaries in IN939.

Fig.1 Typical replica SEM image of (a) 3rd stage vane made of IN738LC, (b) 4th stage vane made of IN939, (c) 4th stage blade made of Nimonic90

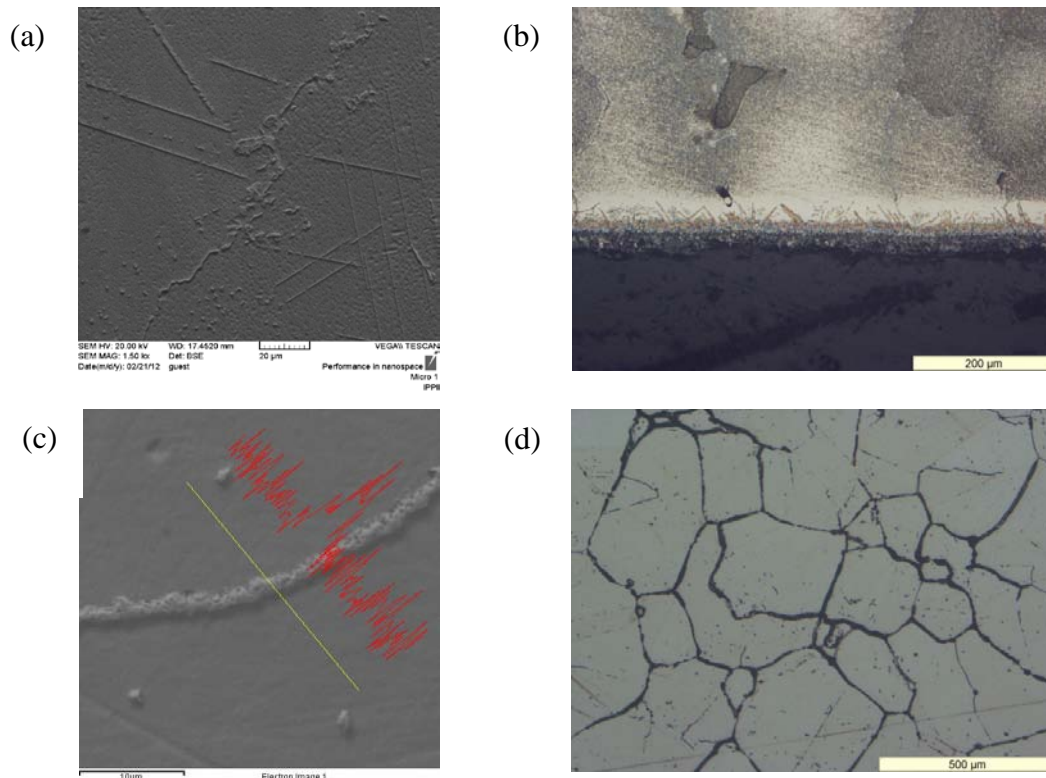
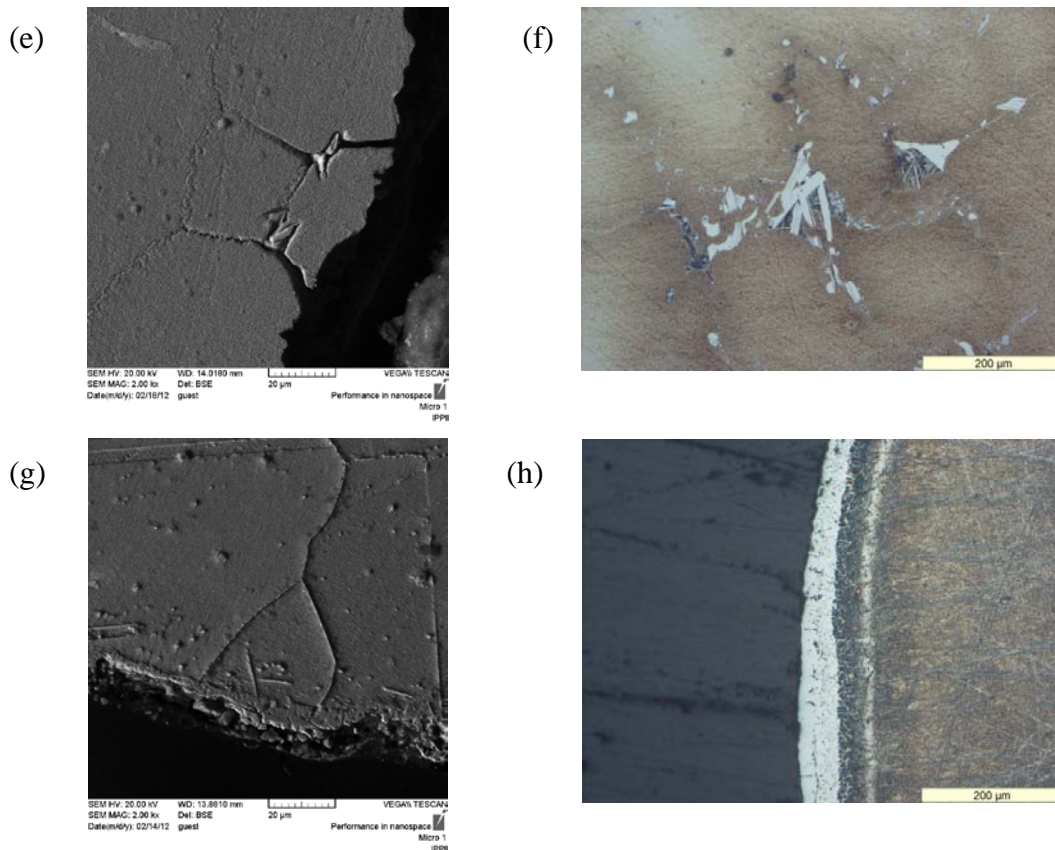
Fig. 2 Microstructural degradation in blades: (a, b) 3rd vane made of IN738LC, (c, d) 3rd blade made of Udimet520, (e, f) 4th vane made of IN939, (g, h) 4th blade made of Nimonic90

IN738LC vane had revealed large amount of needle-like TCP phase as well as thick layers of continuous carbides along grain boundaries (Fig. 2a). Furthermore, a 50 microns surface oxide layer was detected on external and internal surfaces of all three airfoil sections, under which needle-like nitride precipitates has been formed (Fig. 2b).

The microstructure of Udimet520 blade showed formation of continuous networks of grain boundary carbides (Figs. 2c & 2d). EDS analysis revealed high Cr content in such carbides which is characteristic of $M_{23}C_6$ carbides (Fig. 2c).

IN939 vane likewise showed continuous grain boundary carbides at hot regions as well as some white-colored plate-like TCP phases which were rich in Ti, Ta and Cr (Fig. 2f). Formation of these phases along grain boundaries had made the material so brittle that crack nucleation could easily occur (Fig. 2e).

The microstructure of the Nimonic90 blade, especially at mid-span section, included continuous carbide layers and a thick oxide layer. Additionally, needle-like TCP phases were observed at hot regions near the surface (Figs 2g & 2h).

- Formation of a high amount of TCP phases in the mid-height of the 3rd stage vane made of IN738LC.
- Formation of continuous carbide layers along the grain boundaries; as well as complete consumption of coating in the 3rd stage blade made of Udimet520.
- Formation of continuous grain boundary carbides at hot regions as well as some white-colored plate-like TCP phases in the 4th stage vane made of IN939.
- Formation of continuous carbide layers, needle-like TCP phases and a thick oxide layer on the surface of the 4th stage blade (Nimonic90).

In addition, mechanical testing showed a decrease in ductility of all alloys which were consistent with microstructural results showing brittle phases formation. Accordingly, these blades and vanes were not able to tolerate possible FOD or trip overloads and an extra 25000 hours application of these components was not recommended.
