# Addressing Soft Rock Hazards: Case Studies of Sinkholes and Collapses in Faulted Limestone Strata

Seokwon Jeon

**Abstract:** Soft rock formations, particularly faulted and fractured limestone strata, are susceptible to ground subsidence and collapse, posing significant geohazard risks in mining regions. This paper presents two case studies from South Korea that exemplify the complex interplay between geological conditions, anthropogenic excavation, and surface deformation. The first case focuses on a large-scale subsidence event at the Uljin limestone mine, where subsurface cavities, developed along faulted and karstified limestone zones, were found to be the primary cause of surface sinkholes. Geophysical surveys, borehole investigations, and three-dimensional numerical modeling confirmed that past mining operations intersected with natural weak zones, resulting in progressive ground instability. The second case examines the Yemi Mountain area, where sequential surface collapses and slope failures occurred in a zone underlain by old mine workings and structurally weakened carbonate rocks. Detailed analyses, including resistivity surveys, drilling, and mechanical testing, ident

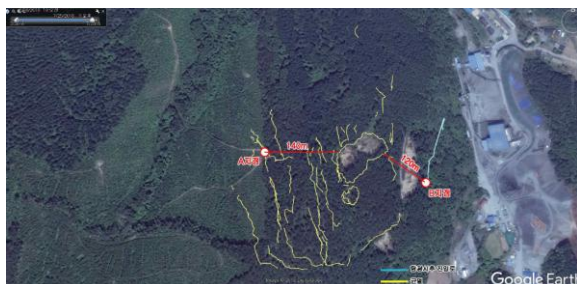
Figure 3. Borehole locations in the Yemi case

In the Yemi case, at Point B, two boreholes were drilled as shown in Figure 3: one horizontal borehole (BH-1) oriented N55W toward the lowest point of the primary subsidence area to investigate subsurface conditions and the boundary between the Hongjeom Formation and limestone, and one 40° inclined borehole (BH-2, 240 m long) designed to explore karst development within the limestone where past mining activity was suspected.

Borehole cores revealed core loss and fault breccia directly beneath the surface subsidence zone. In BH-2, continuous limestone and dolomite were recovered, and numerous small-scale (less than 1 m) dissolution cavities were observed. These findings suggest that faulted zones and small karstic cavities, in combination with past mining activity, likely contributed to the surface collapse.

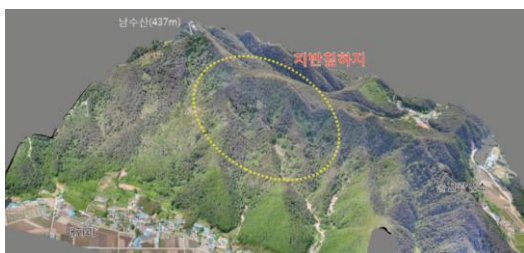
Figure 5. Location of Ground Subsidence in Uljin

Between 2007 and 2016, the area around Mt. Namsu (EL 438 m) experienced a subsidence zone approximately 500 meters in its long axis and 250 meters in its short axis, covering an area of about 30,000 m<sup>2</sup> (13 hectares). The subsidence took the form of a collapse depression accompanied by tension cracks. Four sinkholes—likely associated with nearby faults—occurred along the northern boundary of the subsided zone, and a long, large-scale collapse depression extended northward along the ridge from the summit of Mt. Namsu (Figures 5 and 6).

The surface manifestations of ground subsidence show different characteristics by zone: in Zone A, collapse-type and step-like subsidence occurred; in Zone B, numerous tension cracks were identified; and in Zone C, slope sliding was observed. These types of subsidence differ from the trough-shaped subsidence typically caused by over-excavation and resemble subsidence induced by geological factors. Moreover, little vertical displacement was observed within the boundaries of the subsided area, and no cracks were found between the northern ends of Zones A and B. This suggests that no tunnel collapse occurred directly beneath the center of the subsided area that could explain the surface deformation. Thus, based on surface observations, no correlation can be drawn between the subsidence and over-excavation.

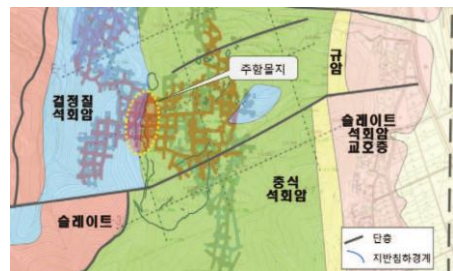
Figure 7. Geology Around the Main Collapse Zone

The investigation confirmed that the initial collapse occurred at the boundary between crystalline limestone and bedded limestone. This area corresponds to the major collapse zone shown on the level maps for Levels 60 and 80. These Levels were excavated through comparatively competent rock within a weak zone, likely to access the eastern ore body.

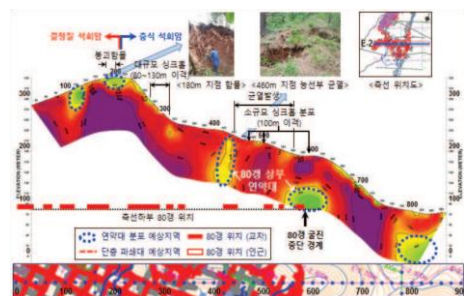
Figure 8. Electrical Resistivity Survey Results Across the Main Collapse Zone

The electrical resistivity survey conducted across the main collapse zone in the east-west direction revealed a low-resistivity anomaly from 180 to 200 meters at depths of up to 20 meters as shown in Figures 8 and 9, with relatively higher resistivity values below. Levels 60 and 80, which run east-west, pass through this zone. This suggests that this section had better rock quality than surrounding areas, allowing excavation across the weak zone.

However, this area corresponds to the boundary between crystalline limestone and bedded limestone, where excavation may have exposed weak rock zones. Infiltration of rainwater likely led to weathering of the limestone, resulting in reduced shear strength of the rock.

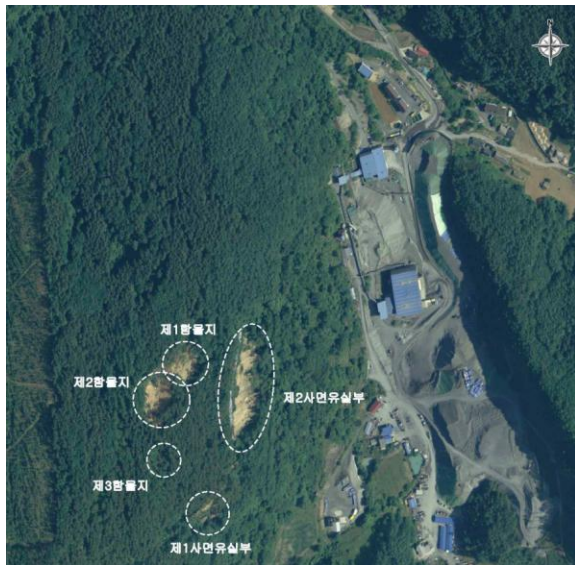
Figure 12. Aerial photo of ground subsidence area at Mt. Yemi

Since a major slope failure occurred in 2010, the Mt. Yemi area has experienced two additional slope failures, three sinkholes, and numerous tension cracks near the mountain summit. These developments have raised serious safety concerns for nearby residents and mine workers. Figure 12 shows an aerial photograph in 2017. Satellite imagery analysis revealed northeastward surface displacement due to the slope failures and sinkholes, while tension cracks occurred toward the southwest, opposite the direction of movement. This suggests a strong link between slope failure and surface collapse.

In the Yemi case, aerial photographs taken on May 8, 2011, revealed the initial sinkhole (Sinkhole 1), followed by the appearance of Sinkholes 2 and 3 in 2013. Sinkholes 1 and 2 were adjacent, while Sinkhole 3 was located approximately 20 meters south. Although Sinkhole 1 initially appeared larger, over time the affected area expanded such that, by 2017, the two formed a single depression with a total estimated collapsed volume of about 25,000 m<sup>3</sup>. The terrain elevation varies by approximately 20 m between the southwest and northeast boundaries, due to the influence of the Mt. Yemi peak. The expansion of Sinkhole 2 toward the southwest appears to be caused not by new subsidence but by slope failure within the original sinkhole boundary. Sinkhole 3 has retained a near-circular shape.

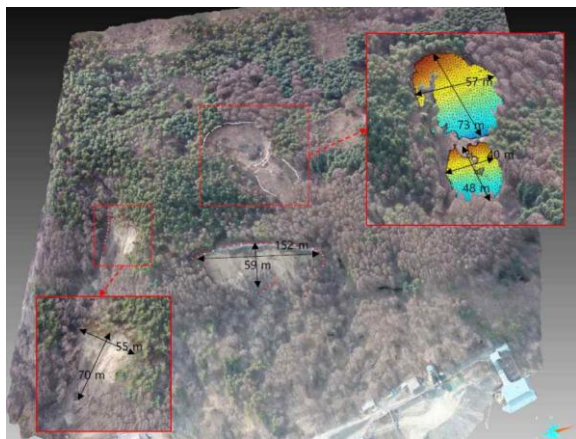
Figure 13. Dimensions of sinkholes and slope failure zones

High-resolution drones with georeferencing capabilities were used to capture aerial photographs as shown in Figure 13, which were then employed to construct a 3D topographic model of the study area. This allowed for quantification of the size of the sinkholes and slope failure zones. The dimensions of the sinkholes were estimated as follows:

- Sinkhole 1: 48 m (long axis)  $\times$  40 m (short axis)
- Sinkhole 2: 73 m  $\times$  57 m

- Slope failure 1: 55 m wide, 70 m in downslope length
- Slope failure 2: 152 m wide, 59 m in downslope length

- Sinkhole 1: 4,288 m<sup>3</sup>
- Sinkhole 2: 20,712 m<sup>3</sup>

Although the lateral expansion of Sinkhole 2 appears prominent, it is likely due to internal slope sliding within the sinkhole rather than ongoing surface subsidence. The combined volume lost beneath the surface, based on the difference between the original and current ground surfaces, is estimated at 25,000 m<sup>3</sup>.

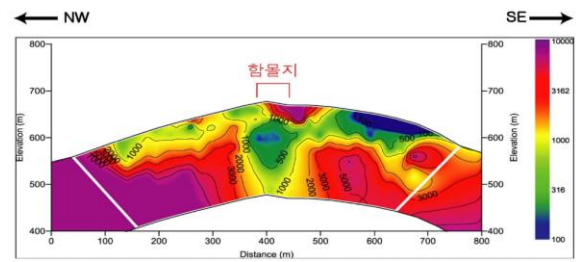
Figure 14. Line-3 electrical resistivity survey results for the Mt. Yemi case

The results from the Line-3 resistivity survey (Figure 14) reveal a distinct low-resistivity anomaly extending to depth beneath the central part of the sinkhole. This is attributed to the presence of a fault breccia zone, consistent with borehole investigations that identified core loss and fault breccia below the sinkhole. Furthermore, the lowest resistivity value—observed at the 600 m mark along Line-1—suggests the presence of a subsurface void responsible for triggering the surface collapse near the 600 m elevation.

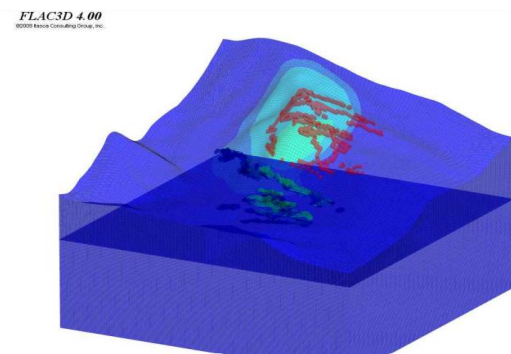
Figure 18. Influence zone of ground deformation induced by mined-out cavities at Mt. Yemi

In the Yemi case, a FLAC3D analysis was conducted, focusing on the distribution of plastic zones resulting from the application of the strength reduction method. The Mohr-Coulomb failure criterion was used, and cohesion, internal friction angle, and tensile strength were all reduced to simulate failure. Figure 18 compares the numerically predicted deformation zone with the actual hazard area. The mapped hazard area, based on field surveys, includes numerous tension cracks toward the south and west, which align well with the predicted deformation zone. This supports the conclusion that overall ground deformation induced by mined-out voids is closely related to the surface cracking observed.
