International Journal of Coal Science & Technology

Analysis of a rock slope instability mechanism combining wedge and circular failure in a soft rock mass

Sifan Yuan¹, Bingdong Ding^{1,2}, Kai Guan^{1,3}, Ignacio Pérez-Rey¹, Tonglu Li⁴, Leandro R. Alejano^{1*}

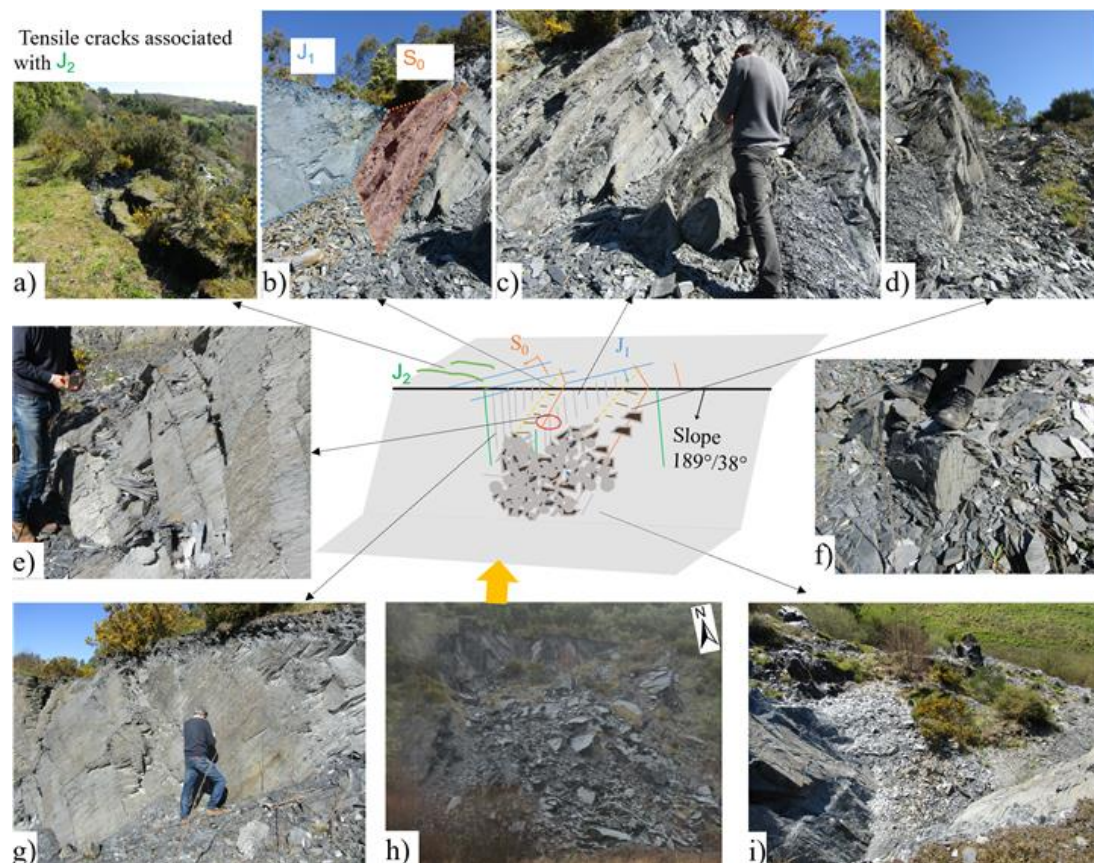
Two field visits were conducted in 2021 to investigate the localized instability in the upper part of the north slope of the mine. The unstable section, composed of weathered and tectonized phyllite (Fig. 5g), is approximately 35 m long, with a slope height of 25 m, a dip direction of 189°, and a dip of 38°. Different pictures of the instability zone are presented in Fig. , where a central sketch synthesizes the most relevant observations.

Figs. 5h and 5i provide frontal and top views of the instability. The slide mass has accumulated in the middle and lower parts of the slope, and a distinct two-wedge saw-tooth-shaped back limit of the failure is clearly visible at the crown of the slope. To enhance clarity, a simplified line drawing in the middle of the figure outlines the key instability features. In the rock mass and mostly at the accessible part at the top of the slope, three major discontinuity sets were identified: S_0 , J_1 , and J_2 . S_0 represents the foliation and primary weakness direction of the phyllite, while J_1 and J_2 are additional joint sets. The main sliding surfaces are formed by S_0 and J_1 , creating two dihedral sliding planes (Figs. 5b and 5d) with a central protuberance (Fig. 5e). The right-side sliding surface is defined by joint J_1 presenting a large outcropping area after failure (Fig. 5g). J_2 , with a sub-parallel strike to the slope and a dip against it, has apparently contributed to the formation of tension cracks at the crest (Fig. 5a).

Fig. 5 Illustrations and photos of the main features of the failed slope sketched in the center of the figure: **a)** Tensile cracks associated with J_2 **b)** Wedge-shaped sliding surface formed by S_0 and J_1 **c)** Protuberant rock mass formed by S_0 and J_1 **d)** Sliding surface on the upper left side **e)** Detail of S_0 **f)** Low-quality tectonized rock mass in the accumulation body **g)** Sliding surface along J_1 **h)** Front view **i)** Overhead view from above

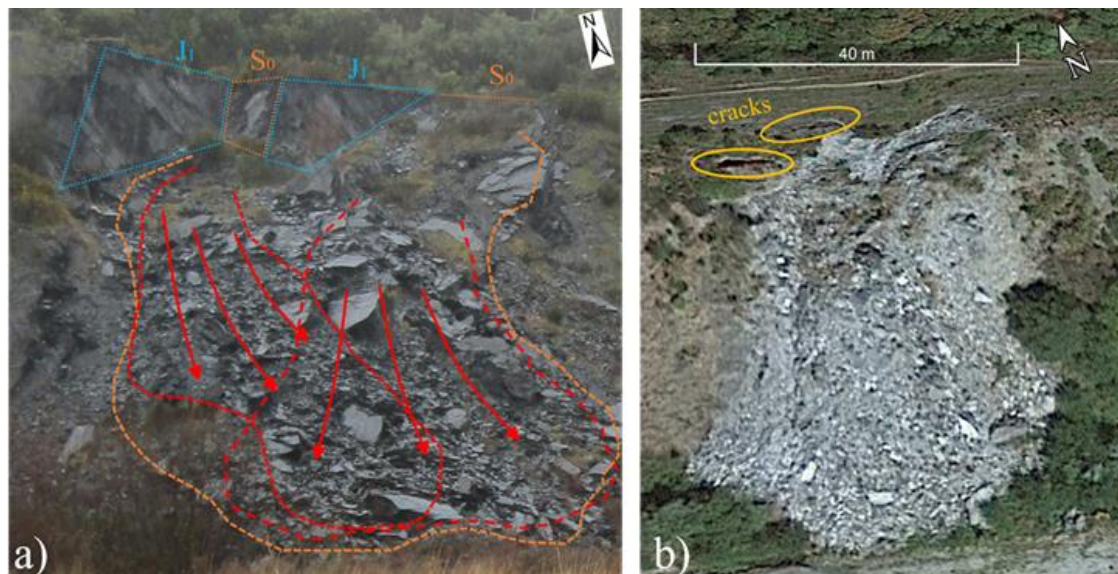
Fig. 8a shows the appearance of the failure under scrutiny photographed from the base of the slope in 2021, where discontinuity planes are observable at the top. Fig. 8b provides an aerial perspective of this unstable area, taken from a Google Earth image in 2017, where discontinuities and two tension cracks can also be identified at the top. Although discontinuities are present, a clear or straightforward failure pattern cannot be readily identified, nor is there evidence of a simple slope failure mechanism, such as planar, wedge, circular, or toppling failure, is observed in this case.

Fig. 8 a Photograph from the base of the slope showing the instability of the bench, and **b** Detailed aerial photograph of the local instability taken from Google Earth in October 2017

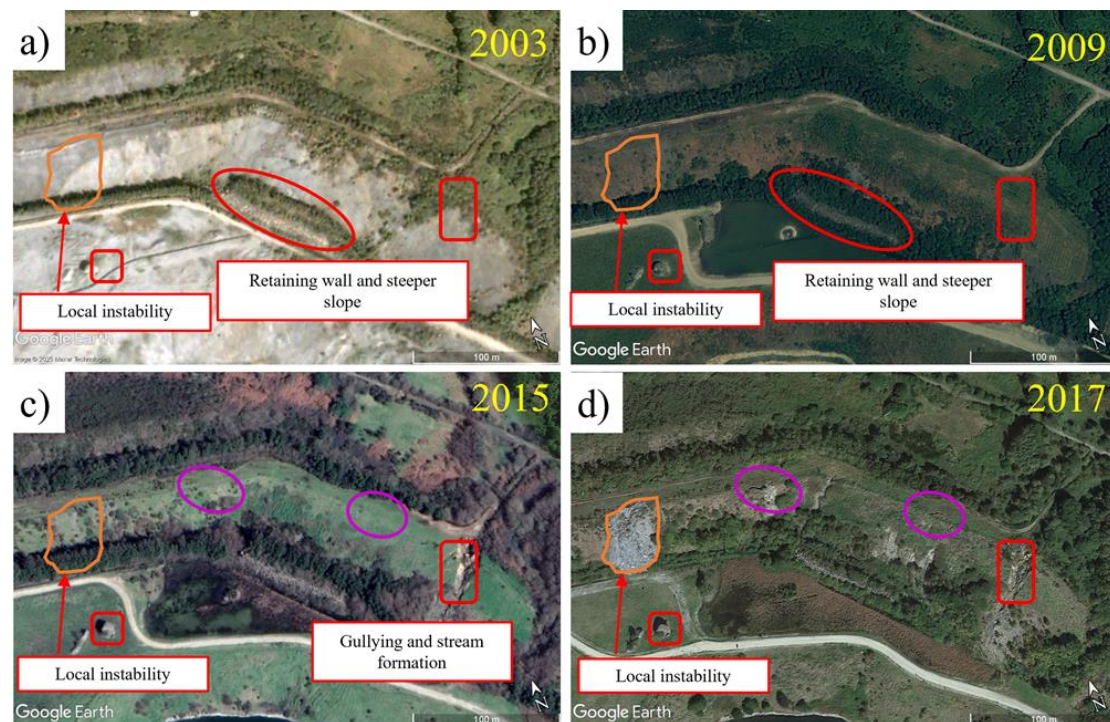
Fig. 9b shows the same area in 2009, after the mining extraction process had stopped but before the lake filling was completed. By this time, the entire area was revegetated, with denser vegetation in the previously mentioned retaining wall. No signs of instability are observed. Thus, no stability problems were identified in the detailed analysis area more than 25 years after excavation.

The following aerial image (Fig. 9c) was taken in March 2015, six years after the previous one and about three years after the lake filling was completed. By this time, vegetation had become denser, and localized erosion was observed on the south-east due to stream evolution. Nevertheless, more than 30 years after excavation, no significant instability phenomena had occurred in the studied zone, despite fluctuations in groundwater levels associated with occasional periods of intense rainfall.

Fig. 9 Details of the instability area in a) 2003, b) 2009, c) 2015, and d) 2017

The aerial image in Fig. 9d, taken in October 2017 shows, for the first time, the appearance in Google Earth of the local instability under study. There has been no notable change in the state observed in this photograph compared to the field observations made during visits in early 2021. Additionally, the opening of two local tension cracks at the top of the bench can be observed, marked with magenta ovals.

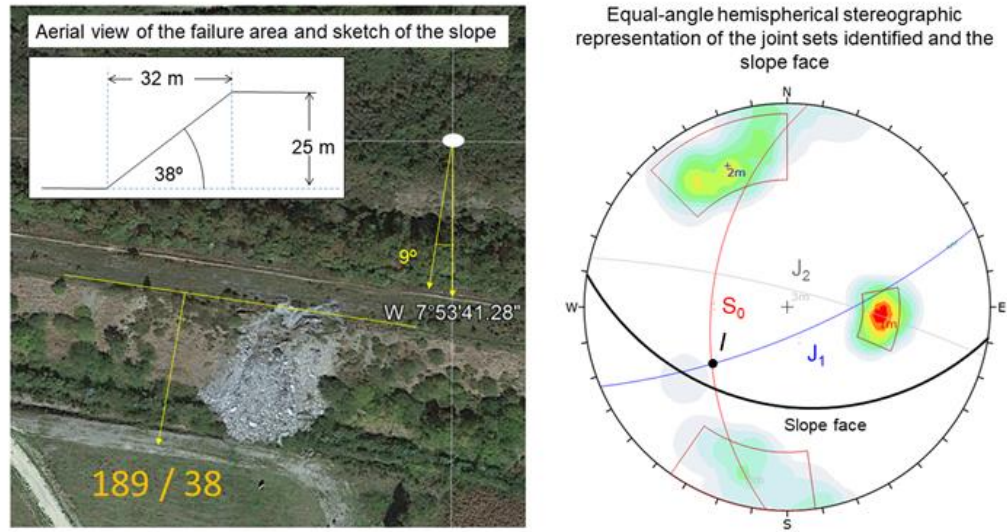
To identify the possibility of this type of failure mechanism, we compare the orientation of the bench slope under study with the stereographic representation of the discontinuity orientations measured in the field, as shown in Fig. 11. For a better understanding, the interpretation of the failure mechanisms is presented with front and side view sketches in Fig. 12. As illustrated, a double-wedge rock block is

formed by the dihedral planes of S_0 and J_1 . The intersection (I) of these planes dips at an angle greater than 40° , which means it cannot intersect (daylight) the slope face dipping 38° .

Fig. 112 Aerial view of the failed bench and stereographic representation of the joint sets at stake and the slope face.

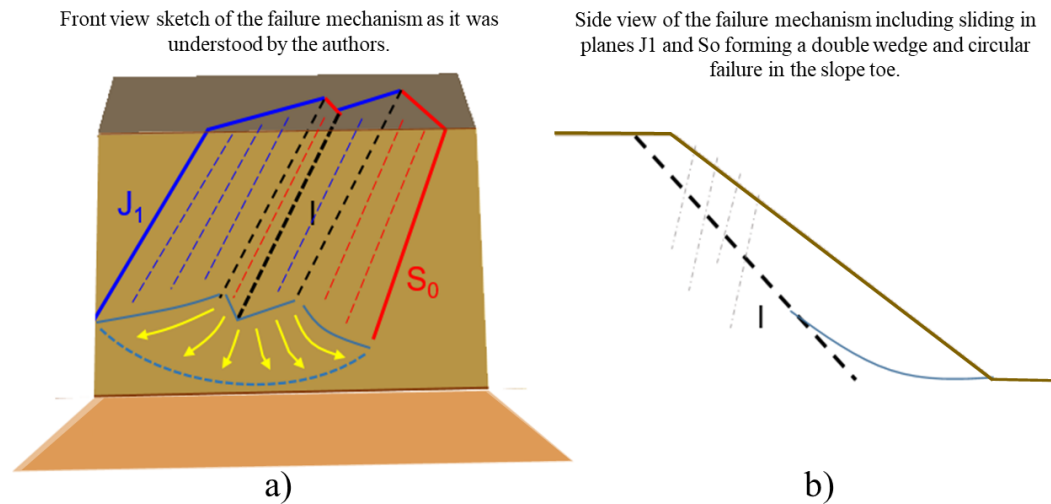
Fig. 12 Interpretation of the failure mechanisms showed in a) front view and b) side view schematics.

Consequently, no wedge failures occur under these conditions. However, as the authors interpret, if there was a possible shear zone through the toe of the slope breaking through the rock mass, the failure mechanism could involve a typically circular failure pattern in this part. Based on these observations, and considering the relatively low quality of the rock mass and its susceptibility to weathering processes, the so-called wedge-circular instability mechanism was introduced to explain the phenomenon of combined wedge and circular failure mechanisms in soft rocks. Although it may be claimed to be speculative, this reasoning is consistent with all the field observations and will be further evaluated using

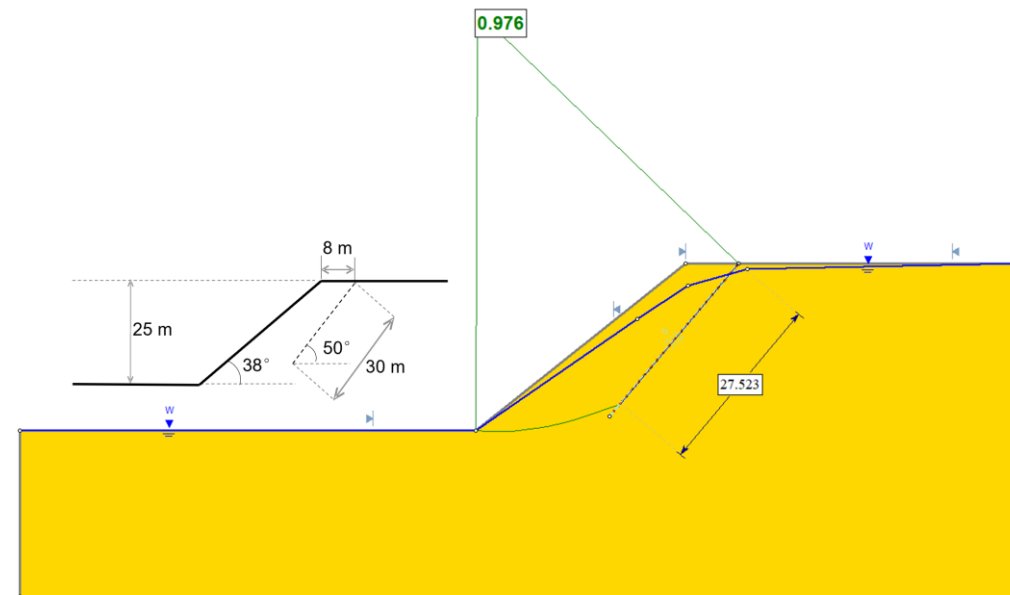
Fig.13 presents the failure mechanism of saturated intermediate values scenario ($Fos = 0.976$). The Spencer method identifies the failure surface as a combination of a 27.52 m planar segment and a circular component, with the circular part emerging at the toe of the slope. Considering the predefined geometry, the planar segment was initially set at 30 m, slightly longer than the computed 27.52 m. However, trial tests indicate that increasing the length of the planar segment beyond this value does not significantly affect the overall failure mechanism.

Fig.13 The interpretation of the failure surface for the saturated intermediate values scenario

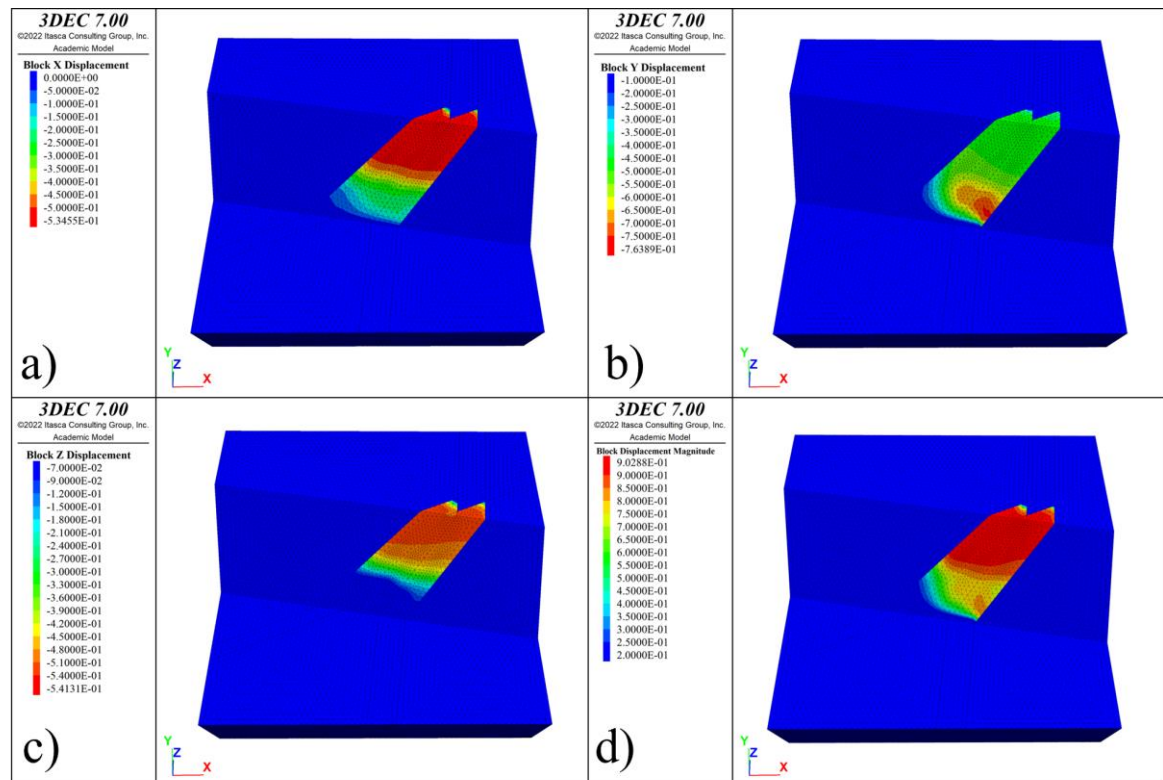
Fig. 17 3DEC analysis: displacement distribution for the case of minimum strength values and saturated slope. a) x-

direction, **b**) y-direction, **c**) z-direction, and **d**) magnitude

Fig. 17 shows the displacement distribution of the unstable state (minimum values saturated). As can be observed, the displacement consists of two components: the upper part exhibits a uniform displacement pattern, suggesting a wedge failure mechanism, while the lower part displays an uneven displacement distribution, characteristic of a circular failure mechanism.

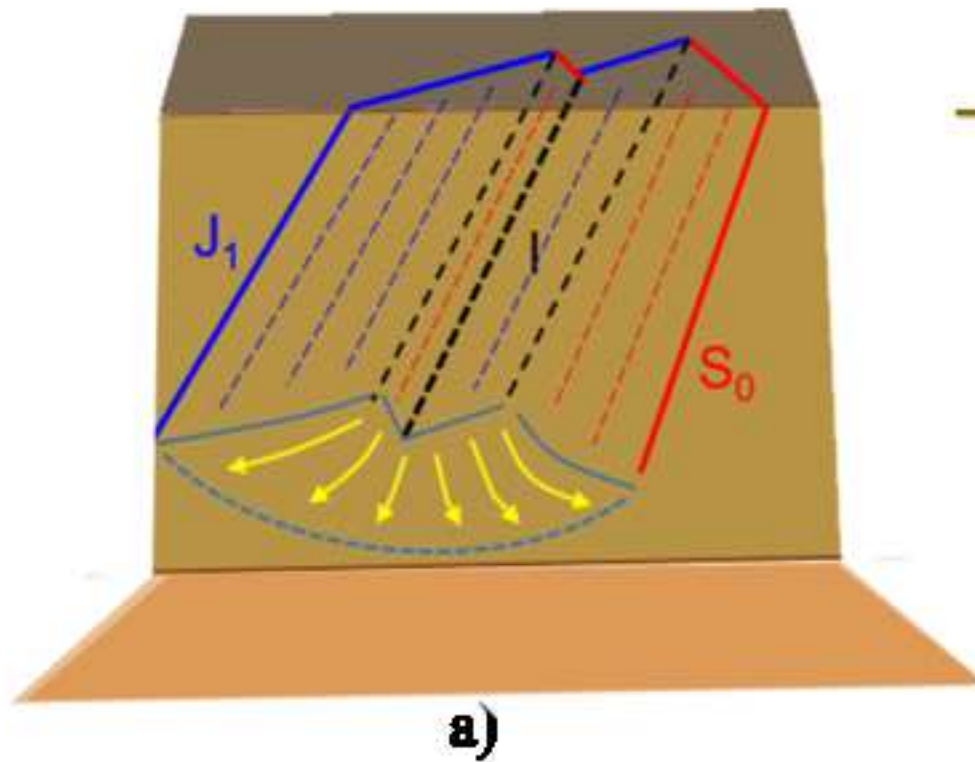
Side view of the failure mechanism including sliding in planes J_1 and S_0 forming a double wedge and circular failure in the slope toe.
