Remote Sensing Strategies for Effective Landslide Risk Management in a Geologically Heterogeneous Slope

Abstract On November 23, 2022, a catastrophic landslide occurred in Palmeira de Faro, Esposende, northern Portugal, resulting in the loss of two lives and substantial structural damage to nearby residences. This landslide serves as a case study for the monitoring of geologically heterogeneous slopes that present complex stability challenges. The affected slope, excavated in weathered porphyritic granite and surrounded by varied metamorphic rocks, displayed a highly heterogeneous weathering degree (grades II to V), ranging from soil, soft rock to almost unweathered hard rock, also displaying several structural discontinuities. These geological factors, coupled with an abnormal increase in rainfall in the previous months, were significant contributors to the slope's instability. A multi-technical monitoring strategy was implemented, including topographic markers, laser scanning, drone-based photogrammetry, and InSAR ground motion detection. Each technique provided unique insights, with InSAR detecting minor shifts that indicated early-stage instability, while drones and laser scan

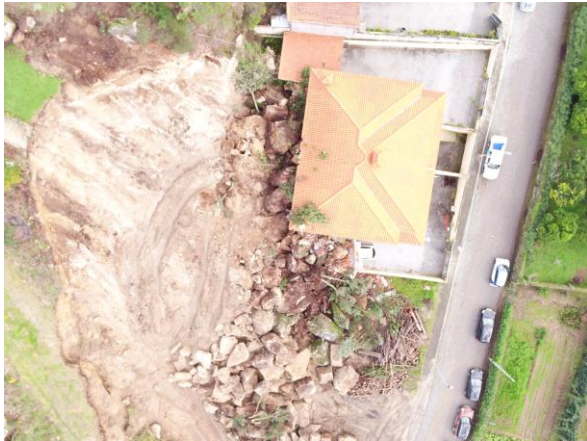
The estimated volume of displaced material was 2000 m³, with the mass following an oblique trajectory relative to the slope, measuring 55.7 meters in length, 36.8 meters in width, and 7.7 meters in depth. The movement's direction was heavily influenced by structural discontinuities, which formed

Fig. 1 Photo of the landslide occurred in November 2022.

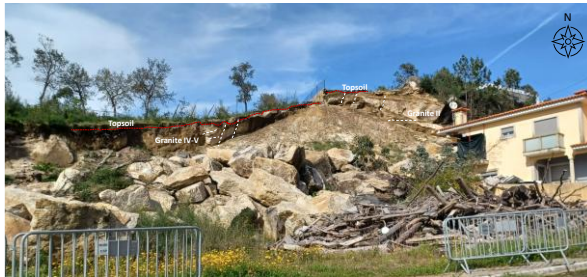
Fig. 2 Front view of the failed slope.

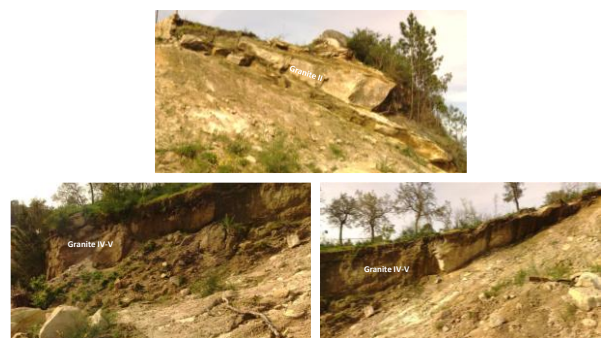
The rock mass of the faulted slope (**Fig. 3**) shows weathering degrees from II (slightly weathered) to IV–V (highly to completely weathered), with a thin topsoil layer and vegetation including shrubs, grass, pine, and eucalyptus. The

area is marked by significant NNE-SSW and ENE-WSW faults, with additional NW-SE faults (Tomás et al., 2023).

Given this information, it is expected that the heavy rainfall in November (and October) had a significant impact on the soft rock, as well as the fact of having abnormally dry summer months. The persistent and intense rainfall have brought the soil to total saturation, creating conditions to the collapse of granite blocks along pre-existing discontinuities with unfavourable orientations.

Fig. 3 Geological characterization and weathering degree of the rock mass. Highlight of the most heterogeneous parts.

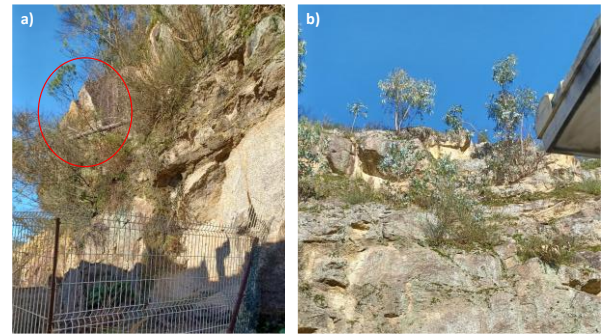
Visual inspections of the slope, including the most recent on April 11, 2024, classified the overall slope conservation state as “Reasonable”. However, for sections of house n.11 and 12, the conservation state was rated as “Bad” due to the presence of potentially detachable blocks posing a risk of falling (**Fig. 8**). Despite these conditions, no changes in the assigned conservation state were observed from the initial inspection in November 2022 to the most recent one, performed in April 2024.

Fig. 8 Presence of potentially detachable blocks at risk of falling on slope sections 11 and 12.

As results, the application of SQI were in concordance since they reflect the same conclusions as the one obtained on visual inspections. House 11 and 12 classified as ‘Bad’ and the remaining with the state of ‘Reasonable’. Similarly, to visual inspections, the empirical system was also computed in every inspection. Therefore, despite the slight improvement compared to the 2022 results (mainly due to the lower evidence of water presence in the slope face), buildings 11 and 12 remain the most critical, requiring short-term interventions to mitigate the risks. The results of the empirical systems as well as the visual inspection are displayed in **Table 3**. Specifically, based on RHRSm2 system application, which focus on the risk of falling blocks, all assessed houses were classified as having a ‘Medium’ risk, except for house n.11, which categorized a ‘High’ risk and house n.12, which, while rated as “Medium” risk, was close to the High Risk’ threshold. Compared to 2022, either visual inspection results and empirical systems (SQI and RHRSm2) showed a slight improvement in the results, attributed to the reduction of water on the slope face, which had in a first analysis significantly increased the risk.

House	RHRSm2 (2022)	RHRSm2 (2023 - 2024)	Risk level (RHRSm2)	SQI (2022)	SQI (2023 - 2024)	Slope condition (SQI)
14	243	201	Medium	3.13	2.70	Reasonable
13	249	207	Medium	3.34	2.94	Reasonable
12	315	273	Medium*	3.46	3.08	Bad
11	351	291	High	3.51	3.08	Bad
6	249	201	High	3.13	2.80	Reasonable

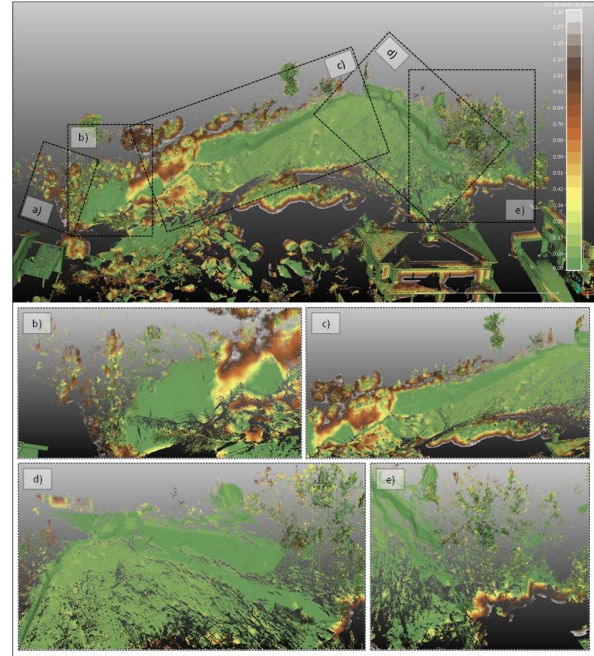
The comparison of point clouds between the first survey (L1, November 28, 2022) and the last survey (L6, April 11, 2024), covers approximately 1.5 years, including two winter seasons with heavy rainfall, which contributed to the accumulation of erosion phenomena on the rugged slope. **Fig. 9** shows the absolute XYZ distances between the L1 and L6 point clouds of the slope (collapsed slope), highlighting small detachments in the western block (sections b and c), material accumulation at the slope's base, and intensified erosive movements on the rocky face (section d).

In section e), the largest displacements, represented by yellow and brown colors, are artifacts caused by limited laser scanning coverage near the slope's base and close to the

damaged structure, where accessibility challenges exist. Along the slope crest, the detected displacements are likely due to the growth of vegetation. These findings reflect small, continuous movements along the slope mainly a result of the erosion factors during the season.

Fig. 9 Total differences between the L6 and L1 clouds in the slope (in meters, X axis - red, Y axis - green and Z axis - blue) with enlarged highlighted areas: a), b) and c) belong to the West bloc; d) belong to the Central and East bloc and e) belong to the East bloc.

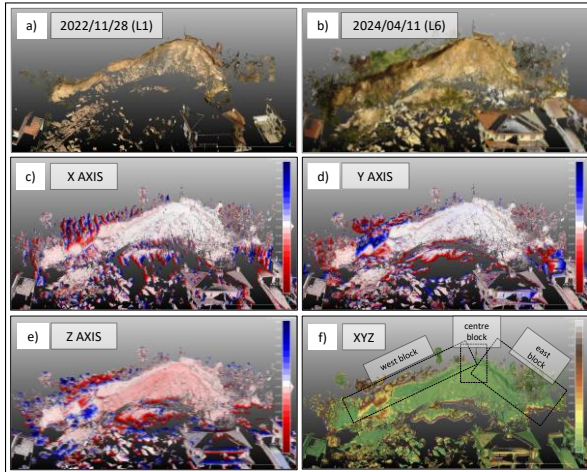
Fig. 11 illustrates the 3D model depicting the magnitude and direction of displacements along the X, Y, and Z axes. Key movements were identified on the slope faces: along the X-axis on the western slope, minor displacements ranging from 1-4 cm were observed, with slightly higher values in localized areas moving east-west (negative X). Positive X-axis movements ranged from 1-8 cm, associated with small-scale soil detachments near the slope's crest. At the base of the western slope, sediment erosion and accumulation were attributed to rainfall runoff. On the eastern bloc (Y-axis), evidence of erosion and block rotation was noted, particularly in exposed areas. For the Z-axis, the most significant displacements occurred at the slope's base (negative Z), varying between 1-12 cm, primarily driven by surface water

Fig. 10 3D visualisation (X axis - red, Y - green and Z - blue) of the L6 - L1 slope clouds: a) and b) RGB images; c), d) and e) Calculated distances in the X, Y and Z direction (respectively) from the slope, in meters; f) Calculated absolute distances in meters.

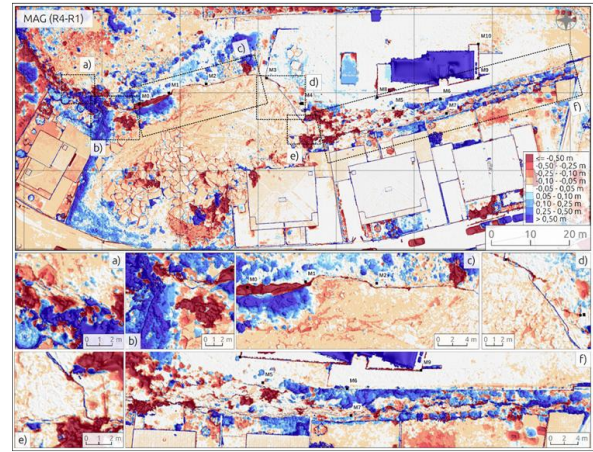
The monthly monitoring of targets installed along the slope's crest enabled the assessment of potential displacements. During the observation period, two targets (M0 and M4) (**Fig. 11**) were lost due to soil detachment, requiring the installation of new targets to maintain monitoring continuity in these areas. Integrating this data with the information derived from the generated 3D models allowed for a clear identification of the most vulnerable sections of the slope, highlighting areas in need of stabilization measures.

Fig. 11 highlights the main areas of interest, including the western section (**Fig. 11** – a) to c)), the central and eastern sections (**Fig. 11** – d) and e)). In the western section, most of the changes are attributed to vegetation growth, except in the area of **Fig. 11** – b), which is a zone of material accumulation. In the area of **Fig. 11** – b) to c), the detachment of material at

the crest of the slope continues to expand to the southwest.

Fig. 11: Geomorphological change map (MAG) obtained by comparing the survey carried out on 26/11/2022 (R1) and the survey carried out on 11/04/2024 (R4), with the location of monitoring points M0 to M10.

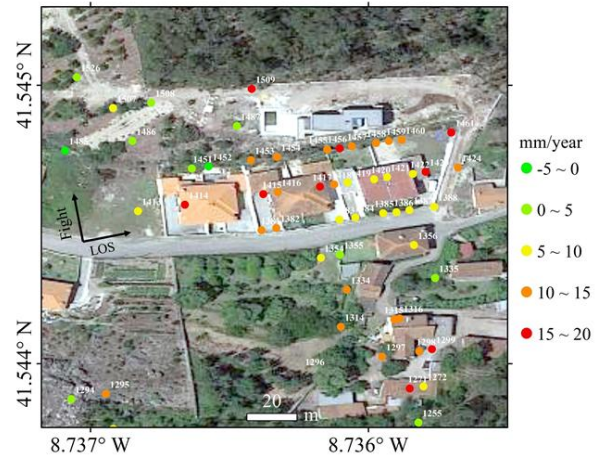
Finally, the annual displacement rate map and displacement time series were computed, providing a detailed visualization of surface movements. The deformation map in **Fig. 13** illustrate the spatial and temporal dynamics of the analyzed area. While small point targets are detected on the fault slope, both the building and the surrounding soil exhibit significant signs of deformation. Notably, the displacements observed in the surrounding building are greater than those on the slope itself. Additionally, higher point targets show a positive displacement rate. Taking into account the local topography and angle of incidence, this could be attributed to the relative motion between the satellite and the ground surface. However, further evidence is needed to validate this hypothesis. SAR images from descending orbits should also be analyzed and compared with those obtained from ascending orbits to assess the influence of the angle of incidence and the line of sight (LOS) direction. Subsequently, the results should be validated using data from GNSS (Global Navigation Satellite System) stations to determine whether the InSAR measurements align with the terrain topography.

Fig. 13 Annual displacement rate map in LOS (Line of Sight) direction.

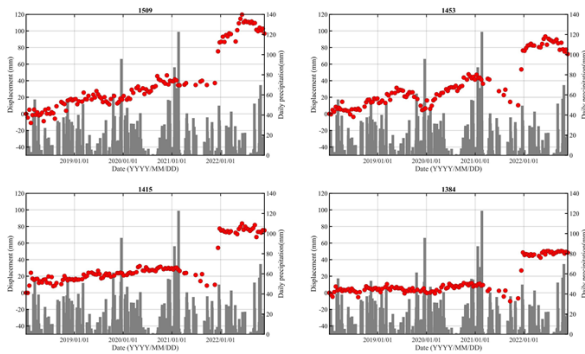
To detect precursors and investigate the failure process of the landslide, displacement time series of selected points were extracted. **Fig. 14** shows the displacement time series of point targets with significant displacement. The four typical points in **Fig. 14** exhibit a similar sharp acceleration in January 2022, which can be correlated with daily rainfall events or other external events such as excavations. The point targets in **Fig. 15** are located near the failure slope. While the displacement magnitudes are lower than those in **Fig. 14**, all of them show periodic variations. Notably, four points (No. 1486, No. 1507, No. 1508, and No. 1452) display a clear increasing trend starting in January 2022.

Fig. 14 LOS (Line of Sight) Displacement time series of active point targets.
