PAPER REF: 3910

A MICROSCOPIC FAILURE ANALYSIS OF MEDIUM TRUCK BRAKE DISCS

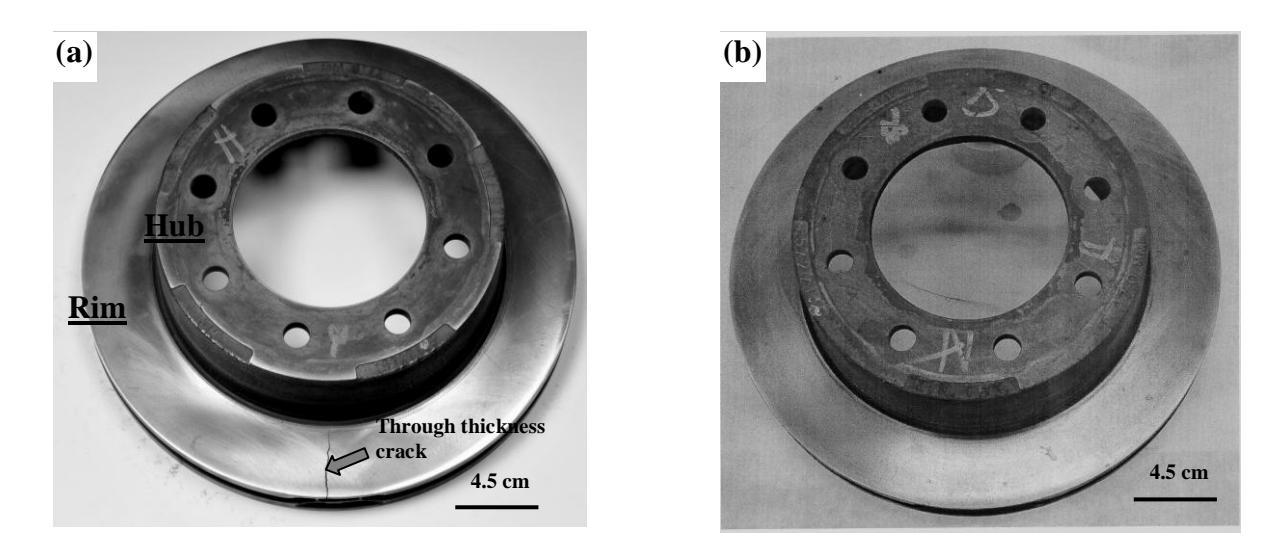
Two brake discs were examined; one (noted rotor 1) was removed after 15000 km of service which contain a through thickness macro-crack (Fig. 1a) while the second (noted rotor 2) was taken out after 6000 km of operating with no indication of macro damage (Fig. 1b). The visual inspection was carried out after soft polishing of the surface rim in order to get rid of dust and oxidation debris.

Fig. 1 The analyzed brake discs (lock bolts side); (a) cracked rotor 1, removed after service of 15000 km, (b) un-cracked rotor 2 removed after 6000 km of service.

In conclusion, in order to prevent or at least to reduce such failure, it has been suggested to replace the discs more often (the exact service time will be based on the fatigue crack initiation study) than recommended by the manufacturer due to the unique circumstances. Alternatively, to replace the conventional gray iron with flake graphite form to gray cast iron with graphite particles in the compact vermicular form (Goo and Lim, 2012) or by Ni addition and Ce inoculation to refine the graphite flakes (Yamabe et. al 2003). The latter material has longer crack initiation lifetime than the conventional material. In addition, to use higher strength steel with stronger resistance for thermal fatigue loading. This trend is being done

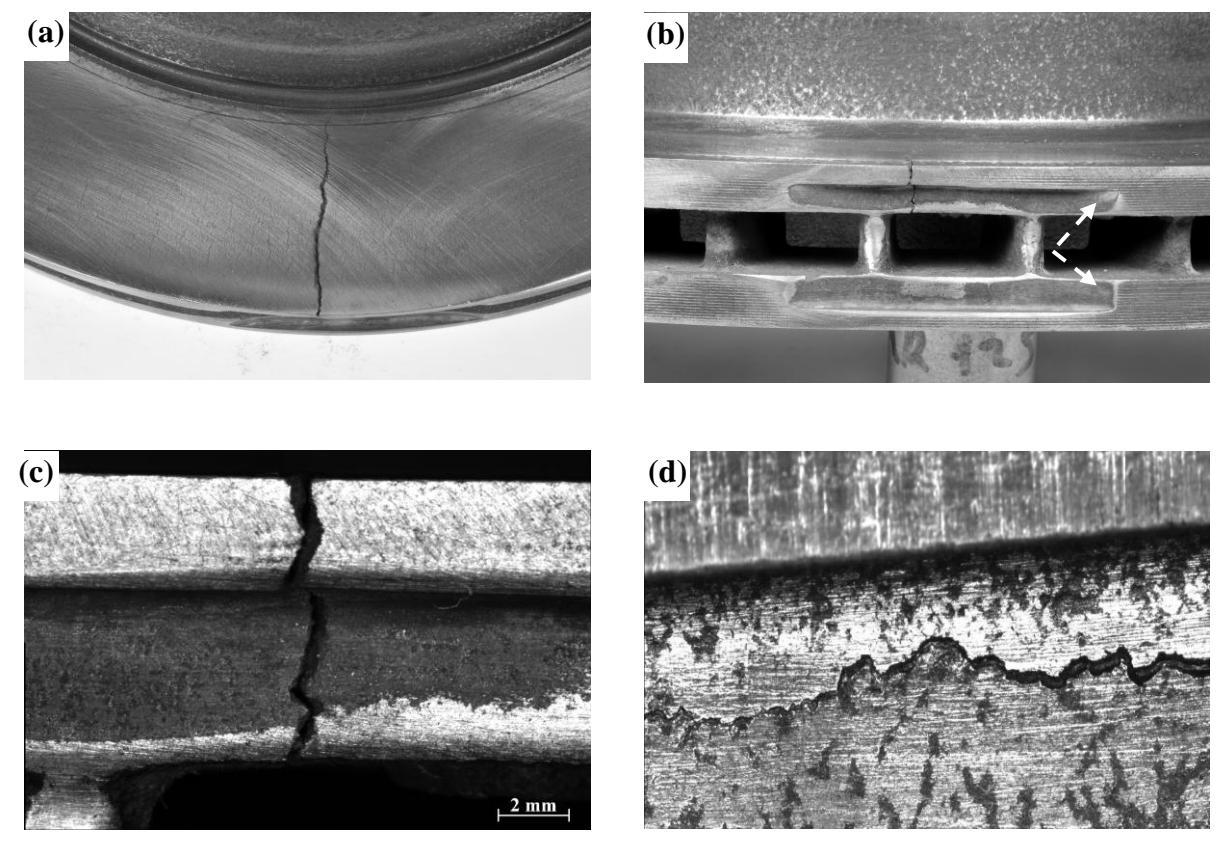
The macroscopic damage in rotor 1 in terms of through thickness crack is shown in Figs. 4a-d in different views indicating three major points; (1) the crack propagated from the exterior part of the rim to the interior one and was arrested at the hub / rim interface (Fig. 4a). This argument is based on the fact that high crack opening is involved at the exterior part (Fig. 4c) and decrease as the crack extended toward the interface hub/rim. (2) The crack propagated at the area where the material was removed by machining for balance consideration (Fig. 4b) (noted by dashed arrows). (3) The crack was initiated near the radius of the cooling vanes (Fig. 4c) and growth along the edge vane (Fig. 4d). The last two preferred cracking sites point out on the high sensitivity of this material to geometrical irregularities which act as local stress intensification. This mechanical response is related to the low ductility (less than 0.5% of elongation) of this brittle material.

Fig. 4 Different views of the macroscopic crack ; (a) rim top view, (b-c) side view depicted the crack preferred location, (d) the crack path in the vicinity of the wall van (view from the interior part of the rim).

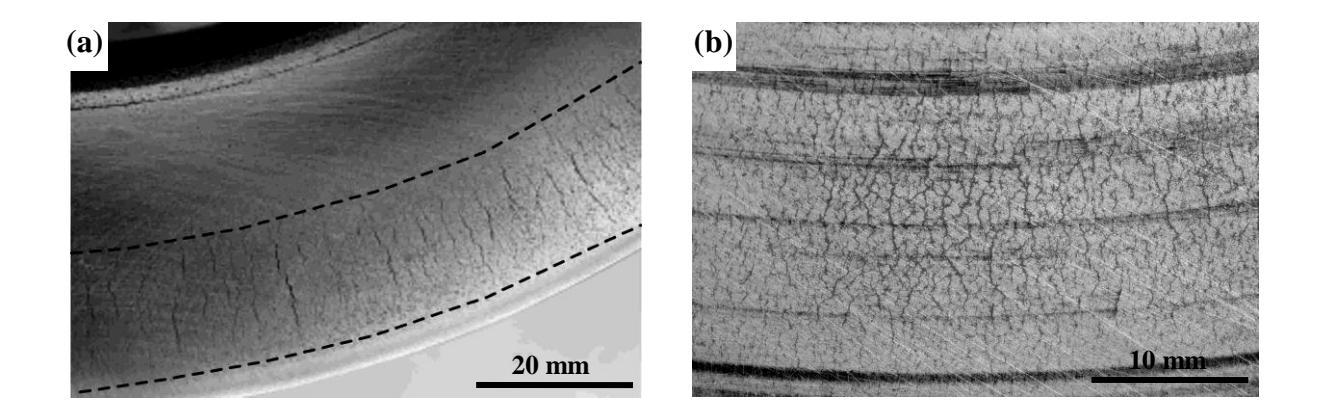
The major crack in rotor 1 was followed by heavily micro-cracking with some radial cracks which extend the trace of pad width as illustrated by two circumferential dashed lines (Fig. 5a). As shown the macro-mechanism of the main crack is the coalescence process of the micro-cracks as noted at the friction surface for some potential sites for macro-crack initiation. The extents of these cracks are in the range of 1-5 mm and the depth varied between 50 μ m up to 0.3 mm (Fig. 6a). As demonstrated, the crack origin is a pit, resulted from the preferred oxidation process at graphite flakes (marked by a dashed line). After reaching a critical pit length (around 100 μ m), crack initiation followed by the crack propagation stage which is being controlled mainly by mechanical process. The crack extended through the graphite flake (see arrows in Fig. 6b) and later on at the interface graphite flaks/pearlitic phase. These findings indicate on the low resistance to chemical and mechanical processes of the brittle graphite phase. The preliminary damage appears in terms

of the micro-cracking network as shown in Fig. 5b for the rotor 2 which was removed after only 6000 km. This form of damage is related to the presence of graphite flakes distributed randomly in the pearlitic matrix, the typical microstructure of this material as will be shown later on.

Fig. 5 Different types of microscopic damages; (a) radially orientated micro-cracks in rotor 1, (b) micro-cracks network in rotor 2.

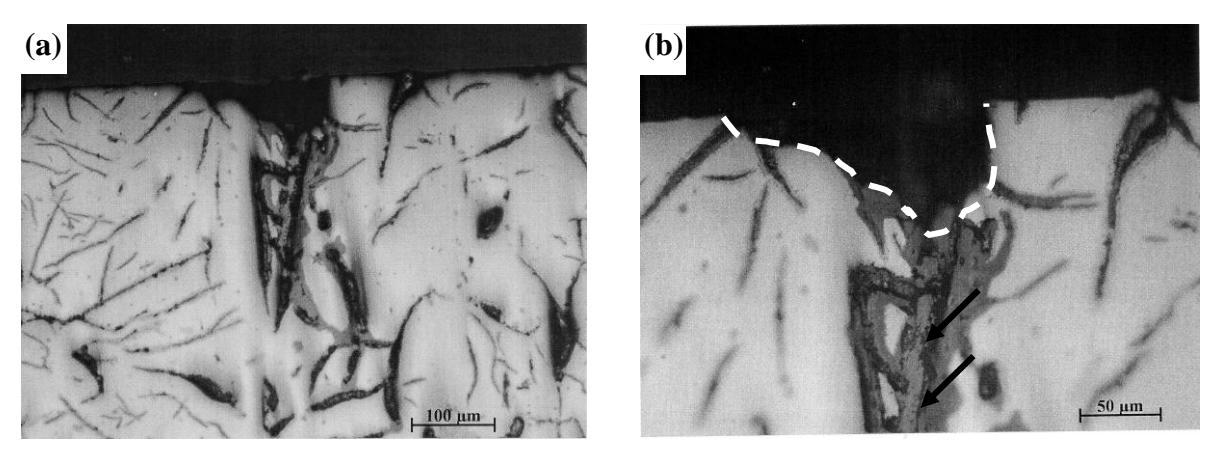
Fig. 6 The depth and the preferred sites of the micro-cracks initiation; (a) pit as a source for crack initiation, (b) crack propagates through graphite flake.

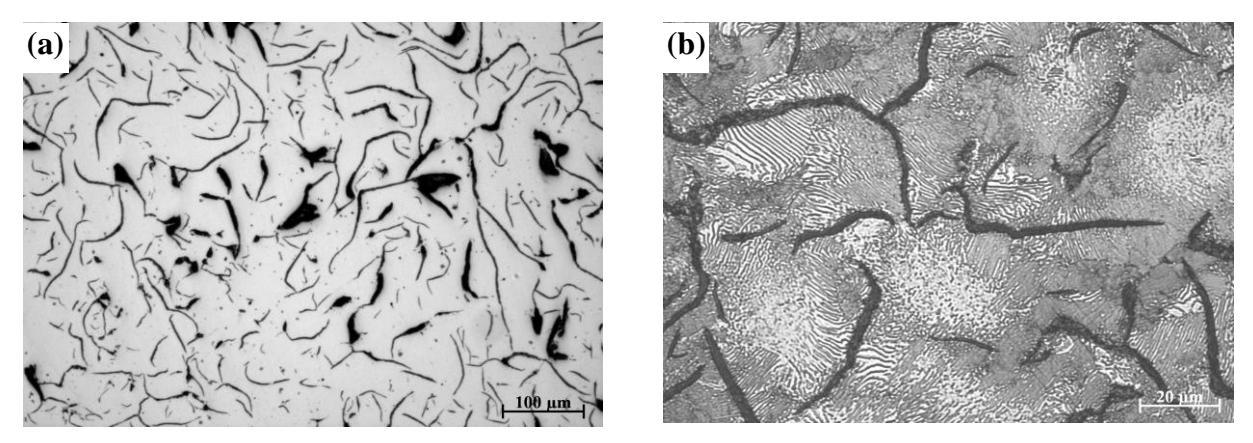
Figs. 7a and 7b illustrate the microstructure of the cast iron from the hub part, far away from the rim, which was exposed to high temperature due to braking cycle. As shown, the polished condition reveals random flake graphite in a uniform distribution which characterized A type graphite distribution in gray cast iron. Etching procedure exposed the graphite flakes within the pearlitic matrix accompanied by lamellar morphology; no evidence of ferritic or retained austenitic phases were detected.

Fig. 7 Microstructure of the cast iron characterizes a 'virgin' material; (a) as polished illustrates the A type graphite with a flake-like morphology, (b) etched sample showing graphite flakes dispersed in a pearlitic structure.

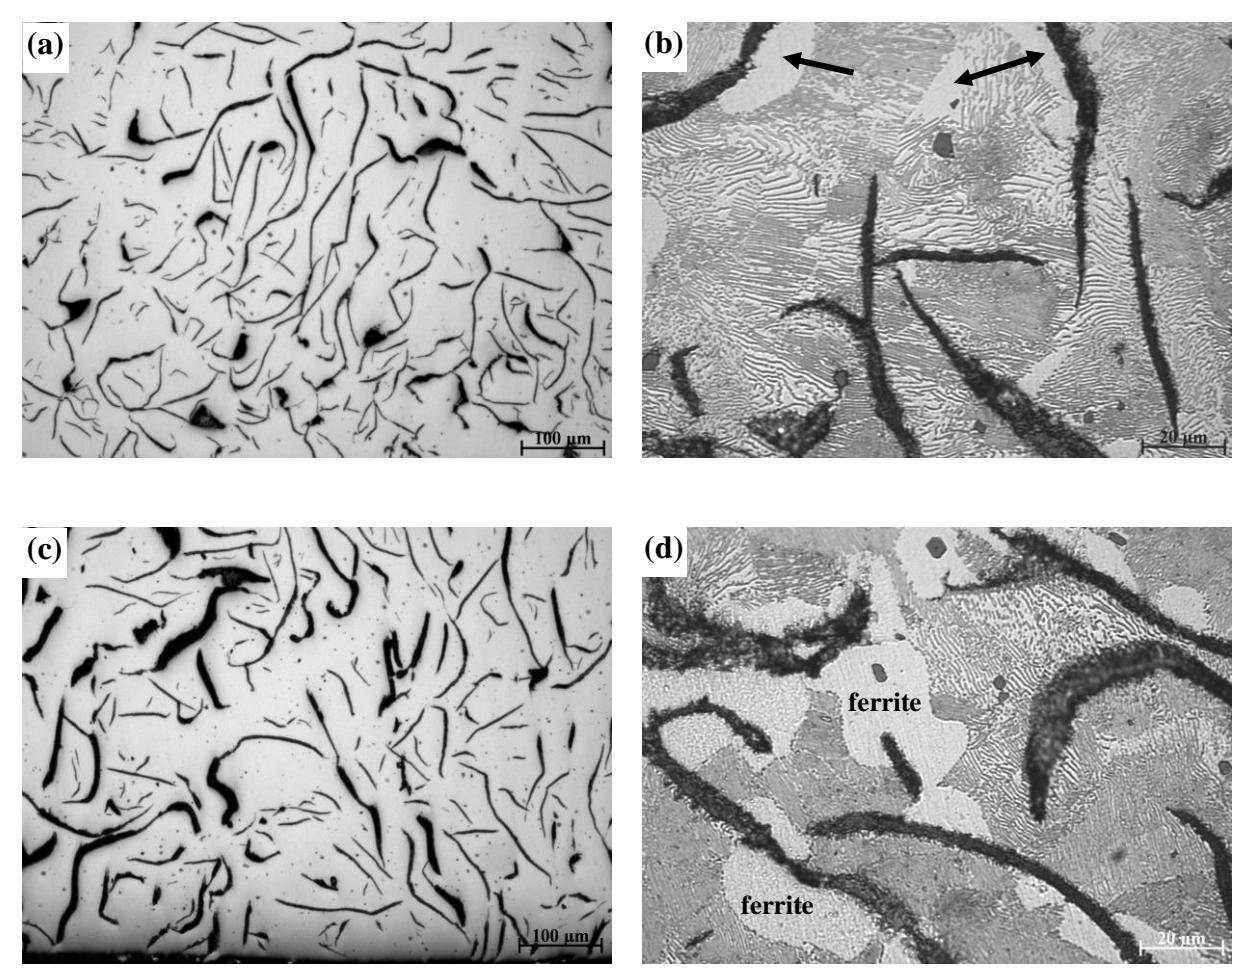
Tracking the microstructure within the friction zone of the rim indicate some phases modification. The microstructure at the rim interior (near the hub) was almost the same as the one shown in Fig. 7b. In the vicinity of the pad, traces of the ferrite phase were detected (see arrows in Fig. 8b), which grows from the graphite flakes interface during the cooling stage. In the middle and at the exterior of the rim, the content of the ferritic phase increases dramatically as shown in Fig. 8d. The flake graphite content and morphology were not altered due to the heating-cooling cycles. The presence of ferrite phase causes to a decrease in the tensile strength as also manifested by low values of hardness with average of 82RB (153 HB) as compared to an average of 92HB (190 HB) in the orginal microstructure. Following the ASM specialty handbook, this change in the hardness is corresponding to a decrease in the yield strength as well as the fatigue endurance limit (Cast iron ASM, 1996).

Fig. 8 Transition of the microstructure within the friction surface zone; (a-b) as polished and etched near the pad with some traces of ferittic phase, (c-d) as polished and etched at the exterior part of the pad with dominate content of ferittic phase.

The chemical analysis, microstructure morphology of the present phases and the hardness values indicate on flake cast iron, material which is being used in the automotive industry for braking applications. The typical mechanical properties are in the range of 350-400 MPa in ultimate strength and 215-250 MPa in yield strength. Thus, from structural material consideration the designer made an appropriate and accepted selection of this safety component. As mentioned previously, the vehicle has been modified from security considerations resulted in an increase of more than 30% in its total mass. This change was not accompanied by any adjustment in the braking system. Obviously, such significant modification, influence on the force values, acting on the brake rotors and accordingly on the temperature arising during braking. The microstructure and hardness changes which have been noticed in the metallographic study (see Figs. 8b and 8d), indeed indicate on high temperature exposure during service of the rotor.

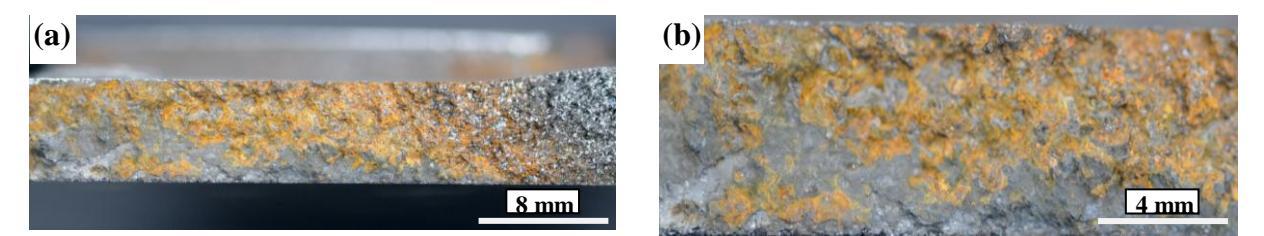
Figs. 9a-b show the macroscopic fracture mode of the main crack which was opened after controlled loading. As shown, most of the fracture surface is covered by oxides (Fig. 9a) with only isolated areas consist of fresh fracture features (Fig. 9b). The mechanical fracture is depicted in the upper right part of Fig.9a with coarse grain morphology.

Fig. 9 Macroscopic fractures of thermal fatigue crack growth and mechanical crack

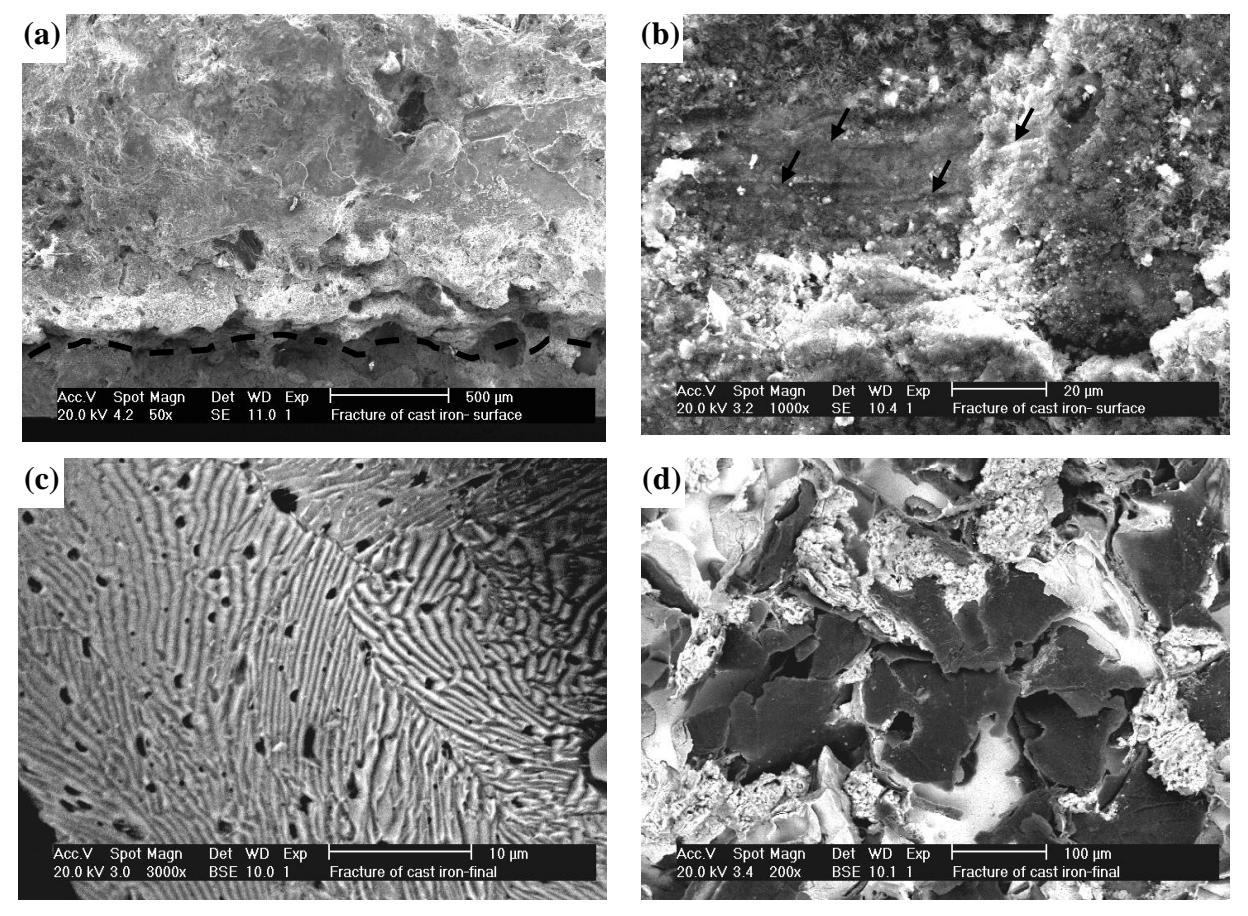
Figs. 10a-d demonstrate the microscopic fracture modes of the crack growth. The pit incubation and growth stage form by the coalescence process of a series of micro holes as illustrated by a dashed line at the bottom of Fig. 10a. This stage was also shown by the metallographic study (see Fig. 6b). The transition to crack initiation stage is well emphasized by flat fracture with some areas characterized by low energy fracture surface. This smooth surface may be a result of oxidation combined with the fact that the crack propagates through and along the interface of the graphite flake. Some indication of thermal fatigue feature is depicted in Fig. 10b (see arrows) in the form of striations- like (similar to mechanical fatigue). Fig. 10c shows the mechanical fracture of the pearlite phase with the lamellar morphology. The brittleness of the graphite flake like cleavage mode surrounded by the pearlite phase is given in Fig. 10d.

Fig. 10 Fracture modes of the thermal fatigue crack growth ; (a) pit morphology and transition to crack growth, (b) striations like , (c) pearlite fracture, (d) graphite flake fracture.

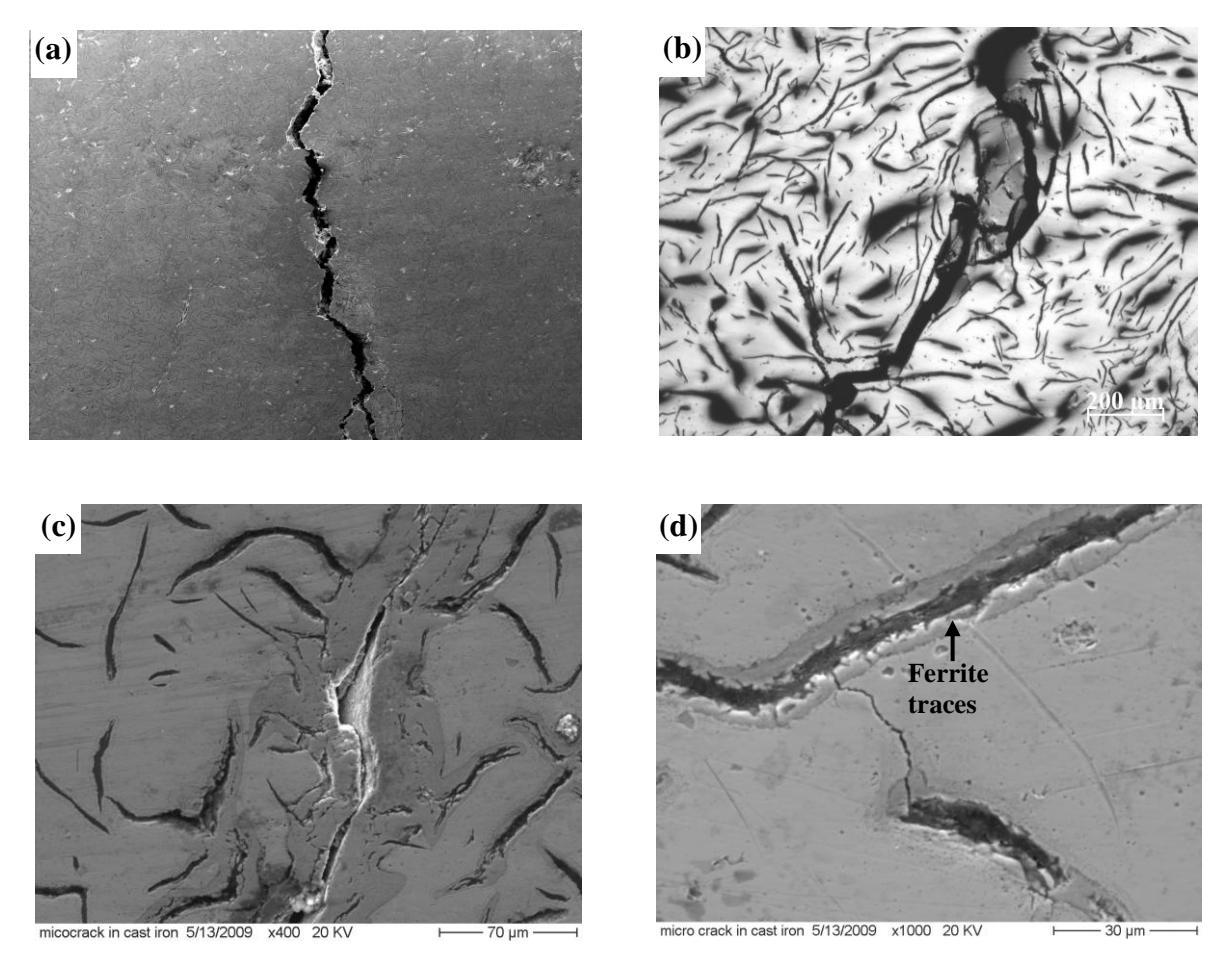
The specimen taken from the damaged rim and was loaded in the resonance machine exhibits crack after 5.10^5 cycles as shown in Figs. 11a-d. The crack path with zigzag, branched and secondary cracking morphologies are shown in Fig. 11a. This type of crack extension is attributed to the preferred crack growth at the graphite flake interface as illustrated in Fig. 11b. In addition it seems that the crack propagates at the ferrite/graphite flake interface (see Fig. 8d). As mentioned the ferrite phase is present due to the heat/cooling cycle of the disk brake. The crack bridging mechanism is shown in Fig. 11d tracking after the adjacent preferred graphite flake.

Fig. 11 The crack path morphology in the fatigue loaded specimen ; (a) macro-crack, (b) the crack following the graphite flake interface, (c) preferred crack growth at ferrite/graphite interface, (d) crack bridging mechanism.

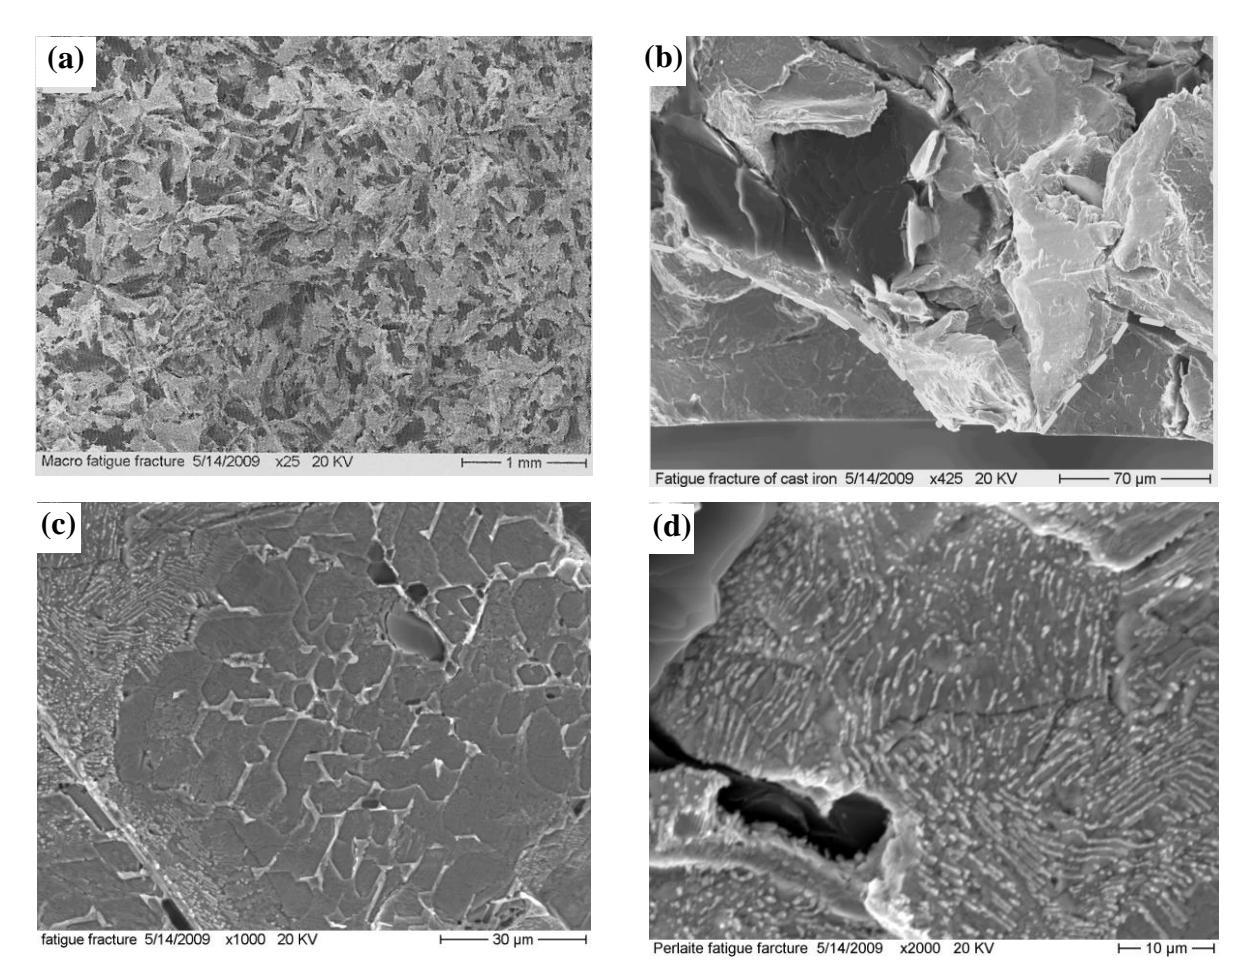
Finally, the next Figs. depicted the fatigue fracture modes which are different from the ones obtained by thermal fatigue combined with oxidation of the fracture surface. Fig. 12a shows cleavage like fracture arises from the brittleness of the graphite flake which emphasized in Fig. 12b. In addition, as in the case of the thermal fatigue, the crack was initiated through or at the interface of the graphite flake. Fig. 12c shows fine features on the cleavage facet with hexagonal shape which may arise from the base plane of the HCP structure of the graphite. The lamellar morphology of the pearlitic phase is well reflected on the fracture surface (Fig. 12d) as already shown in Fig. 10c.

Fig. 12 Fatigue fracture modes obtained by mechanical cyclic loading ; (a) general view with cleavage like fracture, (b) fatigue crack initiation through graphite flake, (c) hexagonal traces on cleavage like of graphite flake, (d) lamellar fracture of the pearlitic phase.
