PAPER REF: 3988

NON-DESTRUCTIVE CHARACTERIZATION AND DYNAMIC IDENTIFICATION OF AN HISTORICAL BELL TOWER

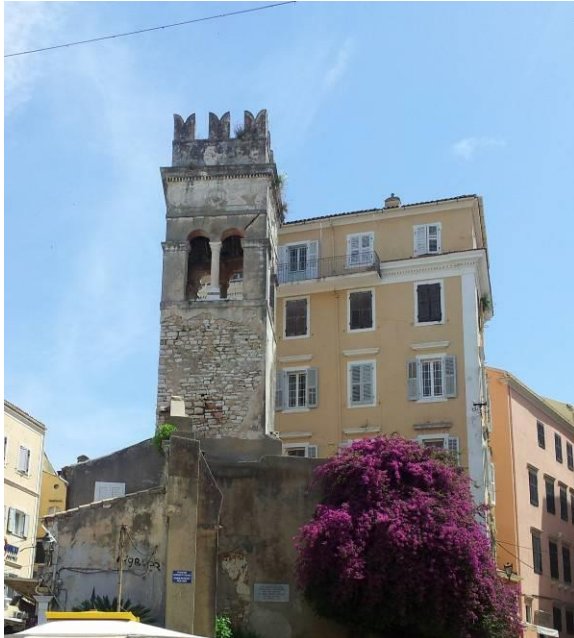
Fig.1: a) Annunziata bell tower

In this paper, the case of study is the bell tower of Annunziata, a masonry tower (Fig. 1a), which shows a high damaged scenario. The bell tower of the church is located in the town of Corfù, Greece. The church was built in 1394 and it was one part of a Roman monastery, nowadays the only existing one. The interior of the church, (Kouris, 2009) contained the tombs of generals who died in the sea battle of Naupactus (1571). The church of Annunziata was bombed during the second world war and it suffered from cracking and the church collapsed in March, 1952, when long term phenomena and earthquakes contributed to

The bell tower is a stone tower with an almost square ground plan, with a side of about 3.5 m. The tower is about 20 m height and it shows a belfry at the top. A double arch (Fig. 1a) supported by a stone column in the center is present at each of the four sides. The structure of the tower is made with masonry walls and the three floor systems made by solid bricks are supported by vaults. At the top of the tower there is the bell cell with four bells. The actual state of the tower may be defined critical, with many damages and cracking.

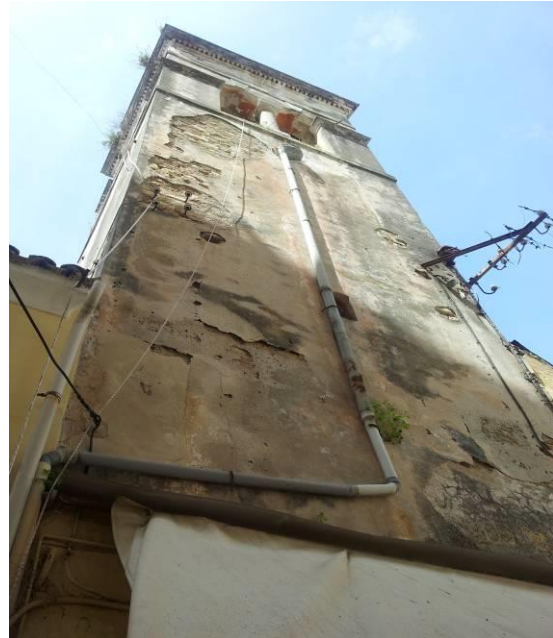
increase the damage. So, from 1952, only the campanile of the medieval monastery complex has survived to the present day with heavy cracking. It is possible to observe (Fig. 1b) deep vertical and diagonal cracking, deterioration of mortar on the stone walls and development of creepers in the masonry.

b) cracking on the lateral side (west side)

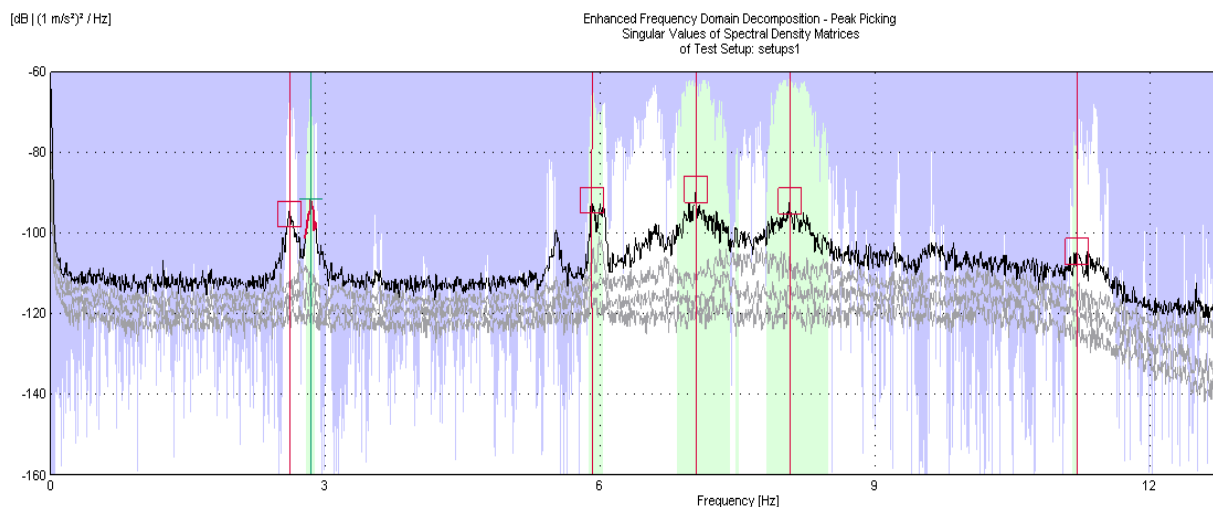
domain. The estimated frequencies with the two methods for the tests a, b, c are reported in Table 1. The extreme repeatability of the first six estimated frequency is evident from Table 1. The corresponding estimated damping are reported in Table 2 and the EFDD method graphics for tests b and c are reported in Fig. 8 and 9.

Fig.8 Identification by using EFDD, test b.

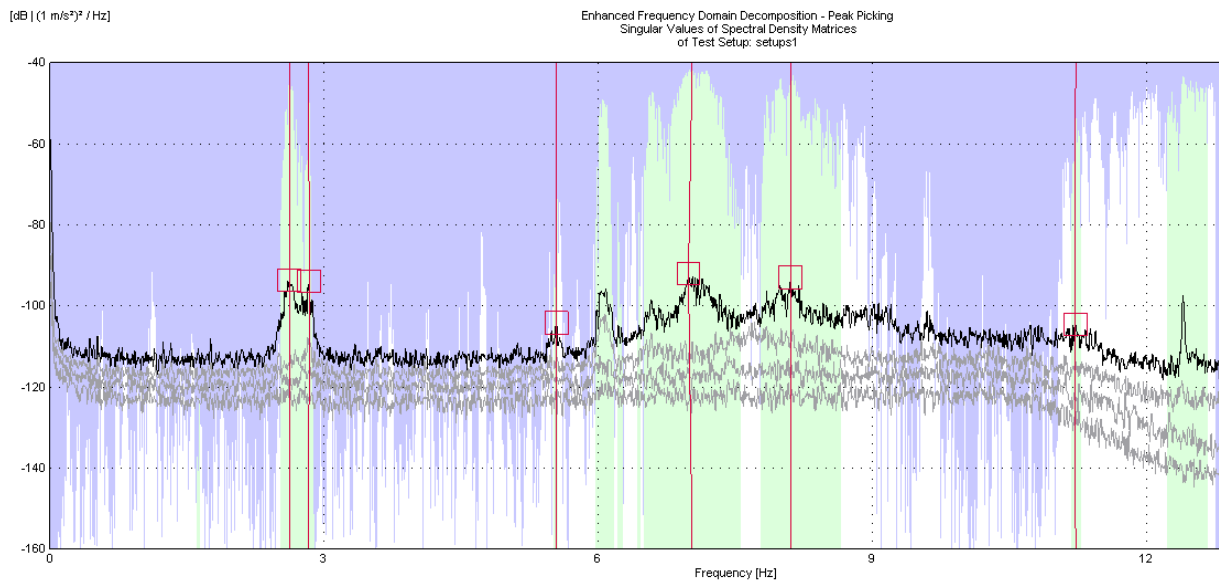
Fig.9 Identification by using EFDD, test c.

In detail the first and second frequency were identified as the first couple of flexional modes directed respectively on the x and y axis, the third frequency was the torsional mode, the fourth and fifth were the second couple of flexional modes directed on the x and y axis respectively, and the sixth is the second torsional mode.

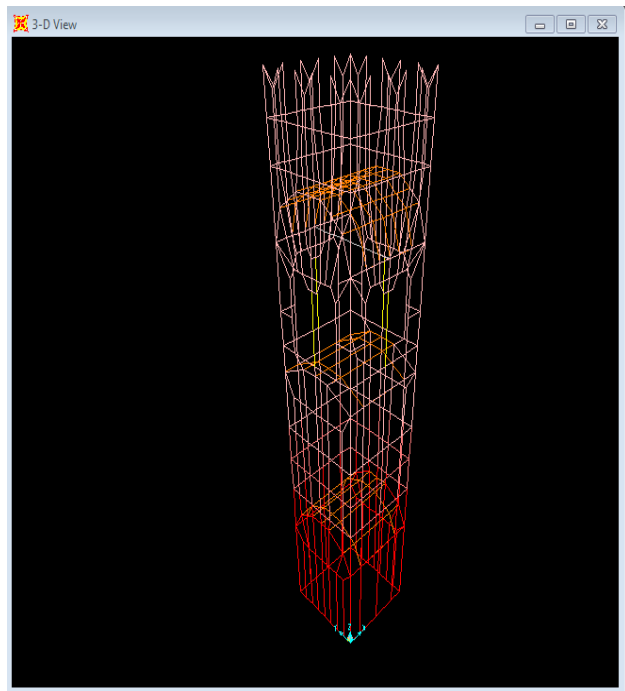
Finally for the vaults filling material it has been assumed γ_s equal to 10 kN/m³. The three dimensional geometrical model of the building has been firstly realized in CAD environment (Fig. 11a), then converted in a FE software (SAP2000, Fig. 11b) opportunely inserting the material properties.

b) FE model
