PAPER REF: 4042

NUMERICAL MODELLING AND EXPERIMENTAL CHARACTERIZATION OF POMBALINO “FRONTAL” WALL CYCLIC BEHAVIOR

Ana Maria Gonçalves^(*), João Gomes Ferreira¹, Luis Guerreiro¹, Fernando Branco¹

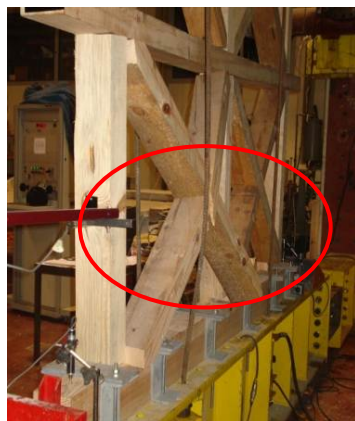
The load was increasing with the imposed displacement until the rupture of one diagonal, which occurred, associated with lateral instability. Fig. 6 shows the failure modes of timber frames.

a) Failure by compression and lateral instability of diagonal in TF1

Fig.6 Failure mode of timber frames.

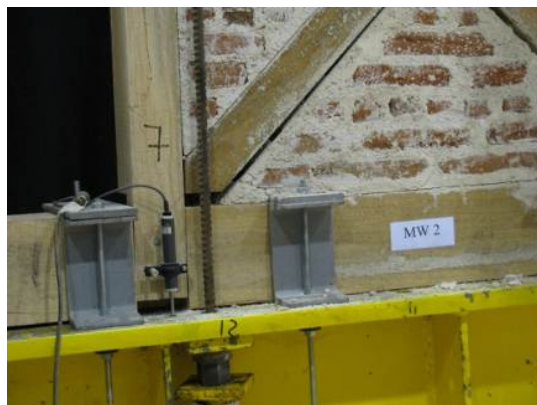
A certain vertical lift of the bottom beam occurred during the wall test, as well as a separation of the vertical timber elements from the bottom beam, as an effect of a rocking movement that was not eliminated, becoming more significant with the increase of the overall deformation (Fig. 8).

Fig. 8 Vertical lift of bottom beam and vertical member.

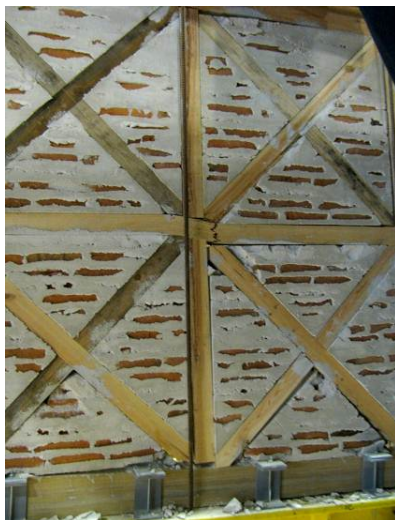
Fig. 11 shows the failure modes of the masonry walls. Rupture in MW1 is associated with compression of the diagonals that caused the shear failure of the intermediate beam. In the case of the model MW2 the wall had an early rupture by shear parallel of the timber fibres at one end of the intermediate beam.

a) Failure by shear of intermediate timber beam in MW1.

b) Failure by longitudinal shear of intermediate timber beam in MW2.

Fig. 11 Failure mode of masonry walls.
