PAPER REF: 4111

IMPLEMENTATION AND MONITORING OF A PASSIVE CONTROL SYSTEM IN A LIVELY FOOTBRIDGE

Elsa Caetano^{1(*)}, Carlos Moutinho¹, Álvaro Cunha¹

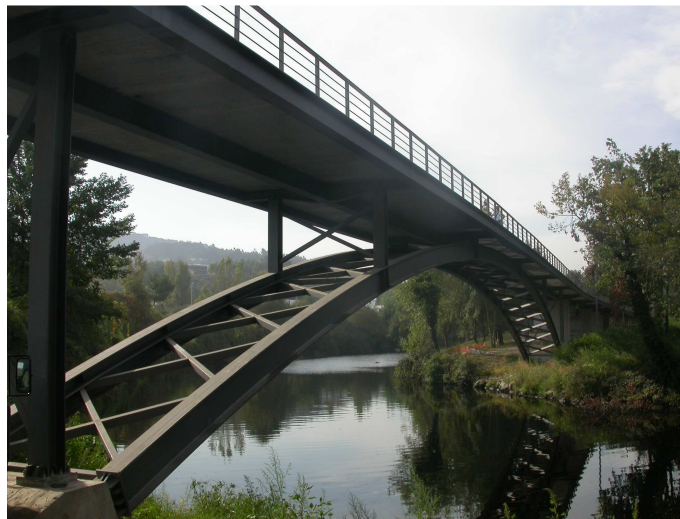
Integrated in the Parque da Rabada, a green park in the north of Portugal, the footbridge is formed by a steel arch with 60 m chord and 6 m rise, supporting a 5m wide concrete slab (Fig. 1). The total length of the structure is 84 m, divided by spans of 12 m. The deck cross section, formed by a light concrete slab 0.15 m thick supported by 3 longitudinal hot-rolled profiles, is slightly asymmetric, due to the inclusion of a timber path on one edge.

Fig. 1 General view of footbridge at Parque da Rabada, Portugal

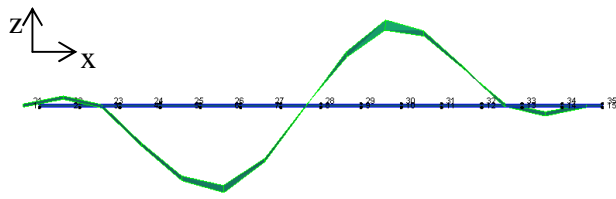
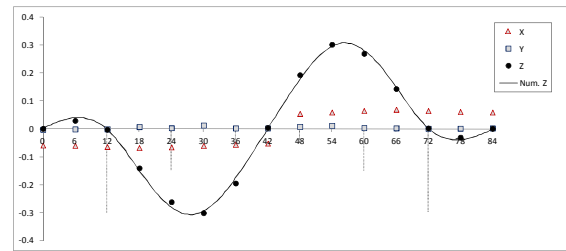
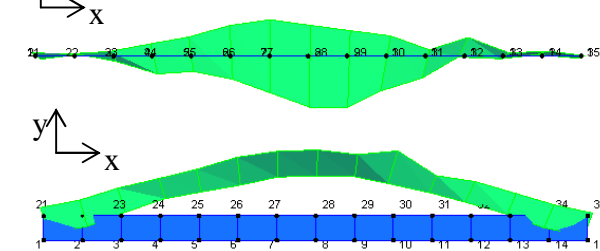
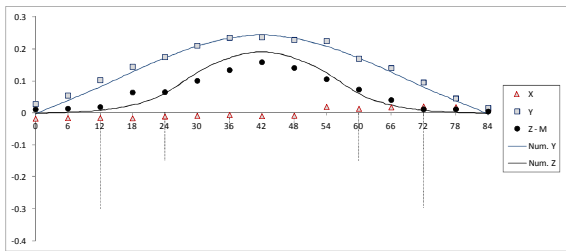
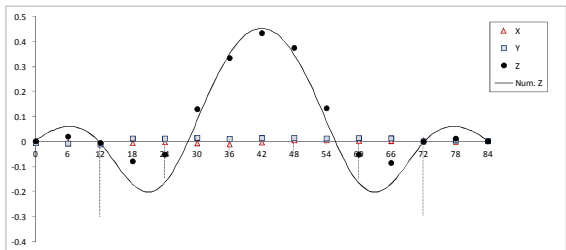
Upon construction of the footbridge, ambient and free vibration tests were conducted (Caetano and Cunha, 2011a), in order to assess the natural frequencies, vibration modes and damping ratios. The characteristics of such parameters are summarised in Fig. 2. This figure includes also a superposition of the identified and calculated modal configurations for the 3 critical vibration modes, showing the good correlation, despite the differences in the frequency values. In this respect, it is mentioned that even though very sophisticated numerical models can be constructed to represent the dynamic behaviour of structures, it is often verified that the identified modal properties substantially differ from calculations in the case of light structures, like footbridges, rather than traffic roadway or railway bridges. This is due to the more relevant influence of supports and other end constraints in lighter than heavier structures. In the present case, the constructed structure displayed a stiffer than calculated behaviour in the first mode, but more flexible behaviour in the higher order modes. This was attributed specifically to the degree of connection between the steel longitudinal elements and the concrete slab.

$F_1 = 1.64 \text{ Hz}$; $\xi_1 = 1.34\%$ (calculated: 1.50 Hz)

$F_2 = 2.03 \text{ Hz}$; $\xi_2 = 0.93\%$ (calculated: 2.45 Hz)

$F_3 = 2.71 \text{ Hz}$; $\xi_3 = 0.60\%$ (calculated: 2.88 Hz)

Fig. 2 Identified modal configurations, comparison with calibrated model

As regards the identified damping ratios shown in Fig. 2, it is referred that higher than expected values were reached.

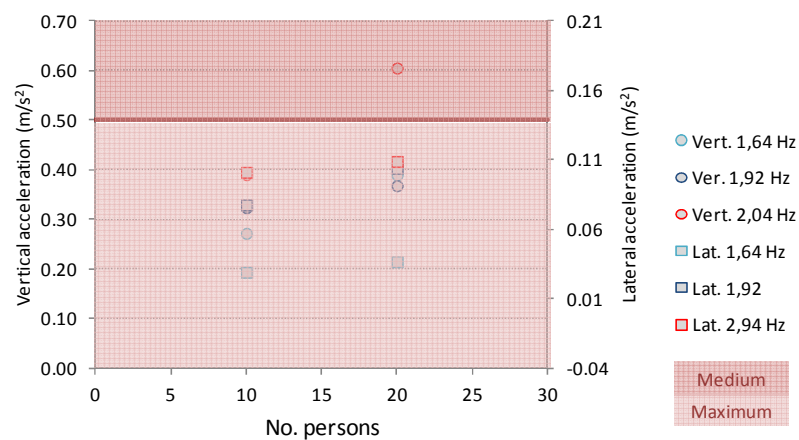
Fig. 3 Maximum vertical and lateral acceleration measured with groups of 10 and 20 persons walking at varying rates

Figures 3 and 4 show peak accelerations measured during the two series of tests superimposed with comfort intervals defined as referred previously. The analysis of these figures shows that a medium comfort level was reached with groups of 20 pedestrians walking, the worst situation corresponding to the walking frequency associated with the second mode (2.04 Hz). For the “jogging” scenarios, it can be observed in Fig. 4 that a very small number of pedestrians (2, 3) could generate extremely high amplitudes of vibration, and 5 jogging pedestrians generated intolerable vertical vibrations.

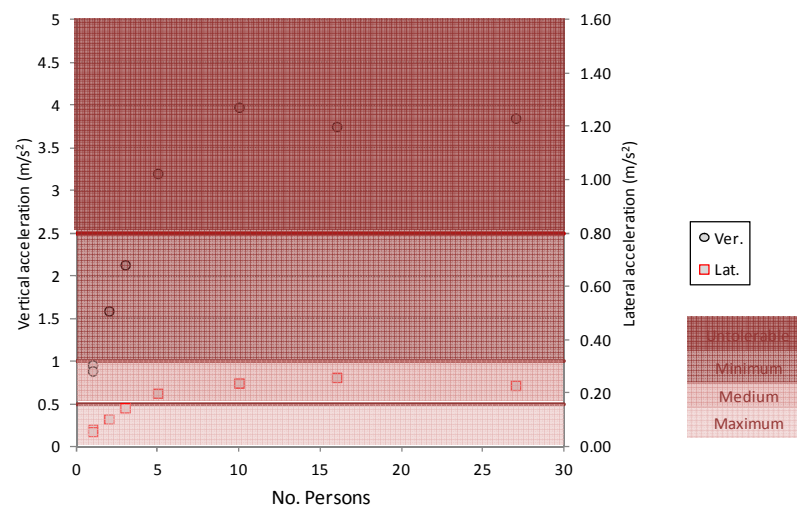
Fig. 4 Maximum vertical and lateral acceleration measured with jogging pedestrians

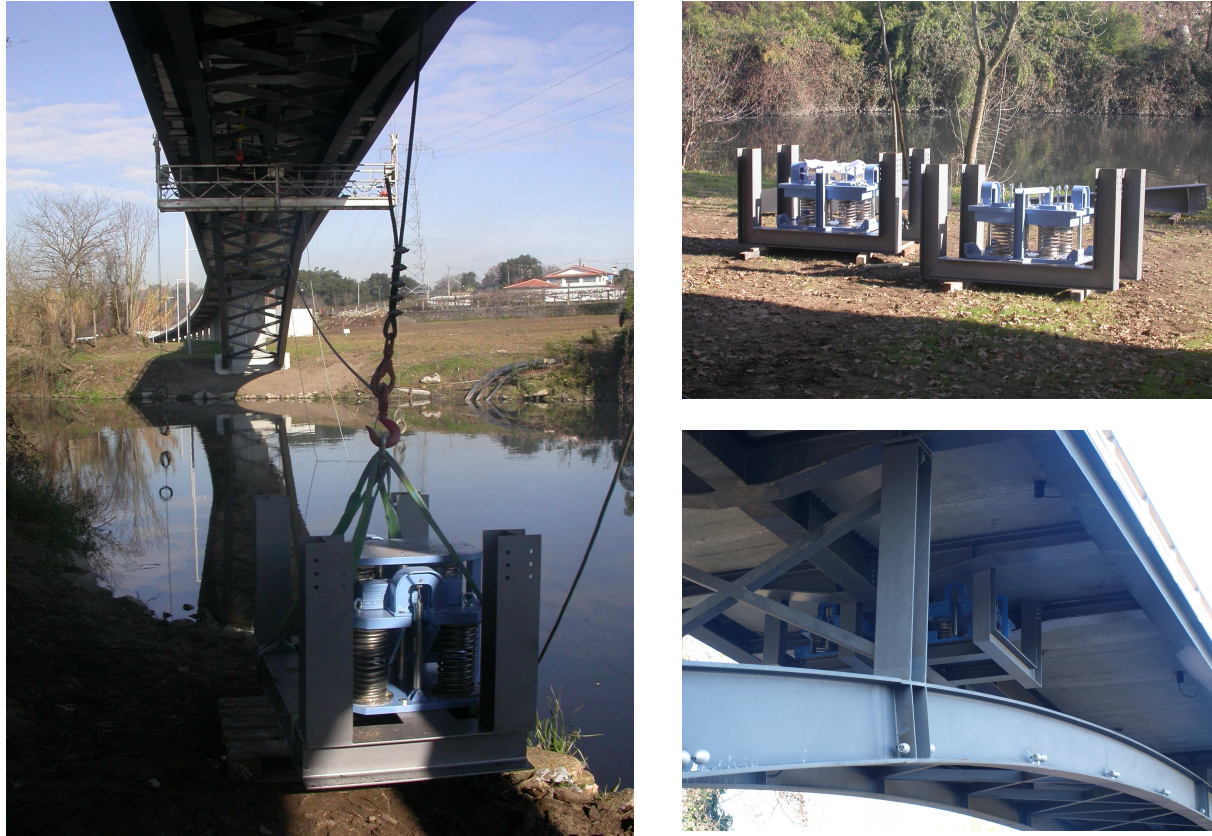
Considering the space available underneath the footbridge for installation of the TMDs, it was decided to divide each TMD in two units with half the mass. Fig. 6 shows images of the installation of the TMDs, after checking and tuning at the workshop.

Fig. 6 Installation of TMDs in the footbridge

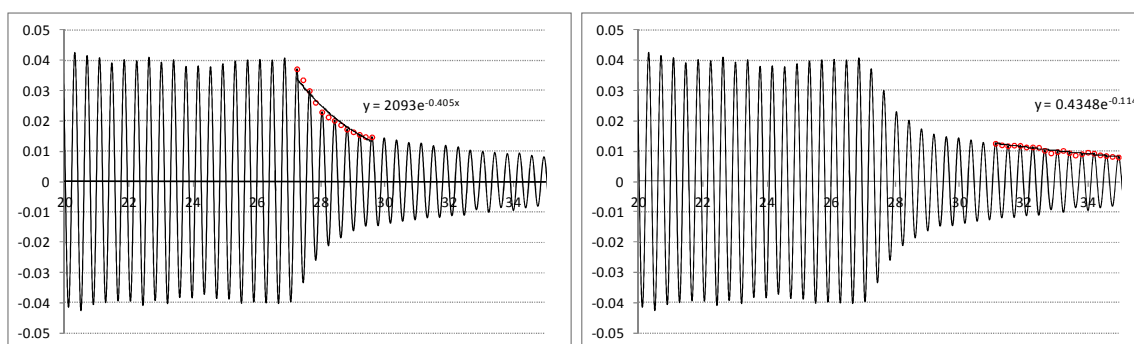
As for the identification of the level of damping introduced by the TMDs, free vibration tests were conducted. During these tests, one pedestrian jumped in resonance at the antinodes of the controlled modes and suddenly interrupted its motion. As exemplified in Fig.7, the free

vibration record of accelerations is formed by two branches, the first being characterised by a higher slope and corresponding to the phase of activation of the TMD, during the higher vibrations, while the second branch reflects the vibration of the footbridge when the TMD deactivates due to a reduction of the response. For the third vibration mode, a damping ratio of 2.5% was measured in the first branch, reducing to 0.7% in the second part of the record (0.6% had been measured formerly).

Fig. 7 Free vibration test for identification of damping ratio of the controlled footbridge

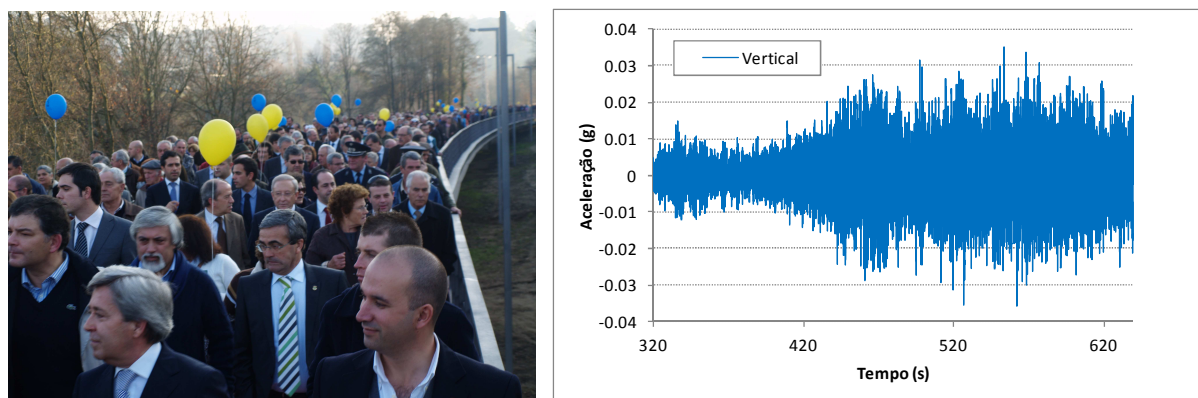
The inauguration of the footbridge took place on 21st January 2012. Considering this as possibly one of the most critical utilisation scenarios, associated with a crowd walking at low rate, it was decided to conduct additional measurements during this event. Fig. 8 shows one image of the footbridge during the crowd load, as well as one record of vertical accelerations. The maximum measured lateral and vertical accelerations were 0.1m/s² and 0.35 m/s², respectively, which are associated with maximum comfort level.

Fig. 8 Inauguration of the footbridge. Example of vertical acceleration record at 1/3rd span

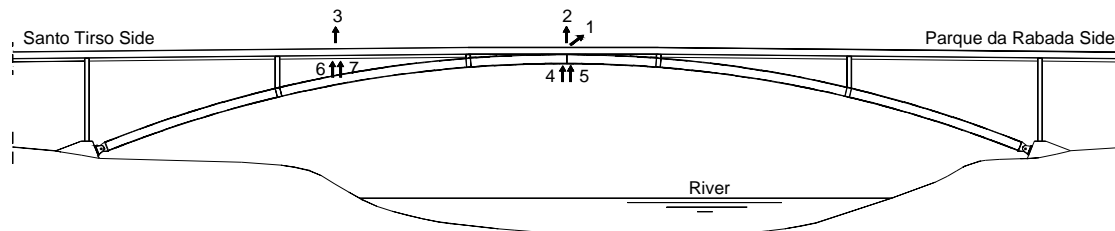
Two of these accelerometers, designated as accelerometers 1 and 2 in Fig. 9, measure directly the vibration of the deck at mid-span in the horizontal and vertical directions. According to the same figure, the accelerometer 3 measures vertical accelerations close to 1/3rd span. Accelerometers 4 and 5 are mounted on each of the masses of the TMD3 (see Table 2) located at mid-span, and accelerometers 6 and 7 are mounted on the masses of the 2 TMD1 units (see Table 1) located close to 1/3rd span.

Fig. 9 Location of the accelerometers installed in the deck and TMD masses

5 (see Fig. 9) reach amplitudes of vibration of 0.50 m/s^2 . This indicates that the TMD 1 (see Fig. 5), designed for crowd excitation, is not activated, while TMD 3 (see Fig. 5), designed for jogging activity, is activated. This should be representative of the normal use of the footbridge by small groups of pedestrians and joggers, while crowd loads should only occur on particular days and events.

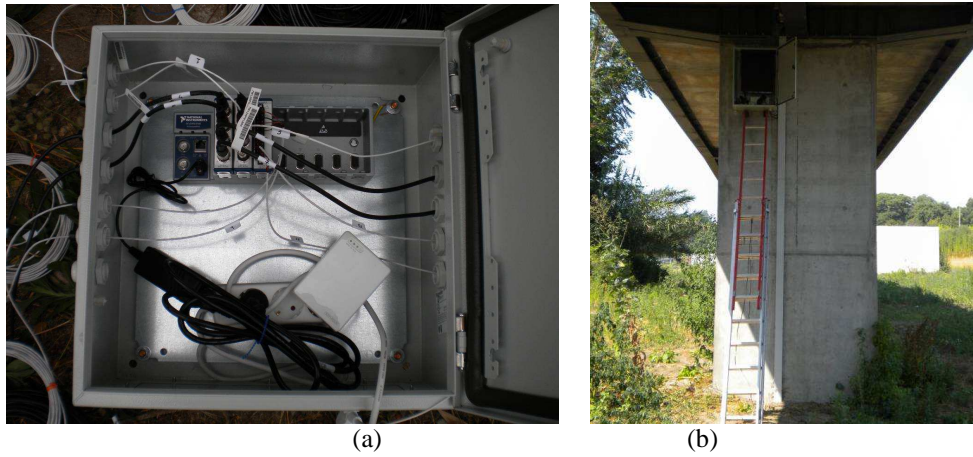
The acquisition system consists of a compact chassis integrating two 4-channel acquisition boards for accelerations and one 4-channel board for thermal sensors (Fig. 10 (a)). The chassis is controlled by a computer installed in an observation post located in one of the lateral concrete columns of the structure (Figure 10(b)). The communication between these equipments is achieved with 2 powerlines that enable the data transfer using the electrical installation of the bridge. The communication system for local data transfer or for remote transfer of files to FEUP is also located in that box.

Figure 10 (a) Compact data acquisition system; (b) Observation post

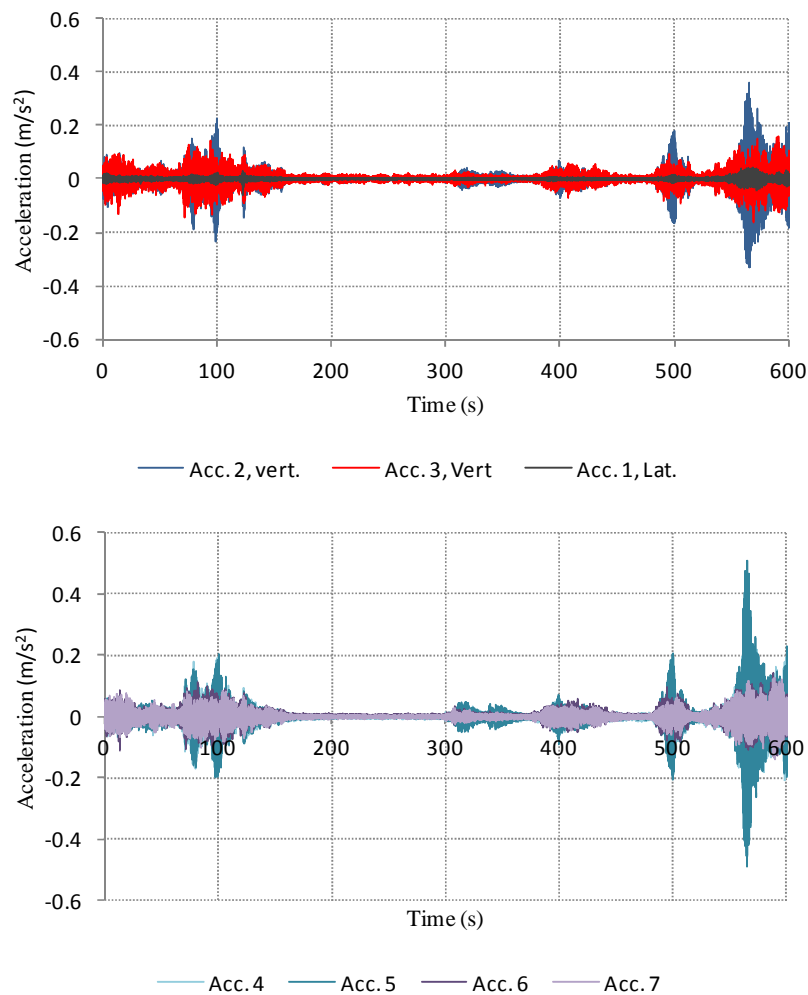
Fig. 11 shows an example of a 10-minute series of acceleration records collected on one particular day (13/2/2013, 17h20) under normal use of the footbridge. Clearly the lateral amplitude of vibration at mid-span is very low, with a maximum of 0.065 m/s^2 , and the vertical amplitudes are also lower than 0.5 m/s^2 . The maximum vertical acceleration occurs at mid-span, with an amplitude of 0.36 m/s^2 , therefore indicating maximum comfort of the footbridge. At the same time, the TMD masses of the units in correspondence with accelerometers 6 and 7 (see Fig. 9) have similar amplitude of vibration to that of the deck (0.16 m/s^2), while the TMD masses of the units in correspondence with accelerometers 4 and

Figure 11 Example of 10- minute records of acceleration. Top: deck acceleration. Bottom: TMD mass acceleration (see accelerometer location in Fig. 9)
