PAPER REF: 4697

INDIRECT REPAIR OF METAL-CERAMIC RESTORATIONS: THE BONDING ISSUE

Paulo Antunes Guimarães¹, Paulo Júlio Almeida¹, Francisco Góis^{1(*)}, João Sampaio Fernandes¹

¹ Faculty of Dental Medicine (FMD), University of Porto, Porto, Portugal

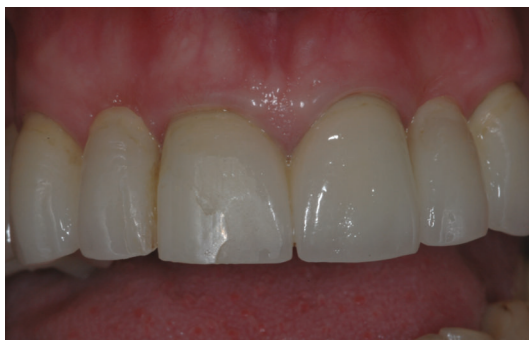
Fig.1 Restoration with a composite material

A 27-year-old female suffered a ceramic fracture on the tooth 11. This tooth was one of the abutments of a maxillary metal-ceramic bridge of 9 elements (from tooth 17 to 23) placed 4 years before. The fracture encompassed the vestibular-distal-incisal area of the tooth without damaging the opaque ceramic (cohesive fracture). After an occlusal evaluation, it was observed that the affected area was not involved on the protrusion and lateral guides and that the overbite and overjet were not marked. Thus, a direct technic was at first chosen, etching with 9,6% hydrofluoric acid (*Porcelain Etch Gel*; *Pulpdente Corporation, Watertown, USA*), silanization (*Monobond Plus*; *Ivoclar Vivadent, Schaan, Liechtenstein*), bonding (*Heliobond*; *Ivoclar Vivadent, Schaan, Liechtenstein*) and restoration with a composite material (*Filtek Supreme XT*; *3M ESPE, St. Paul MN, USA*), as it is shown in Fig.1. Despite of the acceptable aesthetic result, the material fractured several weeks after. A second attempt was performed, but also led to failure.

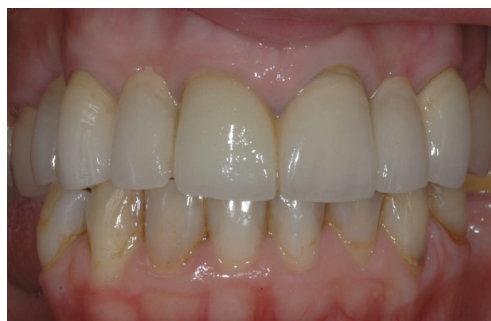
Fig.4 Control after twenty-four months

Twenty-four months later the situation still remained stable (Fig.4).

Since the prepared surface of the abutment was mainly ceramic (feldspathic), we chose to bond the veneer (reinforced lithium disilicate ceramic) with a non-adhesive resin (*Variolink II*; Ivoclar Vivadent, Schaan, Liechtenstein) using the following protocol:

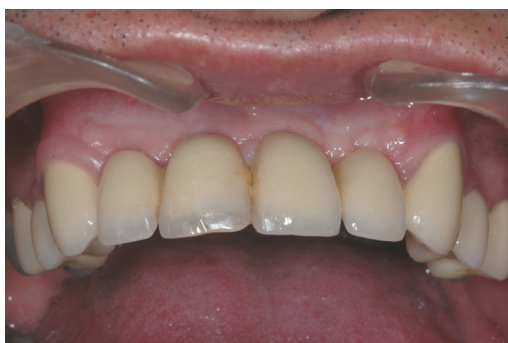
Fig.5 Restoration with a composite material

A 58-year-old male suffered a ceramic fracture on the area of tooth 11. This element was one of the pontics of a maxillary metal-ceramic bridge of 10 elements (from tooth 15 to 25) placed 4 years before. The fracture exposed the metallic infrastructure and encompassed the vestibular-mesial surface and incisal edge of the tooth. A direct technic was at first chosen restoring with composite (*SynergD6; Coltène Whaledent, Altstätten, Switzerland*) yielding a good result (Fig.5). However one year later a new fracture of the ceramic and composite occurred. Nevertheless, a new attempt to restore directly with composite was preformed, but the result was not satisfactory in terms of colour match. So a preparation was done in order to restore the pontic using an indirect technic (Fig.6).

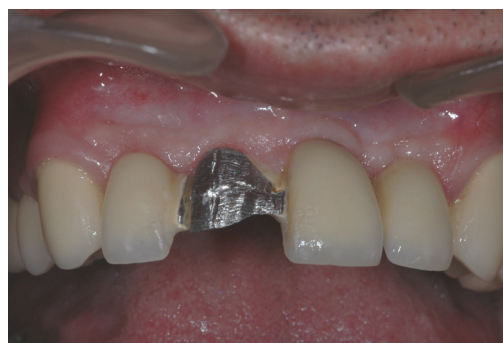
Fig.6 Preparation

Since the fracture had an involvement of the incisal edge, it was extense and presented a reduced thickness of vestibular-palatal ceramic to do a veneer, the preparation was done to do a partial crown. Also, we suspected that the main cause that led to ceramic fracture was due to a lack of support of its infrastructure. After preparation, the remaining structure had a thin layer of ceramic, especially on the gingival margin, so we decided to use a metal-ceramic crown. With this option we aimed to a more resistant structure that brought a correct support to the ceramic layer in the cervical and incisal areas.

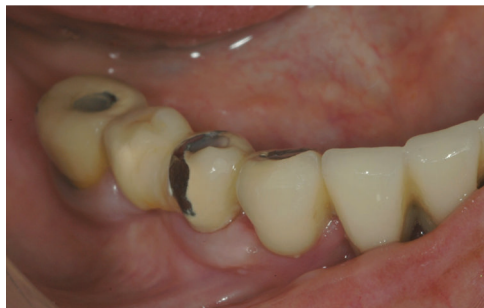
Fig.9 Ceramic fracture

A 60-year-old female suffered a ceramic fracture of a lower metal-ceramic bridge of 12 elements (46 to 36) over implants. The fracture involved the region of the tooth 44, which was one of the retainers of this rehabilitation placed 5 years before. It involved the vestibular and occlusal areas exposing the metallic infrastructure (Fig.9). The coating ceramic was too thin and it could have been the main cause of the fracture.
