PAPER REF: 7102

STUDY OF THE EFFECT OF STRESS CONCENTRATORS IN FATIGUE FAILURE ANALYSIS OF A CRANKSHAFT

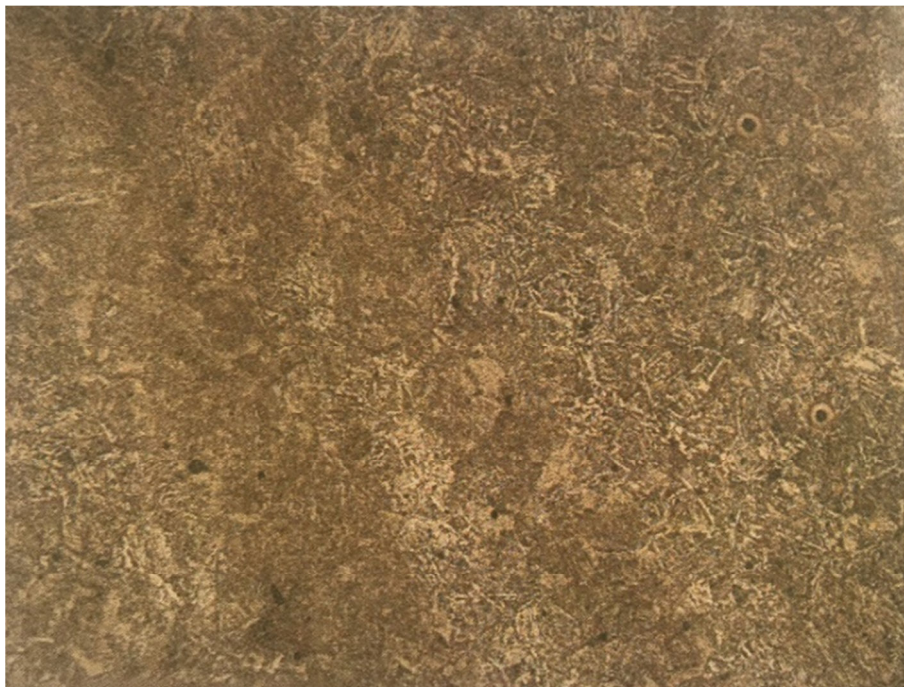
Fig. 1 - Microstructure of AISI4140 utilized to manufacture the crankshaft in this study (magnification 200X)

Figure 1 shows that microstructure is a perlite matrix with some ferrite areas. It seems to be a bulk steel of solidification.

A metallography sample was prepared and the image in the optical microscope is shown in Figure 1.

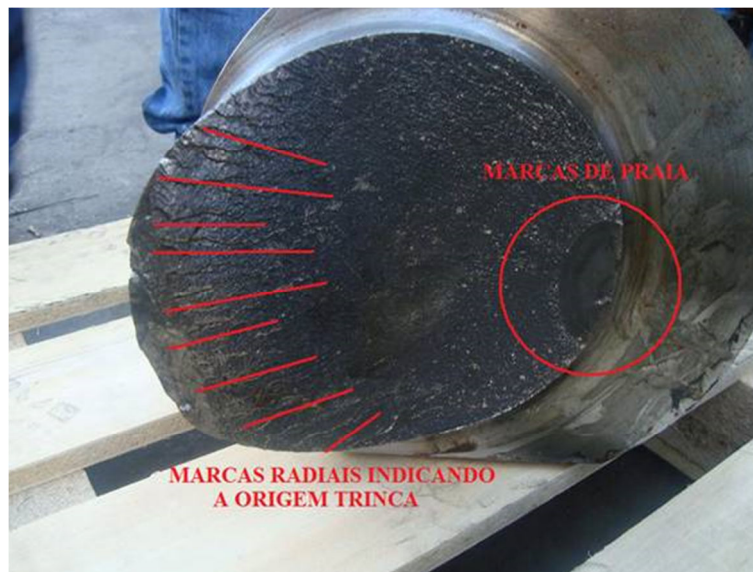
Fig. 2 - Broken crankshaft

Analyzing the break, it is possible to verify that the fracture occurred close to radius of curvature, a stress concentrator, by the radial marks. It presented bench marks, a typically fatigue loads failure.

Figure 2 shows the broken crankshaft that was analyzed in order to identify root-cause of problem in this case.

The shaft has failed close to the radii of curvature, so it has been supposed that it was a stress concentrator and the possible stress concentrator was calculated based on Shigley, Mischke and Budynas (2005) graphic. The results are indicated in Figure 3, where K_t is the stress concentrator.
