PAPER REF: 7265

## **FAULT DETECTION IN DIESEL ENGINE INJECTORS USING A VIBRATION AND SOUND PRESSURE LEVEL TECHNIQUE**

Federal University of Rio Grande do Norte (UFRN), Natal-RN, Brazil

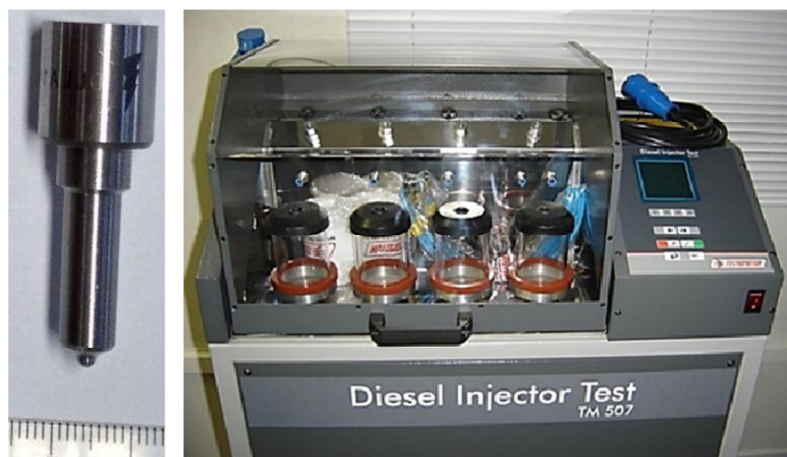
The atomization and wear tests were performed in a commercial rig, called Diesel Injector Test - TM-507, manufactured by the company Tecnomotor located in the city of São Carlos, Brazil, Figure 1. The evaluated nozzles were new Common Rail piezoelectrics type, manufactured by Bosch do Brasil, with reference code DLLA 148 P1067.

Fig. 1 - Test rig Diesel Injector Test TM 507 Common Rail

The test rig had a standard configuration in which the nozzles were evaluated in four simulated engine operating regimes: pre-injection, low load, partial load and full load. These tests had a fixed and limited time window, just a few seconds, making it impossible to carry out the long duration tests. In this way, it was necessary the collaboration of the manufacturer,

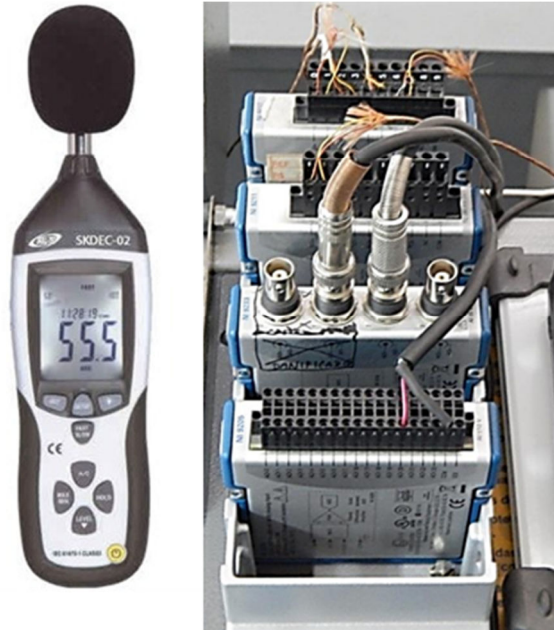
The signals acquisition was performed using software developed in the LabView® graphic programming language. The system used was the CompactDaq with the NI 9205 module for volume reading, 24-bit resolution, and the NI 9234 module with 12-bit resolution for editing

the analog output of the decibel meter, Figure 3. It was used a sampling rate of 50 KHz and a sampling time of 0.24 seconds. The accelerometer was positioned in the direction of actuation of the injection needle of the injector nozzle.

Fig. 3 - Sound level meter and signals acquisition modules

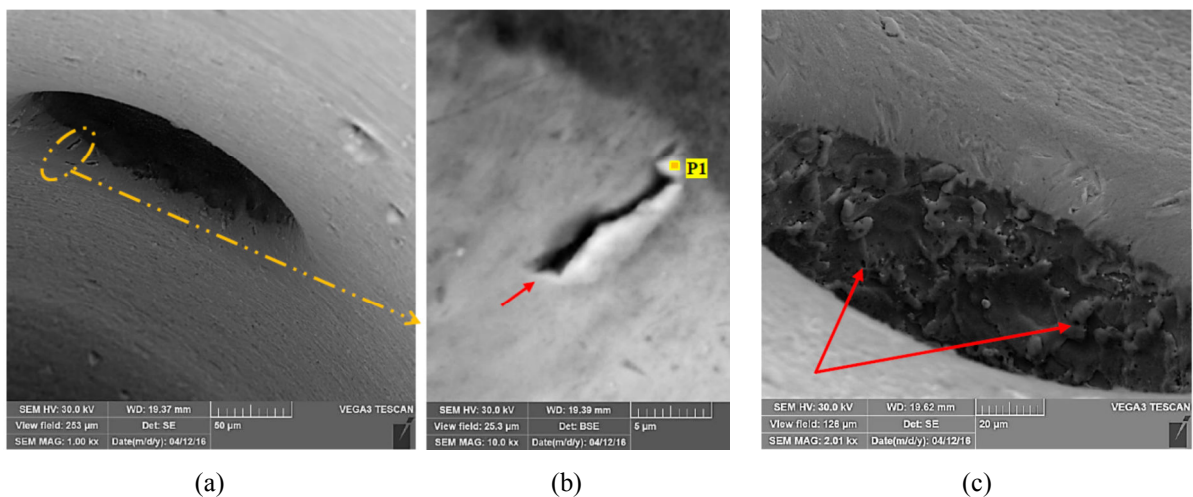
Fig. 6 - Inner surface of the injector nozzle

The images of Figure 6 correspond to the inner surface of the nozzle, located at 1h position. Figure 6(b) shows evidence of abrasive wear on the lower edge of the nozzle with scratches or grooves. The grooves formed in this region probably arise due to the displacement of a hard particle in the substrate of the nozzle's wall.

In most of the surfaces of these nozzles, there was found micropit formation downstream of the nozzle entrance edge, Figure 6(c). They are the result of the synergism between erosion and cavitation and they have a diameter of approximately  $2\mu\text{m}$ .

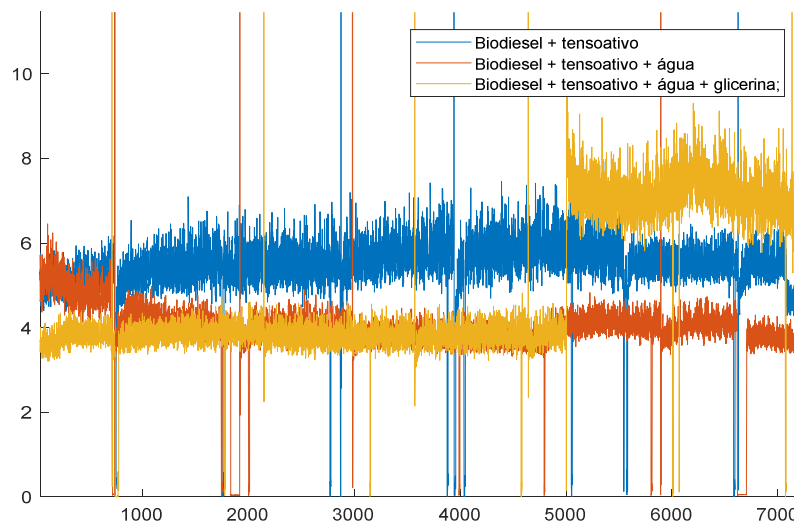
In the following topics, they are presented the time series of the vibration and NPS signals, obtained in the different tests. The RMS time series of the vibration of the three tests is shown in the Figure 9 below. It was noticed that the injector nozzle which worked with glycerin in the fuel formulation, when it reached the 15 hour of testing, it presented a sudden change in the signal level by doubling its intensity, reaching the highest value of all 3 tests, 8 gms. This change is possibly related to the transition from the oxidative to severe oxidative wear mechanism in which the oxide layer reached a thickness limit and began to crack as observed in SEM images. After identifying this transition, assuring the severity of the damage, the test was reprogrammed until it reached the catastrophic failure of the diesel injector nozzle that occurred at 62 hours of test when it completely stopped working.

Fig. 9 - Vibration signal of the injector nozzle, working with the 3 tested fuels.

It is also observed in Figure 9 that the vibration signal of the EI which worked with B6 + tensoactives was kept almost constant and reached the same level as observed when the oxidative wear mechanism occurred in the test performed with the glycerol in fuel composition. Probably, the water present in the fuel formulation contributed to the formation of a thin oxide layer which during the 20 hours of testing contributed to the reduction of the friction, reducing the vibration of the engine injector. Although the SEM images showed the erosive-cavitative and micro-spalling wear mechanisms. It is very likely that oxidation is the predominant wear mechanism for this test.

The injector which worked without water in the fuel composition had the highest vibration levels during the 15 hours of the test while the other injectors possibly presented the predominance of oxidative wear mechanism in that period.

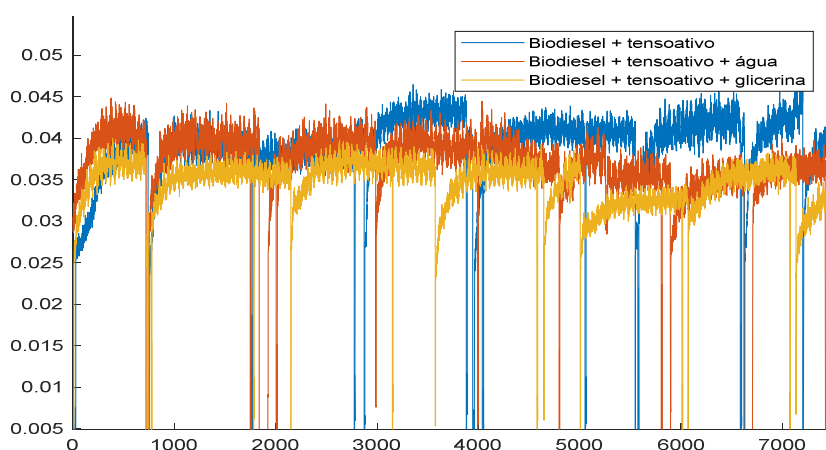
The time series of NPS signal, Figure 10, shows that the response of the EI with predominance of erosive-cavitative wear was increasing, with the maximum level of 45 mV

(B6 + tensoactive). The signal obtained using B6 + tensoactives showed to be decreasing, reaching the level of 35 mV at the end of the test, which is the same level as the test in which severe oxidative wear occurred. The injector nozzle that ran with glycerin in the fuel, presented the lower NPS level compared to the other tested injectors. However, the NPS signal was unable to detect the transition from regular oxidative wear to severe oxidative wear as identified by the vibration signal. These data showed a direct correlation between NPS signal and lubricity of the fuel, quantified by the WSD in HFFR tests, which is related to the biodiesel content.

The time series of SPL, Figure 10, show that the response of the EI with predominance of erosion-cavitation wear was increasing reaching the maximum value of 45 mV (B6 + tensoactive). The EI signal using B6 + surfactant + water decreased, ending the test at 35 mV, at the same level as the test that presented severe oxidative wear. The injector nozzle that used the glycerin in the fuel obtained the lowest SPL in relation to the other tests, however the SPL could not detect the transition from the oxidative mechanism to severe oxidative, as was possible with the vibration signal. These data showed that the SPL presented a direct correlation with the WSD quantified in the HFFR test that, according to Farias (2013), is related to the biodiesel content, however the SPL was not sensitive to the oxidative wear mechanism of the diesel injector nozzle.

Fig. 10 - NPS signal emitted by the injector nozzle, when working with the 3 tested fuels.
