How to recover strong ground motion from the behavior of simple structures: the case of Azores earthquake 1998

Carlos Sousa Oliveira

Instituto Superior Técnico/Ceris/Universidade de Lisboa

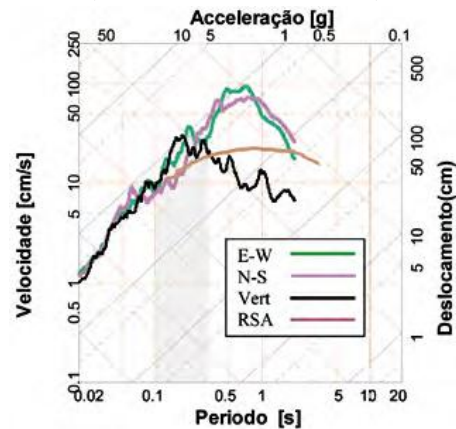
Figure 6. Response spectra for the main event; comparison with the Code spectrum (RSA, 1983) for zone A, earthquake type 1 and terrain type I; 5% damping. (Shaded represents the region where the predominant frequencies of the housing stock of Faial and Pico are located).

The response spectra ($\zeta = 5\%$) of the intense phase of the accelerogram are represented in Figure 6, being confronted with the code spectrum (RSA, 1983) for zone A (which includes the city of Horta), type earthquake 1 (near-field) for a type I terrain (rocks and hard coherent soils).

From the analysis of Figure 6 it is clear that for periods longer than 0.2 sec, the Code response spectrum presents ordinates systematically lower than those of the main earthquake. Furthermore, it should be noted that the maximum acceleration now recorded is about 2.3 times higher than the value underlying the RSA-1983 (170 cm/s^2).

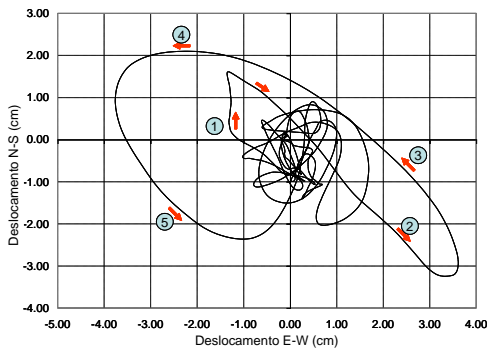
Figure 7. Orbit of movement recorded in the horizontal plane in terms of displacement.

Figure 7 shows the trace of the particle motion in the horizontal plane showing a predominant component in the NW-SE direction.

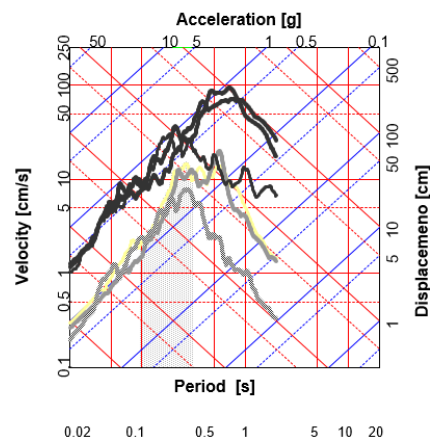
Figure 11. Response Spectra of main shock (black) of July 9 and aftershock (gray) of July 11, 00h49m ($\zeta = 5\%$).

Figure 11 compares the response spectra of the aftershock on July 11, 1998, at 00:49 UTC with those of the main earthquake.

It is evident that the largest spectral ordinates are now found in the range of 0.2 to 0.8 seconds, indicating a concentration of energy at higher frequencies compared to the main shock. This behavior confirms the significant influence of magnitude on the spectral shape. The polarization of the P-waves for this aftershock is NE-SW.

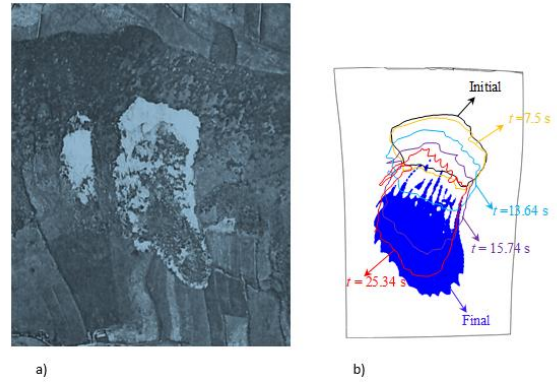
Figure 17. a) Plan view of the landslide in Lomba Grande; b) Modeling (Chen et al. 2025)

- The Lomba Grande landslide (Figure 17) was analytically simulated using numerical modeling (Chen et al., 2025), and the observed reality aligns closely with the model results when a peak ground acceleration (PGA) of 0.60 g is adopted.

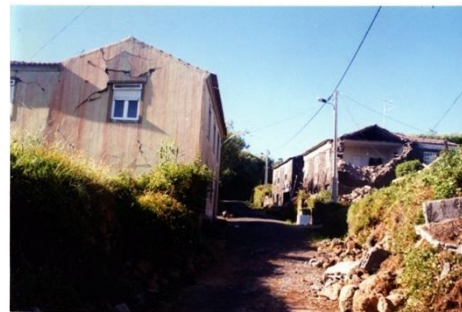
Figure 18. Bulging and collapse of gable walls to the south.

Other notable cases indicating the movement of settled bodies include several instances on Faial Island. On Faial Island, numerous cases reveal the preferential direction of soil movement. We will subsequently discuss the most interesting cases, commenting on the observed phenomena. Many gables of old stone masonry houses, constructed according to traditional methods, collapsed in a more or less widespread manner. Although a systematic study of the predominant direction was not conducted, it appears that the gables of houses in the parishes of Pedro Miguel, Ribeirinha, and Salão, which face south, more frequently collapsed in that direction (Figure 18).

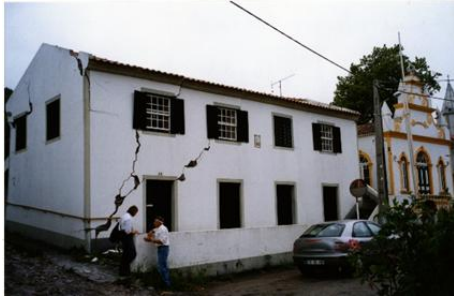
Figure 19. Cracking in walls in the N-S direction denoting the ground movement to the North (Freguesia da Ribeirinha).

In the case of the Casa da Canada do Sousa, in the transition from the parish of Salão to Cedros, already a bit further from the epicenter, a bulging to the south of the two gable walls was observed, without collapse, indicating a predominant push to the north. All these walls were poorly braced in the direction perpendicular to their plane, making them more vulnerable to 'out-of-plane actions.' Quick calculations based on out-of-plane wedge instability loads (by courtesy A. A. Costa, 2008) lead, for typical one-story houses with gables, to acceleration values around 0.3 g to cause gable collapse. In the houses of those same parishes with walls oriented in the N-S direction, the movement caused diagonal cracking in the plane, also indicating a predominant ground push to the north (Figure 19).

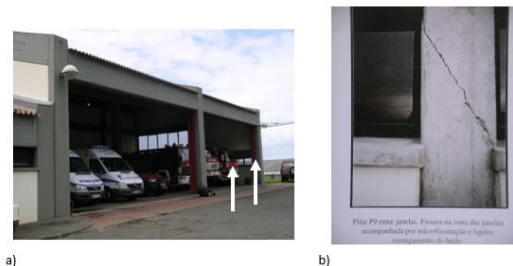
Figure 20. Fire HeadQuarter in Lajes-Pico: a) view of garage with shear cracks in columns; b) Damage in central column (outer view from West).

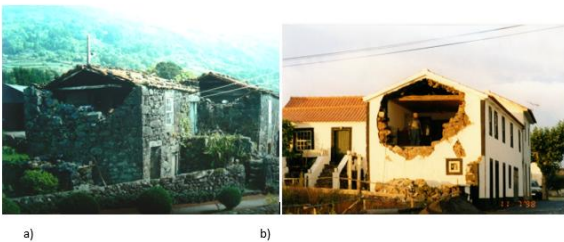
Figure 22Gables fallen to the West in Pico: a) Ribeira do Cabo; b) Madalena

Two stone masonry houses in the area of Ribeira do Cabo showed a very similar collapse of the gables to the west (Figure 22 a)). This phenomenon is also observed in Madalena (Figure 22 b)). The Church of São Mateus displayed a bulging of the north wall towards the north, suggesting ground movement to the south.

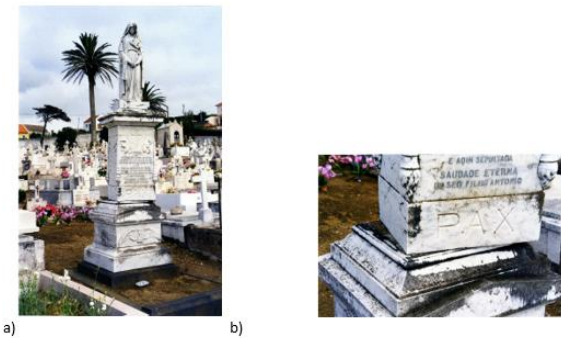
Figure 24 Rotation movement in Horta cemetery: a) pedestal; b) detail of movement.

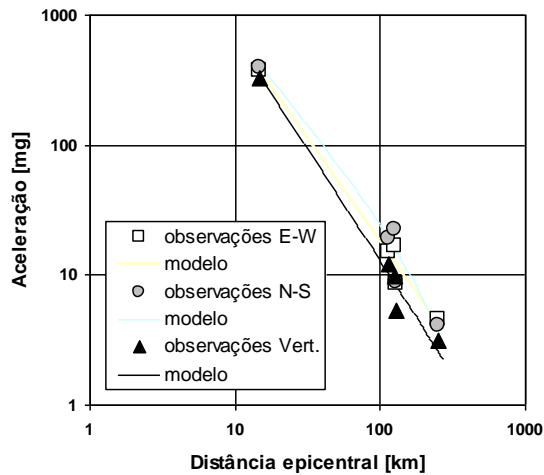
Figure 27 Attenuation of observed versus predicted values for the 5:19 earthquake. (white ellipse at top corresponds to the estimate of maximum acceleration at Farol da Ribeirinha – Figure 5- the closest inland point to the fault plane).

where **a** is the maximum acceleration of the record; **R** is the distance from the station to the epicenter and the constants **c**₁, **c**₂ and **c**₃ are estimated by linear regression analysis from the peaks of the accelerometric recordings. Figure 27 illustrates the attenuation of maximum acceleration with the epicentral distance of the observed and predicted values. Attenuation reaches a "plateau" for epicentral distances less than 10 km.

This visual marker aids in identifying discrepancies between actual recorded data and theoretical predictions. Significant deviations between observed and predicted values may suggest that local site effects or specific geological features are influencing seismic wave propagation. Such analyses are essential for refining predictive models and enhancing the accuracy of seismic hazard assessments. Table 10 compiles the constants of the attenuation models plotted in Figure 27, along with the root mean square errors (RMSE) of the estimates for each component. The abbreviation "ns" indicates that, according to the t-test, the constant is not significantly different from zero. In such cases, the regression was redone, excluding the non-significant variable. Notably, when extrapolating the model's application to very short distances (5 km), the results generally align with studies conducted for the Farol da Ribeirinha (Sincrain et al., 1999). This suggests that the model's predictions remain robust even at shorter distances, supporting its validity and usefulness in seismic hazard analysis for that region.
