PAPER REF: 3910

A MICROSCOPIC FAILURE ANALYSIS OF MEDIUM TRUCK BRAKE DISCS

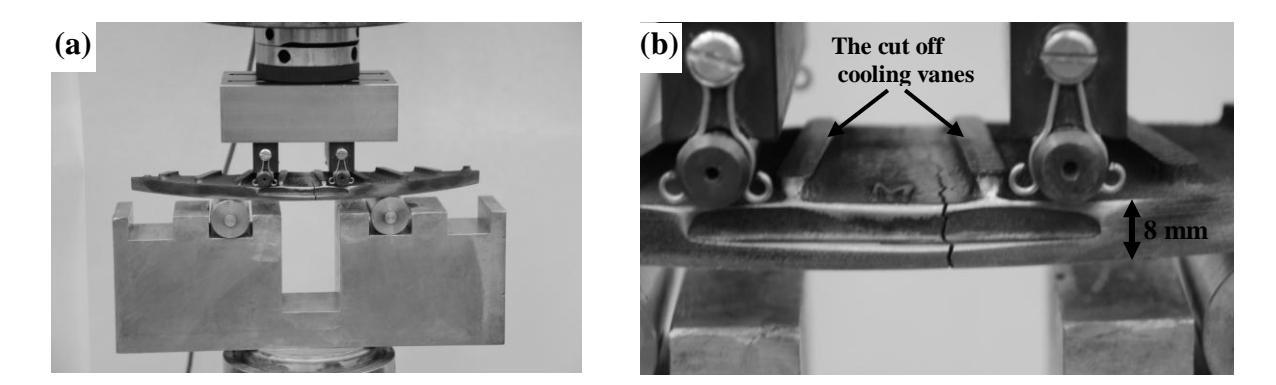
In order to expose the fracture surface of the macro crack, the rim was cut so that the part included the crack was loaded at flexural mode using four point device. Fig. 2a depicts a general view of the experimental set-up, while Fig. 2b shows the crack direction with respect of the inner loading cylinders.

Fig. 2 The cracked segment loaded in four point apparatus device; (a) general view, (b) the location of the crack with relation to the inner loading cylinders.

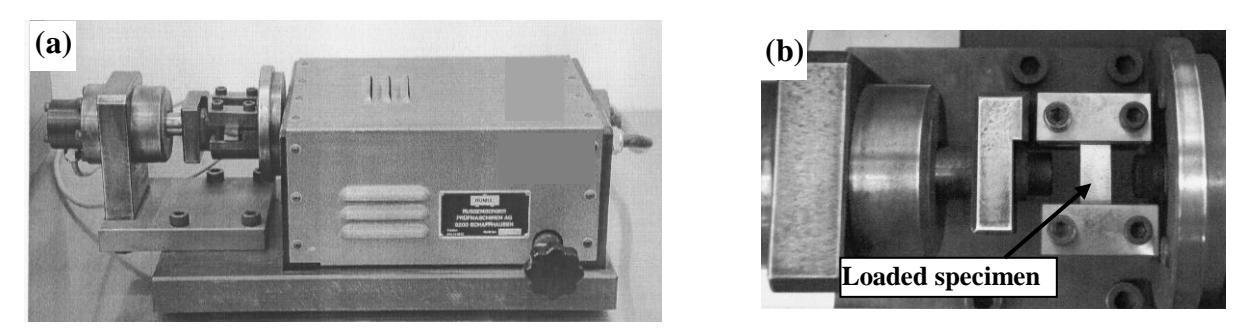
Fig. 3 Electro resonance system; (a) general view, (b) loaded cracked specimen.
