A REVIEW ON CONSTRUCTION DETAILS THAT INFLUENCE THE STABILITY OF BRICK FAÇADES

Tiago Teixeira Martins^{1(*)}, Borja Jiménez Salado¹, Suyapa Dávila Sánchez-Toscano¹, Ramón Álvarez Cabal¹⁻²

¹Instituto Técnico de Materiales y Construcciones (INTEMAC)

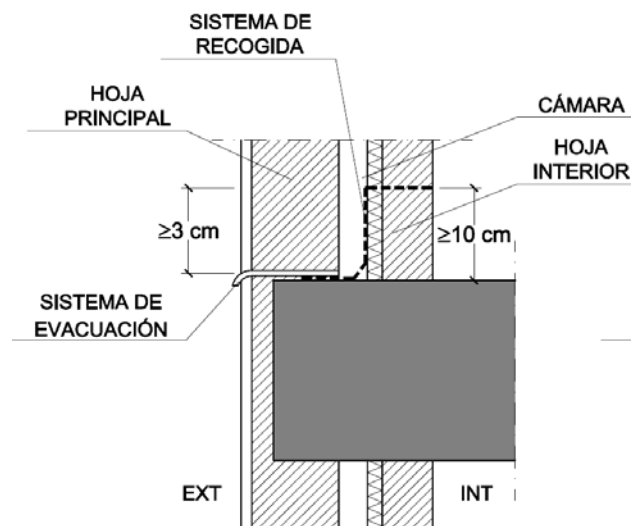
- To improve waterproofing and drainage conditions, standards recommend using a waterproof sheet to collect and evacuate outside water leaked in through the wall and condensation that may exist in the air chamber, extending foil in the blade support brick exterior with horizontal structure. This leads to friction reduction between building enclosure and framework, compromising the stability of the façade, especially if the sheet has slope as it is recommended by standards (Fig.4 and 5).

Fig. 4 Support on floor structure as indicated in CTE

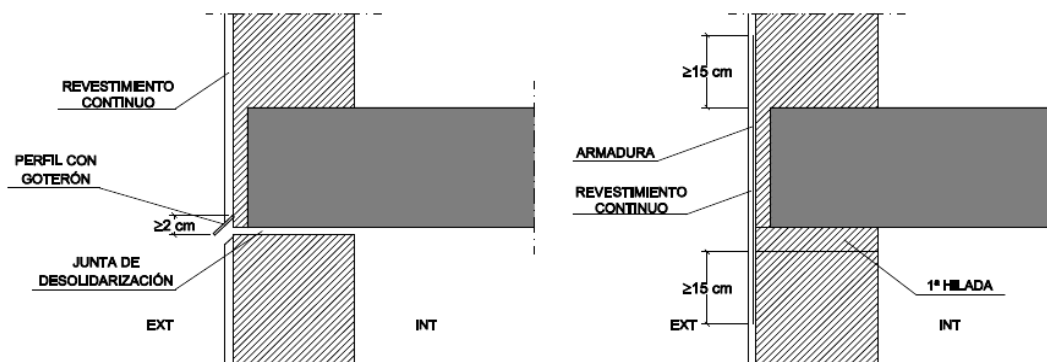
If there is an outer coating, the CTE-DB-HS1 proposes two types of solutions: create a joint of decoupling that will be filled once drying shrinkage has finished on the main sheet with a material whose elasticity allows the predicted deformation of the floor and provides a drip edge to protect the seal leaks, or place a mesh inside the outer coating (Fig. 9).

Fig. 9 Two types of solutions for outer coating proposed by the CTE-DB-HS1

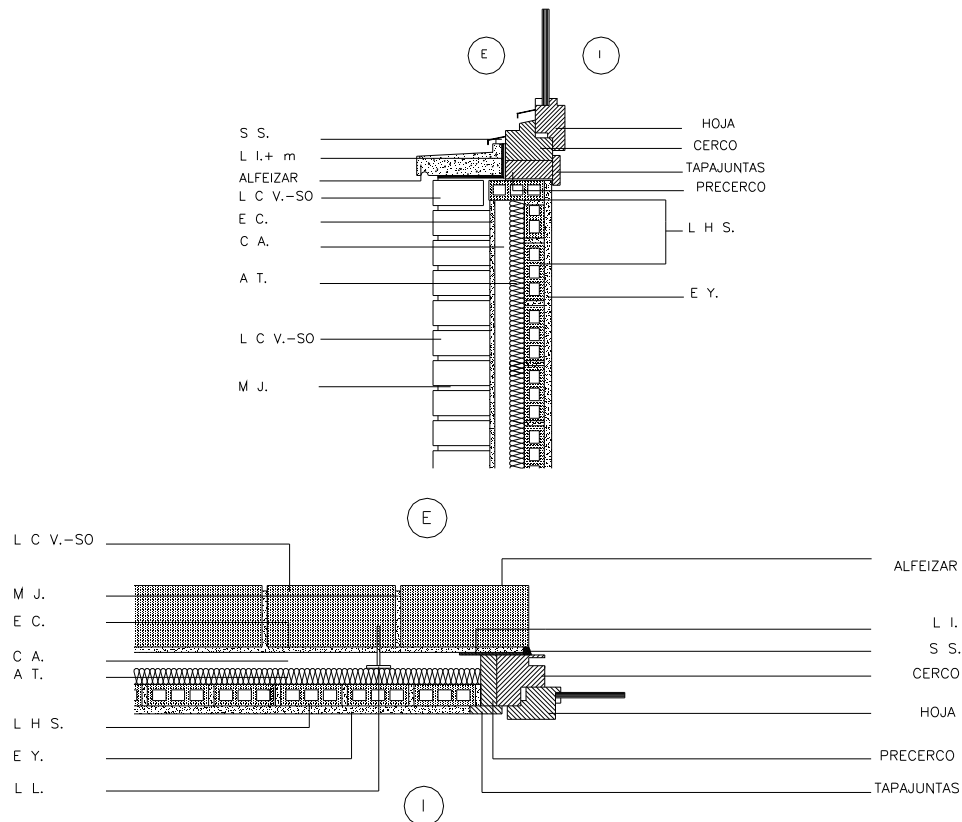
For carpentries support, standards cover the same construction detail observed in Lorca in most of the buildings checked. Carpentry is located on the inner side of the wall to prevent moisture penetration and the existence of thermal bridges. However, the wall lined on the inside (drywall or thick brick wall), rarely has enough bearing capacity to collect loads transmitted through the windows, especially those related to wind or earthquake.

Fig. 16 Theoretical carpentry location in the enclosure wall [9]
