# Addressing Soft Rock Hazards: Case Studies of Sinkholes and Collapses in Faulted Limestone Strata

Seokwon Jeon

**Abstract:** Soft rock formations, particularly faulted and fractured limestone strata, are susceptible to ground subsidence and collapse, posing significant geohazard risks in mining regions. This paper presents two case studies from South Korea that exemplify the complex interplay between geological conditions, anthropogenic excavation, and surface deformation. The first case focuses on a large-scale subsidence event at the Uljin limestone mine, where subsurface cavities, developed along faulted and karstified limestone zones, were found to be the primary cause of surface sinkholes. Geophysical surveys, borehole investigations, and three-dimensional numerical modeling confirmed that past mining operations intersected with natural weak zones, resulting in progressive ground instability. The second case examines the Yemi Mountain area, where sequential surface collapses and slope failures occurred in a zone underlain by old mine workings and structurally weakened carbonate rocks. Detailed analyses, including resistivity surveys, drilling, and mechanical testing, ident

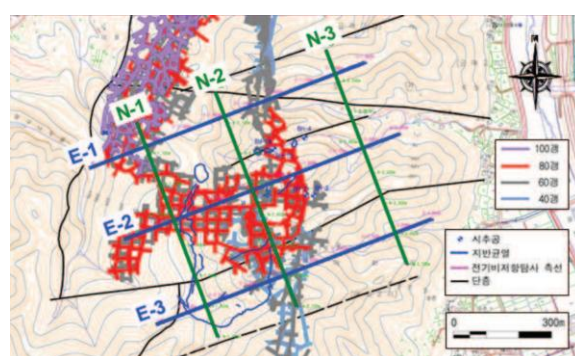
Figure 1. Location map of electrical resistivity survey lines

Three survey lines were set in the NE-SW direction parallel to the Songchon Fault, a major geological feature in the area, and another three lines in the SE-NW direction perpendicular to it. Among these, two lines were designed to pass through fractured zones and one through an unfractured zone to assess the effects of ground discontinuities on deformation. Figure 1 illustrates the location of the electrical resistivity survey lines.

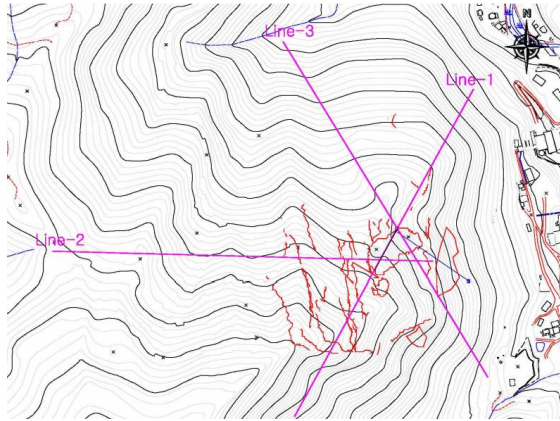
Figure 2. Electrical resistivity survey lines in the Yemi case

In the Yemi case, the survey lines passed directly beneath the surface subsidence zone. Based on surface geology, the fault strikes were identified as NNE, and surface cracks predominantly developed in the N-S direction. Thus, Line-1 (NE-SW, 760 m), Line-2 (E-W), and an additional Line-3 (NW-SE) were surveyed as shown in Figure 2..

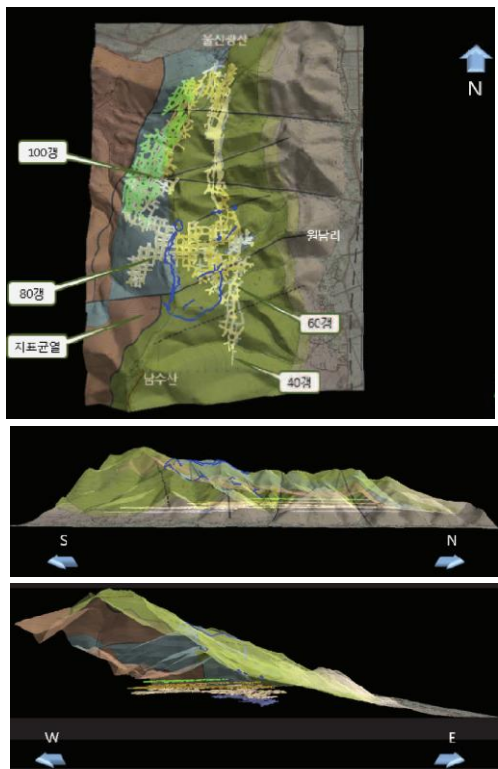
Figure 4. Layout of Mine Tunnels at the Uljin Limestone Mine

The Uljin limestone mine previously operated an open-pit site for high-grade raw material production. However, since 1995, large-scale underground mining tunnels—referred to as Levels 40, 60, 80, and 100 (named according to elevation above sea level)—have been developed to extract limestone for steelmaking and desulfurization purposes. Figure 4 presents the layout of mine tunnels at the Uljin Mine.

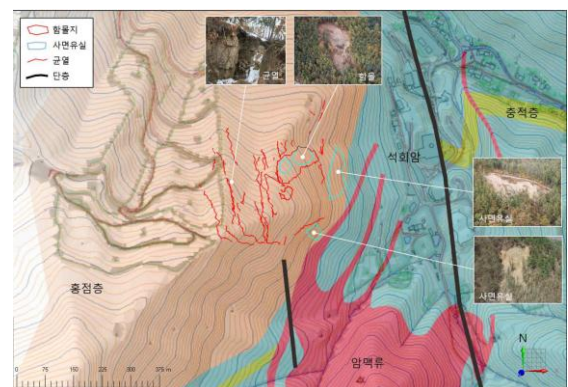
Figure 15. Composite model of the Yemi case

A composite geospatial model was developed using drone imagery, 3D geological models, resistivity data, tunnel layouts, and field observations. The terrain surface was derived from a 1:5,000 digital elevation map published by the National Geographic Information Institute of Korea. Satellite imagery, aerial photos, and drone footage were draped over the topography to create a 3D visualization (Figures 15 to 17).
