International Journal of Coal Science & Technology

Analysis of a rock slope instability mechanism combining wedge and circular failure in a soft rock mass

Sifan Yuan¹, Bingdong Ding^{1,2}, Kai Guan^{1,3}, Ignacio Pérez-Rey¹, Tonglu Li⁴, Leandro R. Alejano^{1*}

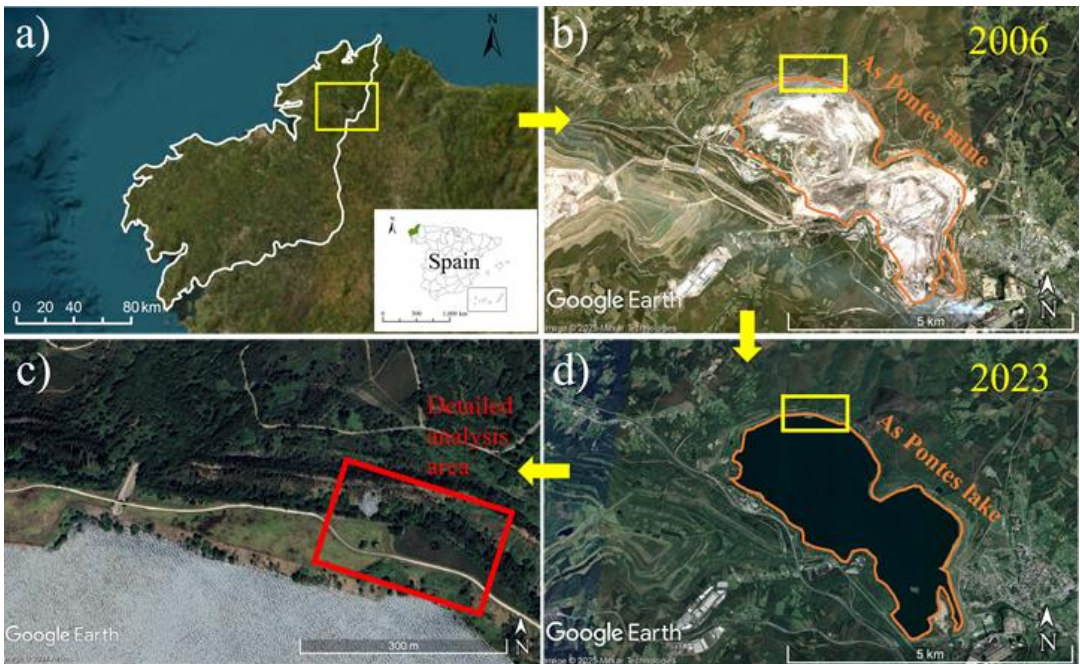
146 After the cessation of mining activities, the pit underwent a controlled flooding process that lasted six
147 years, resulting in the formation of a large lake, which was fully established by 2013. This lake now
148 occupies the former excavation site, transforming the area into a post-mining landscape (Fig. 2d).
149 Although the slopes of the mine were overall stable after the mine pit was impounded, a localized small-
150 size instability phenomenon affecting an area of roughly 1900 m² was observed on the northern slope
151 (Fig. e). This instability is analysed in due detail in this study.

Fig. 2 General schematic and aerial photographs of the Mine: **a)** Location in Spain, **b)** Pre-closure aerial view, **c)** Detailed study area of local instability in 2017, and **d)** Aerial view once the mine was fully flooded.

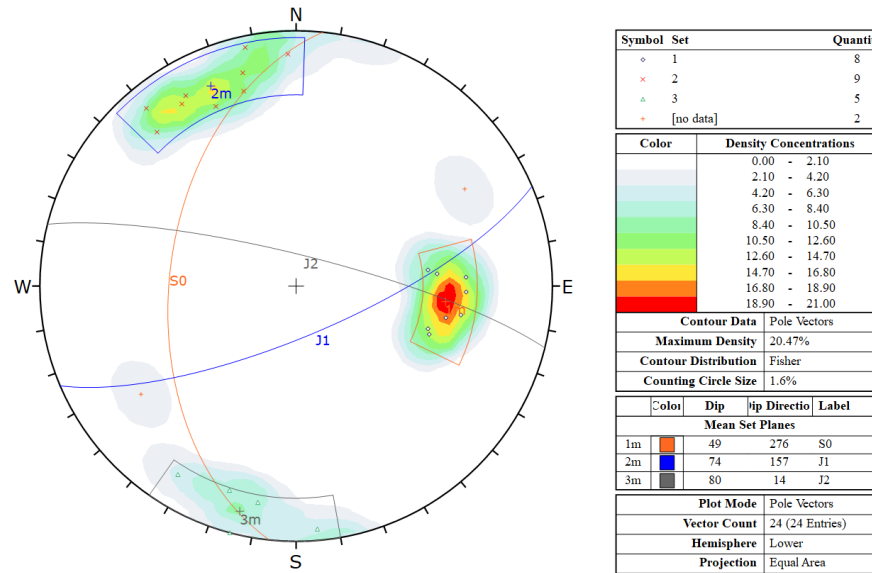
A small number of discontinuities were characterized in the phyllite outcrop of the fallen area, due to its limited size. Fig. 6 illustrates the stereographic projections of the discontinuity poles measured in the field, while Table 1 summarizes their average orientation values together with their more relevant geomechanical features.

Fig. 6 Equal area lower hemispherical stereographic representation of the poles of the representative planes of each discontinuity set, along with iso-distribution lines of poles and estimation of the mean orientations of each discontinuity set

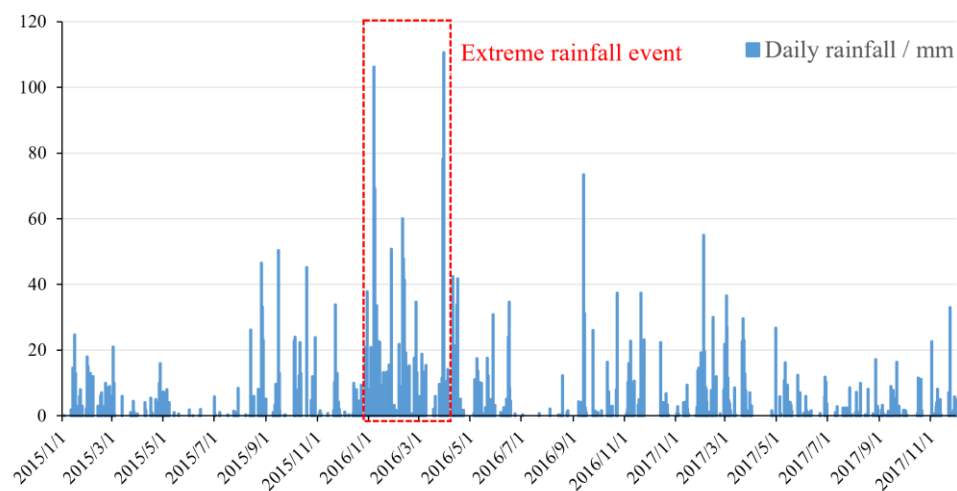
Although the exact date of the occurrence of the instability phenomenon is unknown, it must have occurred between March 2015 and October 2017 (the dates of the images before 9c and after 9d the event). A date could be around the first months of 2016, which were among the rainiest winter months in Galicia and particularly in the mine area of this century (Fig. 10). During this time, various minor instability phenomena were reported in quarry benches and road slopes in Galicia, northwest Spain. Regardless of the exact date, probably around 35 years passed since the opening of the area until the occurrence of this local instability.

Fig. 101 Daily rainfall during the period of time when the slope might fail, *A Coruña* observatory, 45 km from the slope area

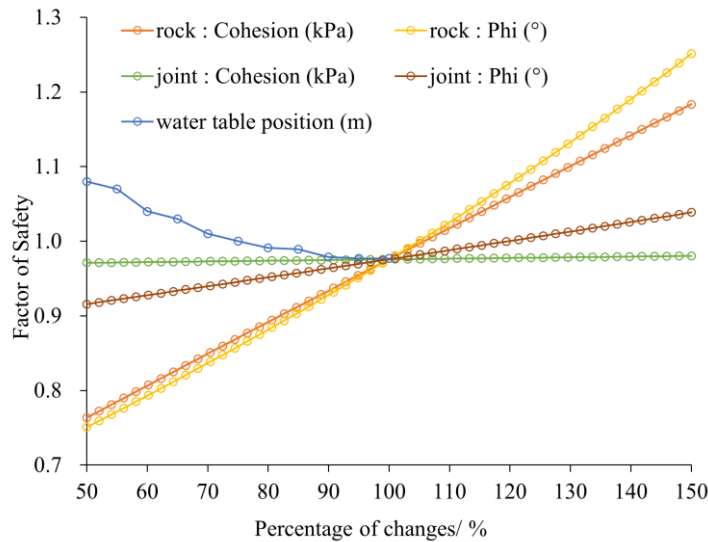
Fig. 14 Sensitivity analysis spider diagram.

Based on this variability assessment graph (Fig.14), rock mass strength and water table location play a critical role in the stability of the planar-circular mechanism. An increase in rock material strength generally enhances stability, whereas a higher water table significantly reduces the FoS due to increased pore water pressure and reduced effective stress. Conversely, joint properties have a comparatively lower impact on stability. Since the dip angle of the joint is greater than that of the slope, the downslope component of the driving force along the joint is relatively small. As a result, the joint strength (once fixed their orientation) does not play a relevant role on stability.

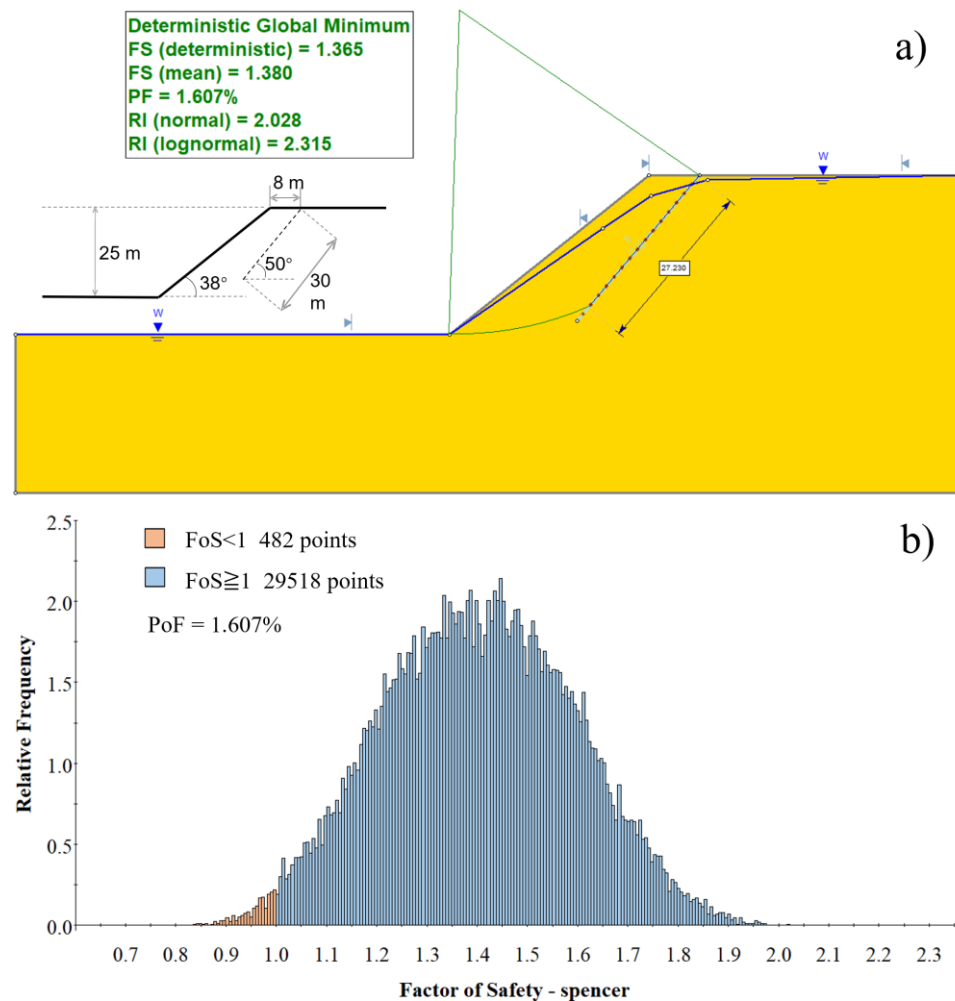
Fig. 15 a) The interpretation of the failure surface and probabilistic factor calculated from mean values **b)** Distribution of Factor of Safety

The probabilistic analysis estimated a probability of failure (PoF) = 1.607%, which falls within the acceptable range for open pit slopes. Indeed, 30 years after excavation, in the roughly 1.5 km long northern slope bench of the mine (Fig. 2c) no failure was observed (PoF = 0%). Only after around 35 years, a local failure was observed along a 35-m section of the bench, corresponding to a PoF of approximately 2.5% (35 m /1500 m).

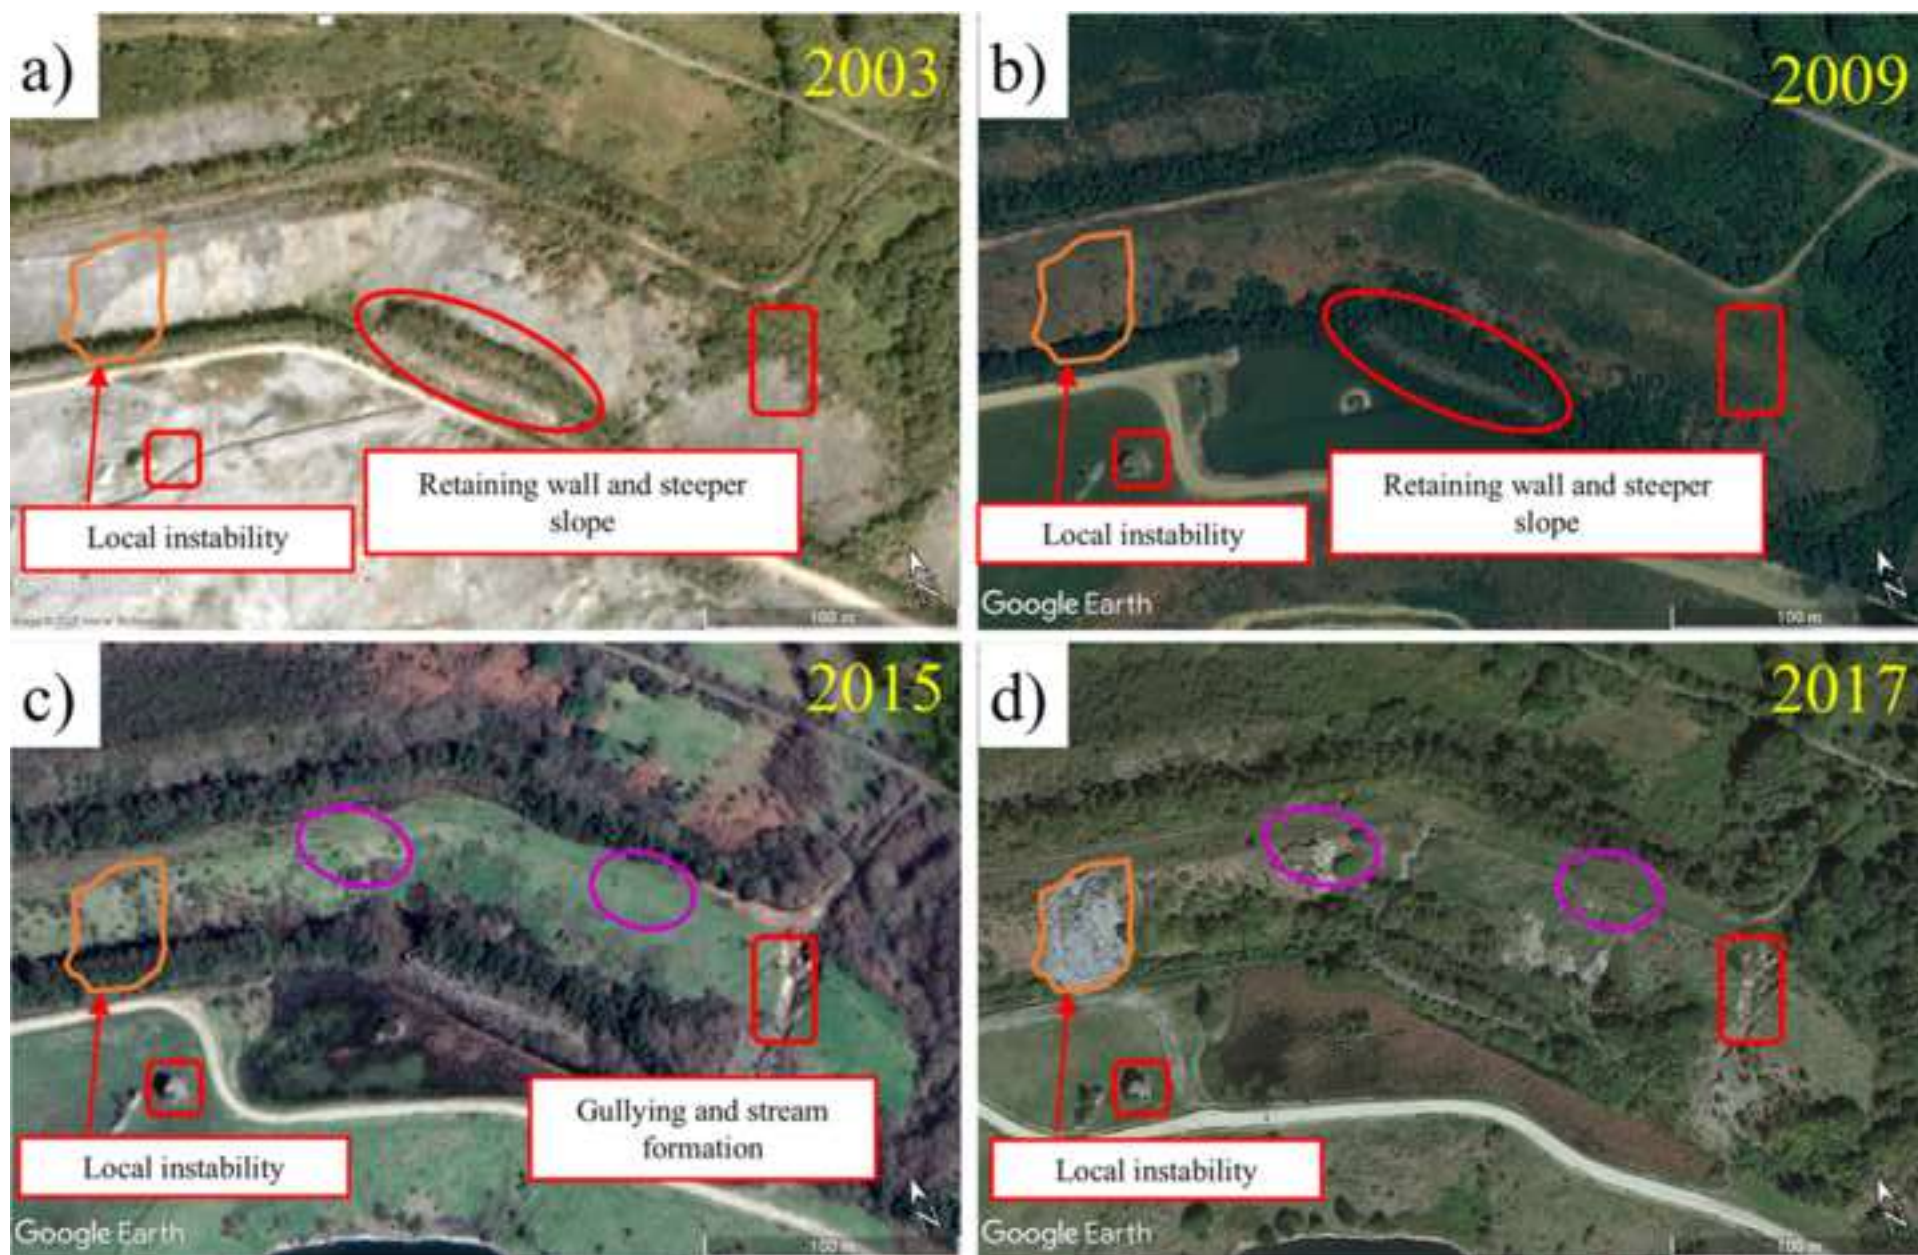
Fig. 9 Details of the instability area in a) 2003, b) 2009, c) 2015, and d) 2017

The aerial image in Fig. 9d, taken in October 2017 shows, for the first time, the appearance in Google Earth of the local instability under study. There has been no notable change in the state observed in this photograph compared to the field observations made during visits in early 2021. Additionally, the opening of two local tension cracks at the top of the bench can be observed, marked with magenta ovals.

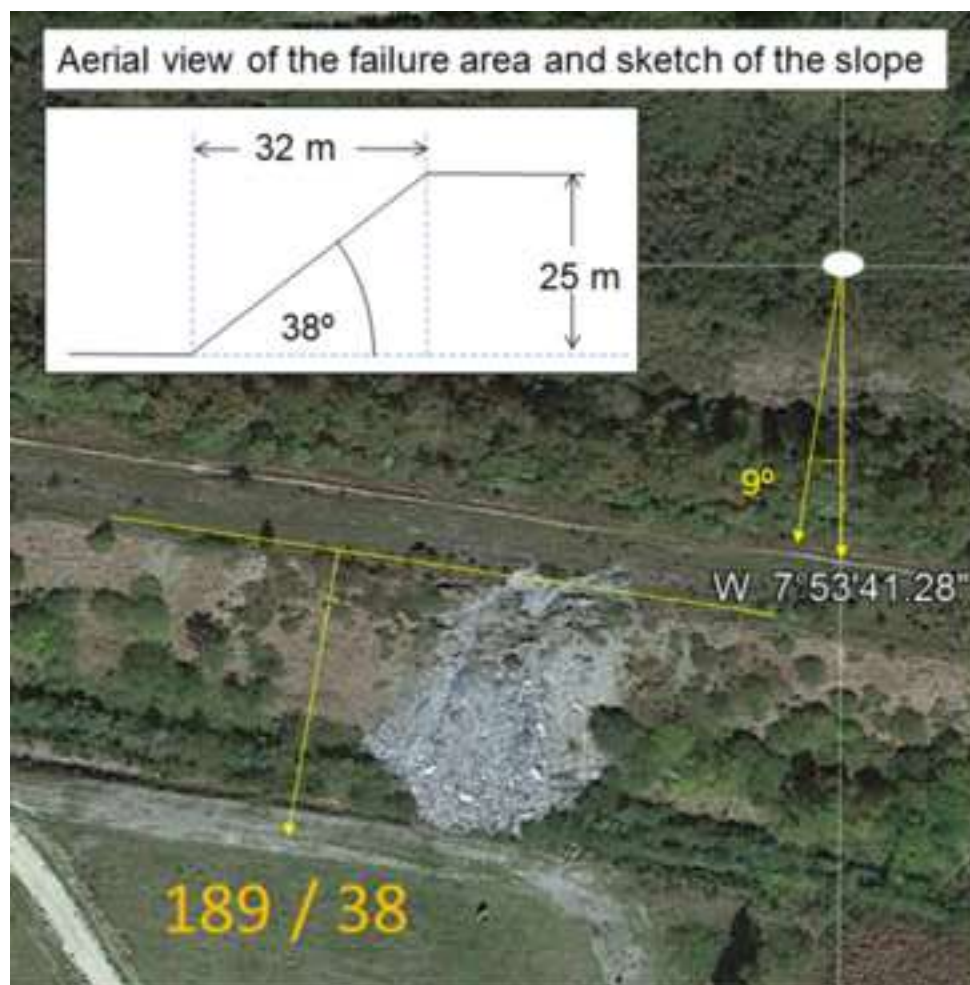
To identify the possibility of this type of failure mechanism, we compare the orientation of the bench slope under study with the stereographic representation of the discontinuity orientations measured in the field, as shown in Fig. 11. For a better understanding, the interpretation of the failure mechanisms is presented with front and side view sketches in Fig. 12. As illustrated, a double-wedge rock block is

Equal-angle hemispherical stereographic representation of the joint sets identified and the slope face
