Remote Sensing Strategies for Effective Landslide Risk Management in a Geologically Heterogeneous Slope

Abstract On November 23, 2022, a catastrophic landslide occurred in Palmeira de Faro, Esposende, northern Portugal, resulting in the loss of two lives and substantial structural damage to nearby residences. This landslide serves as a case study for the monitoring of geologically heterogeneous slopes that present complex stability challenges. The affected slope, excavated in weathered porphyritic granite and surrounded by varied metamorphic rocks, displayed a highly heterogeneous weathering degree (grades II to V), ranging from soil, soft rock to almost unweathered hard rock, also displaying several structural discontinuities. These geological factors, coupled with an abnormal increase in rainfall in the previous months, were significant contributors to the slope's instability. A multi-technical monitoring strategy was implemented, including topographic markers, laser scanning, drone-based photogrammetry, and InSAR ground motion detection. Each technique provided unique insights, with InSAR detecting minor shifts that indicated early-stage instability, while drones and laser scan

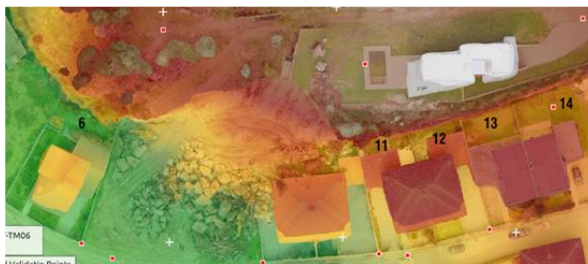
Fig. 7 Division of the slope into 5 sections according to the numbering of the buildings located in its immediate vicinity,

Visual inspections of the slope, including the most recent on April 11, 2024, classified the overall slope conservation state as “Reasonable”. However, for sections of house n.11 and 12, the conservation state was rated as “Bad” due to the presence of potentially detachable blocks posing a risk of falling (**Fig. 8**). Despite these conditions, no changes in the assigned conservation state were observed from the initial inspection in November 2022 to the most recent one, performed in April 2024.

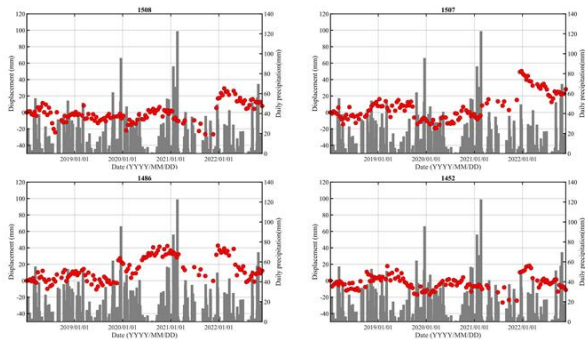
Fig. 15 LOS (Line of Sight) Displacement time series of relative stable point targets.
