Documentation, Restoration and Reuse of Heritage

BOOK OF PROCEEDINGS

Proceedings of the
Xth edition of the ReUSO - Documentation, Restoration and Reuse of Heritage

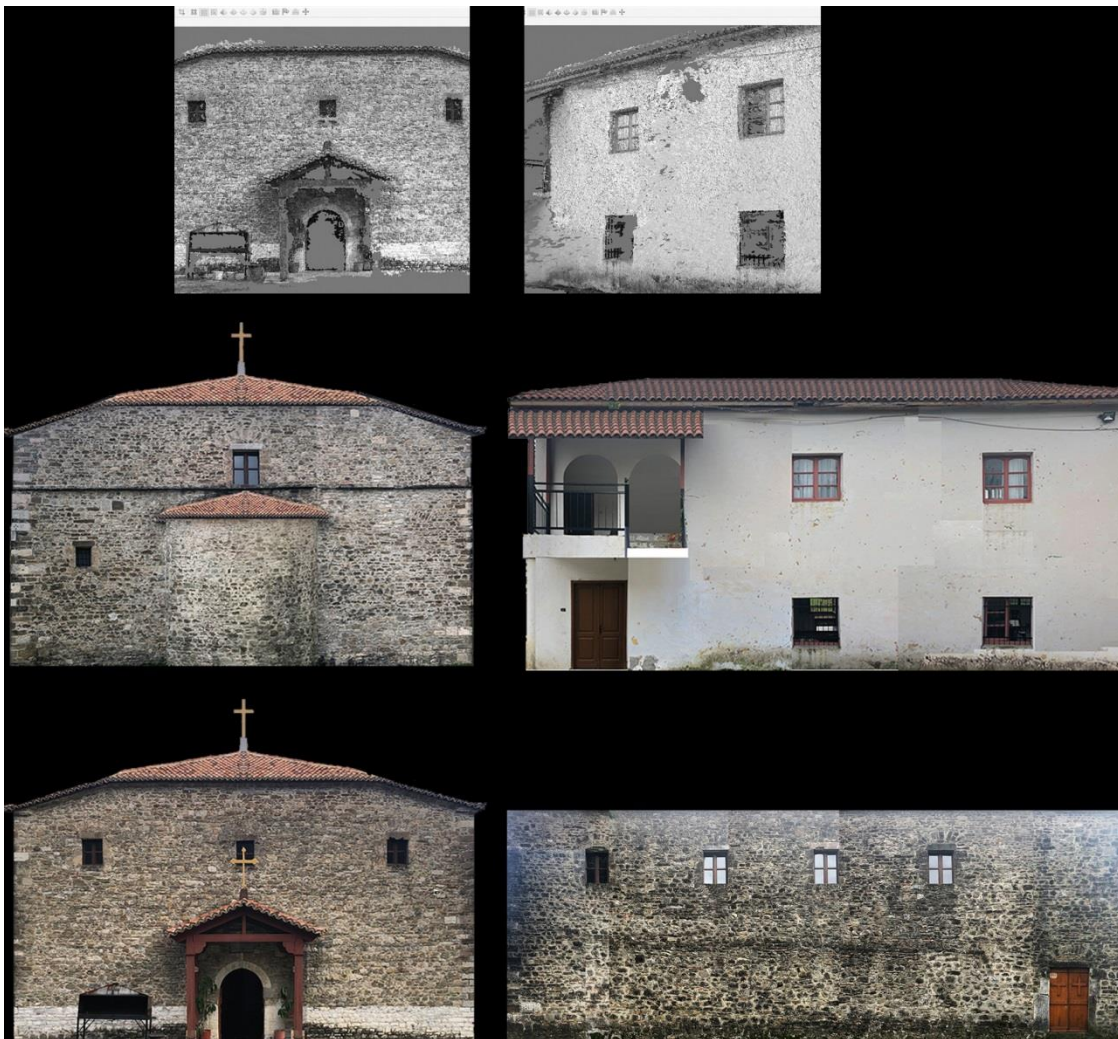
Figure 2. Point cloud processing and orthomosaic generation from photogrammetric survey

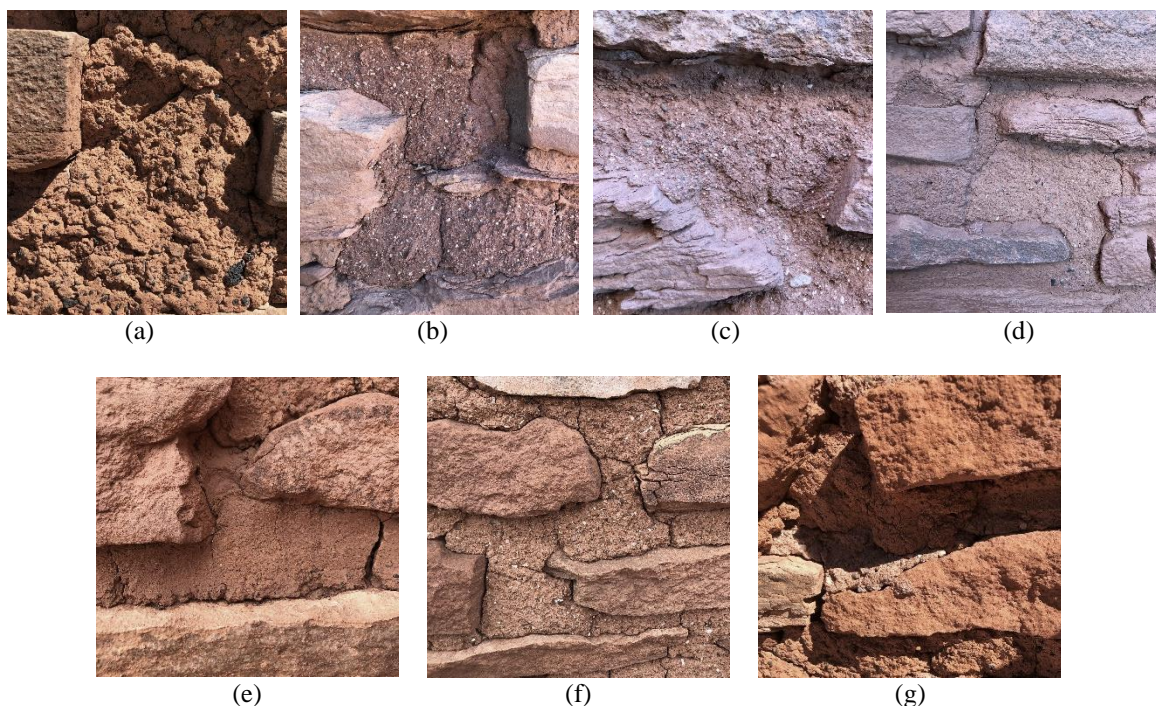
Each type of mortar is investigated according to the four aforementioned NDTs. It is worth noting that the recurrent operations of repointing are often very superficial (up to a couple of millimeters in depth) causing an extreme variability in the acquired values. Therefore, for each test, multiple acquisitions in different places of the site are preferably conducted in order to overcome possible localised defects of the surface, e.g. detachment, superficiality of re-pointing or degradation.

Figure 3. Types of mortar tested on-site:(a-f) amended earth-based mortars; (g) cement mortar.

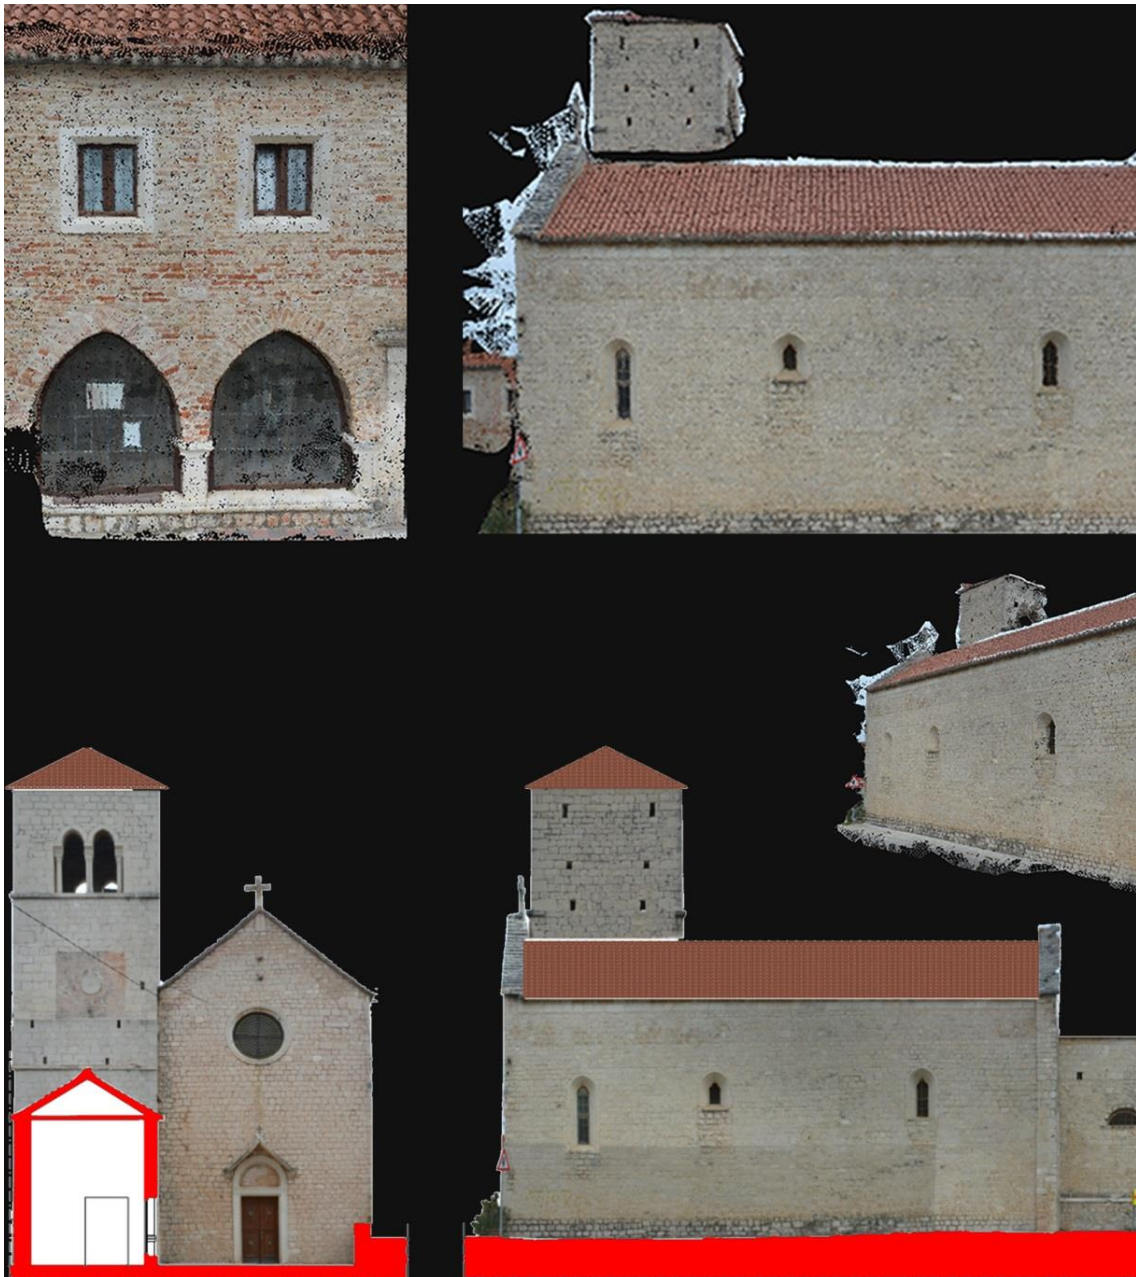
Figure 3. Processing of point clouds and orthomosaics from photogrammetric survey.

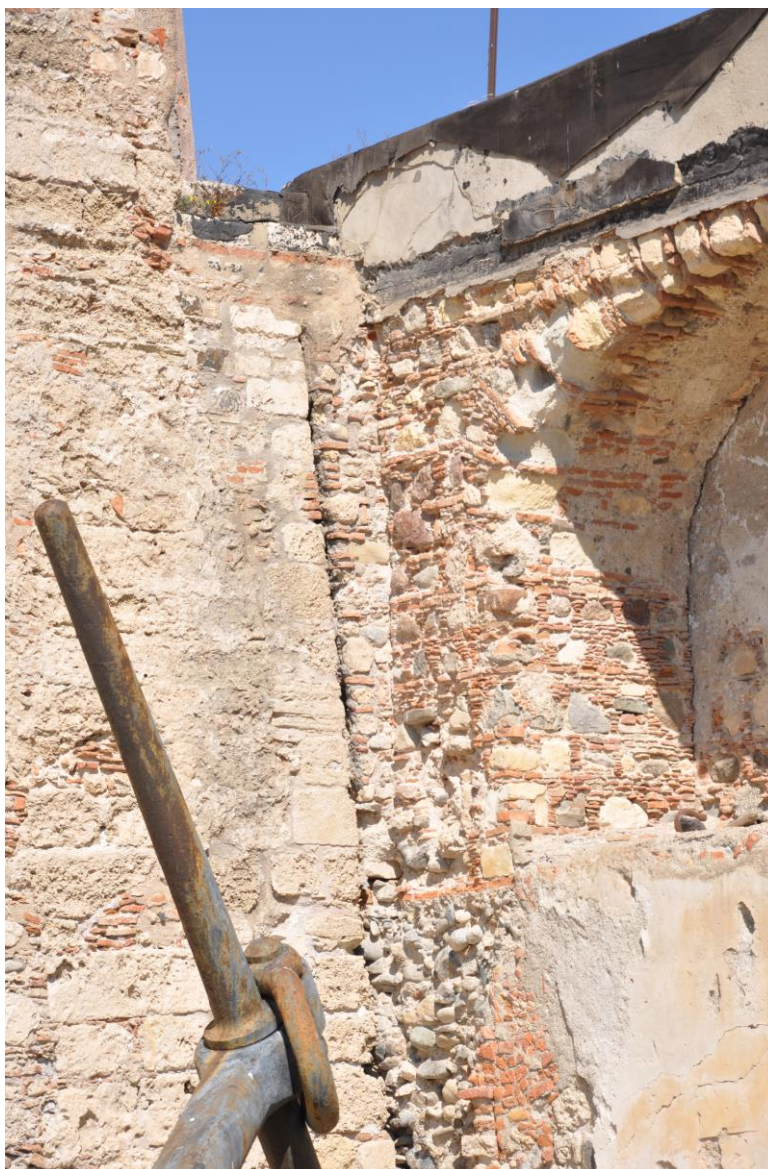
È questo il caso del Forte Campana che oltre agli stravolgimenti del suo nucleo centrale una volta occupato dalla Torre di Sant'Anna, dopo le demolizioni causate dal terremoto del 1908 ha subito numerosi restauri e riparazioni che hanno trasformato significativamente il contesto inquinando fortemente la possibilità di una lettura di dettaglio. L'attacco tra il forte Campana e la cinta murata a nord manifesta chiaramente un appoggio denunciando la posteriorità cronologica di quest'ultima. (Fig. 13)

Fig. 13. Dettaglio dell'appoggio della muratura nord del forte del SS. Salvatore sul cantonale del muro nord-est di Forte Campana

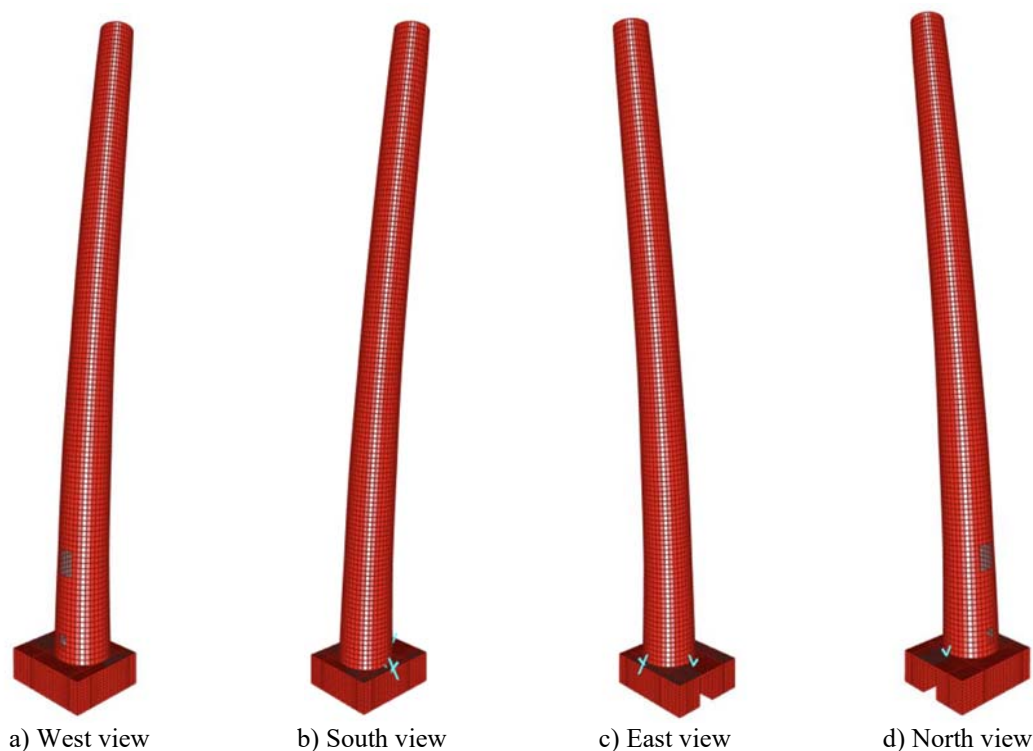
Figure 9. Displacements due to wind action (characteristic values).

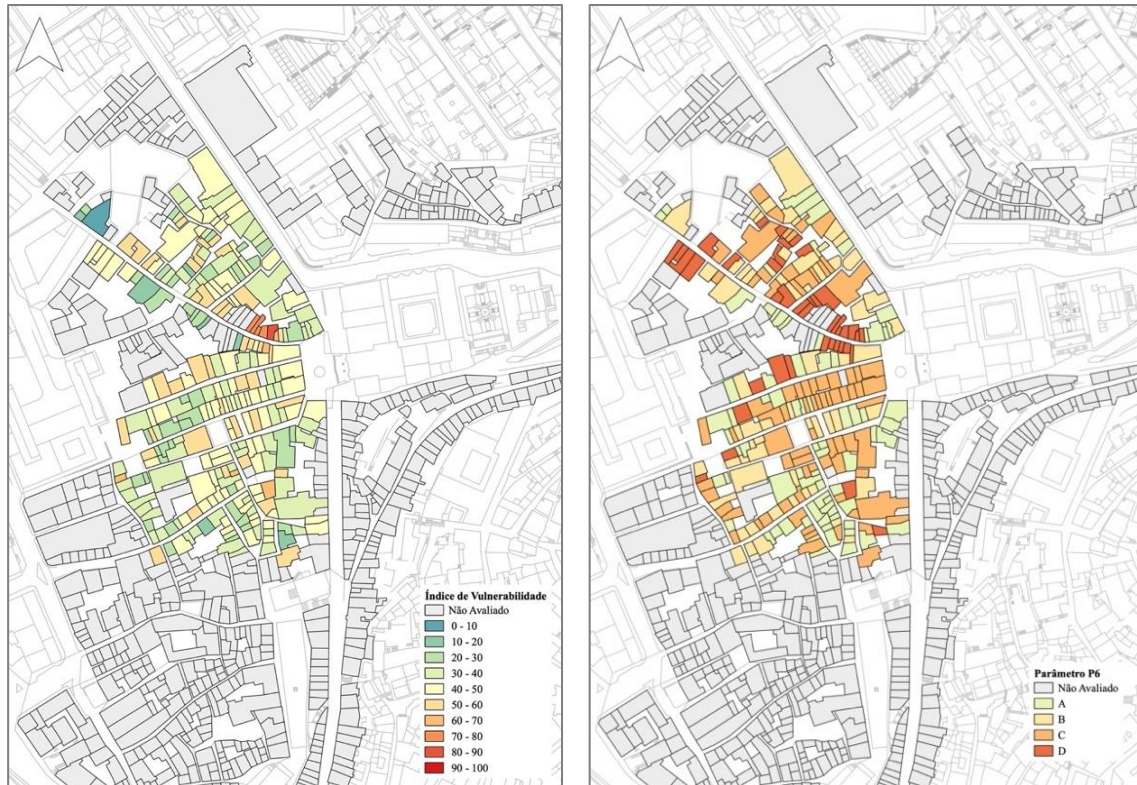
Figura 2. Mapeamento da vulnerabilidade sísmica dos edifícios avaliados (a) classes de vulnerabilidade obtidas; (b) parâmetro P6.

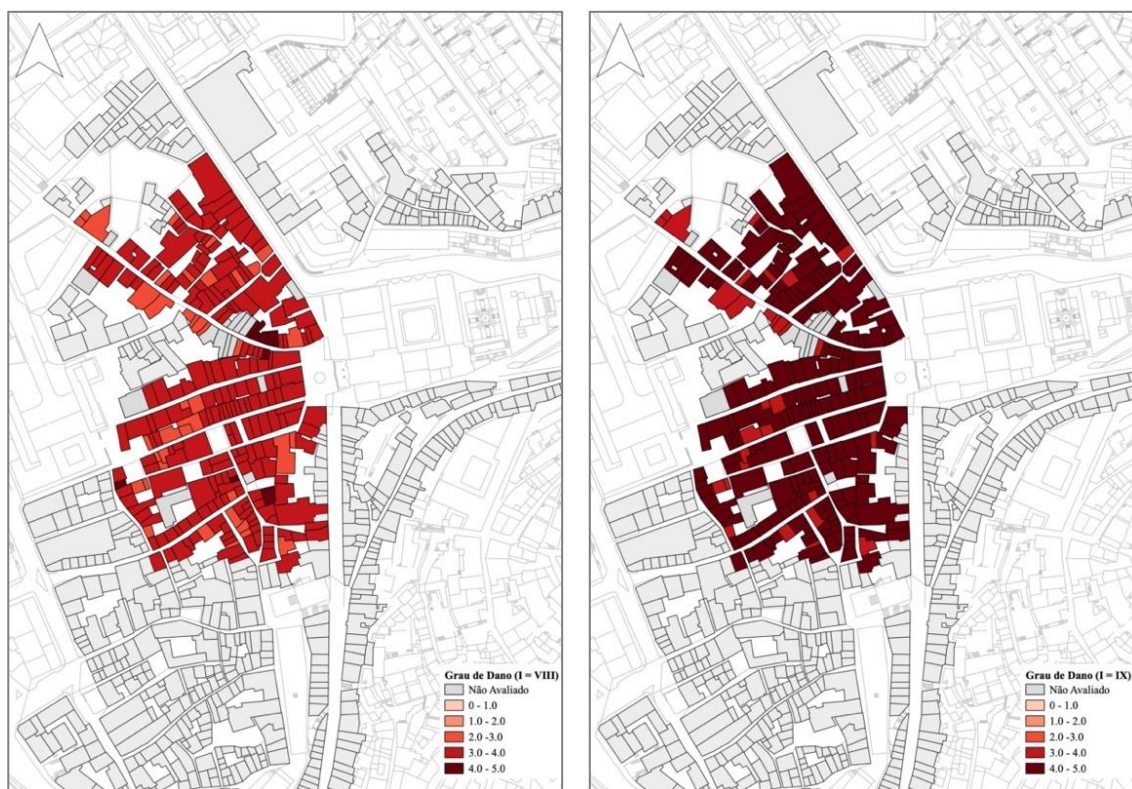
Figura 4. Cenário de danos estimado para intensidade sísmica $I_{EMS-98} = VIII$ (a) e IX (b).

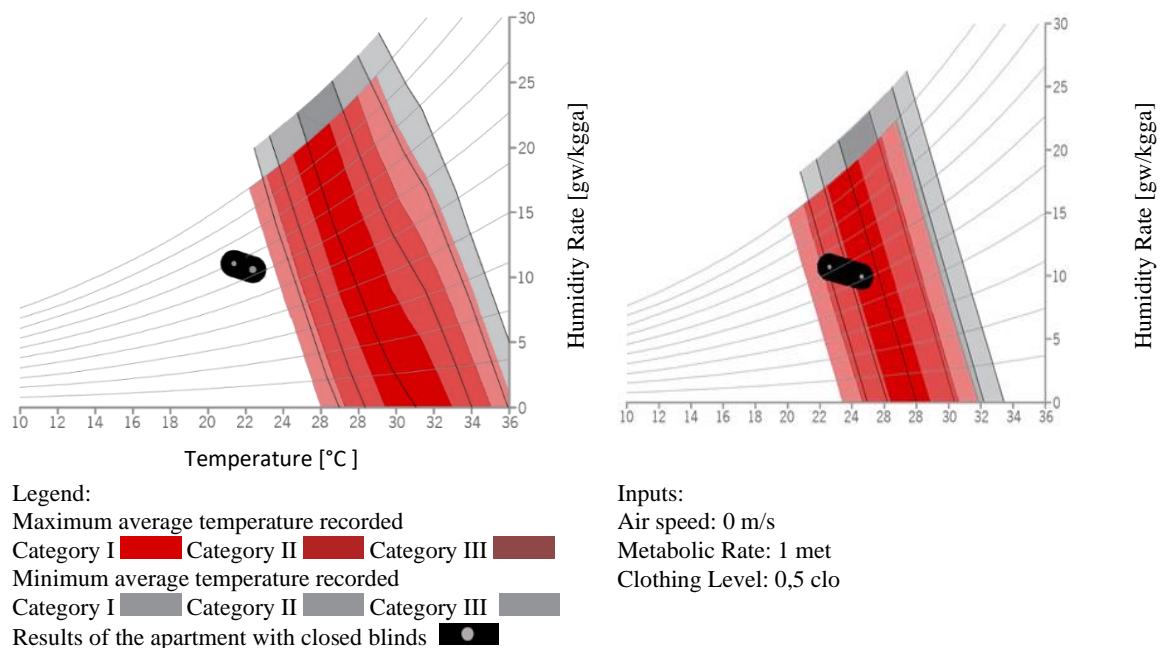
Figure 6. Evaluation of comfort in the apartment with blinds closed (left) and open (right), from 21 to 29 May.

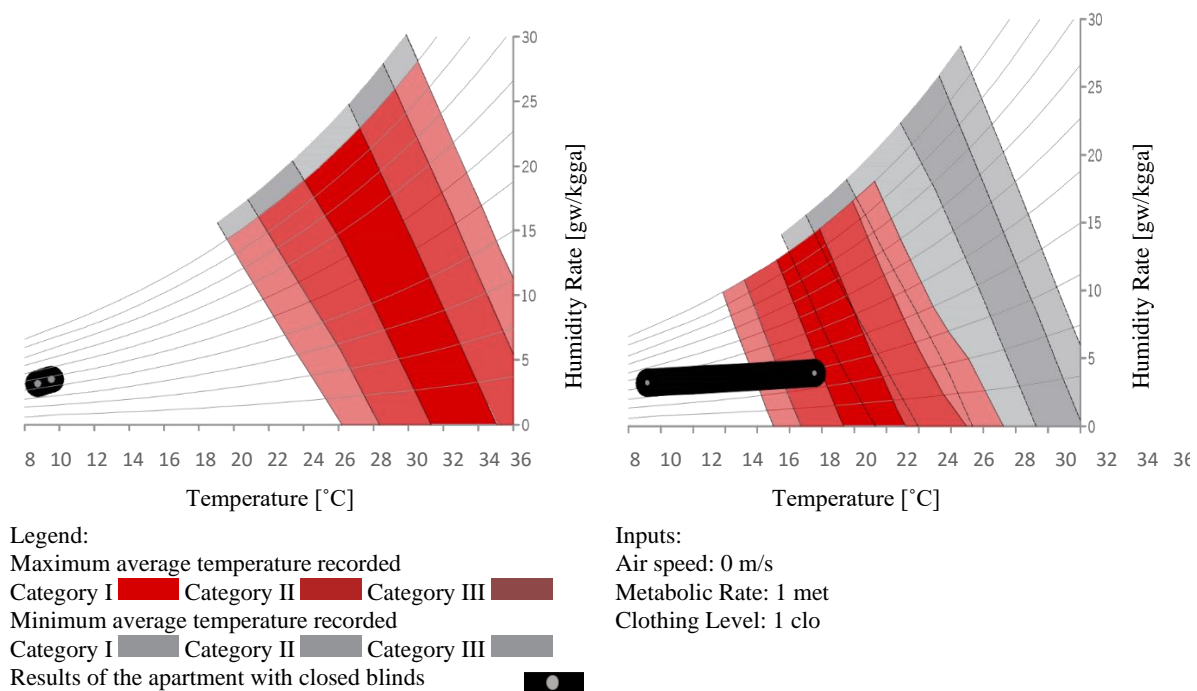
Figure 7. Evaluation of the comfort in the apartment with the blinds closed (left) and open (right), from 05 to 12 January.

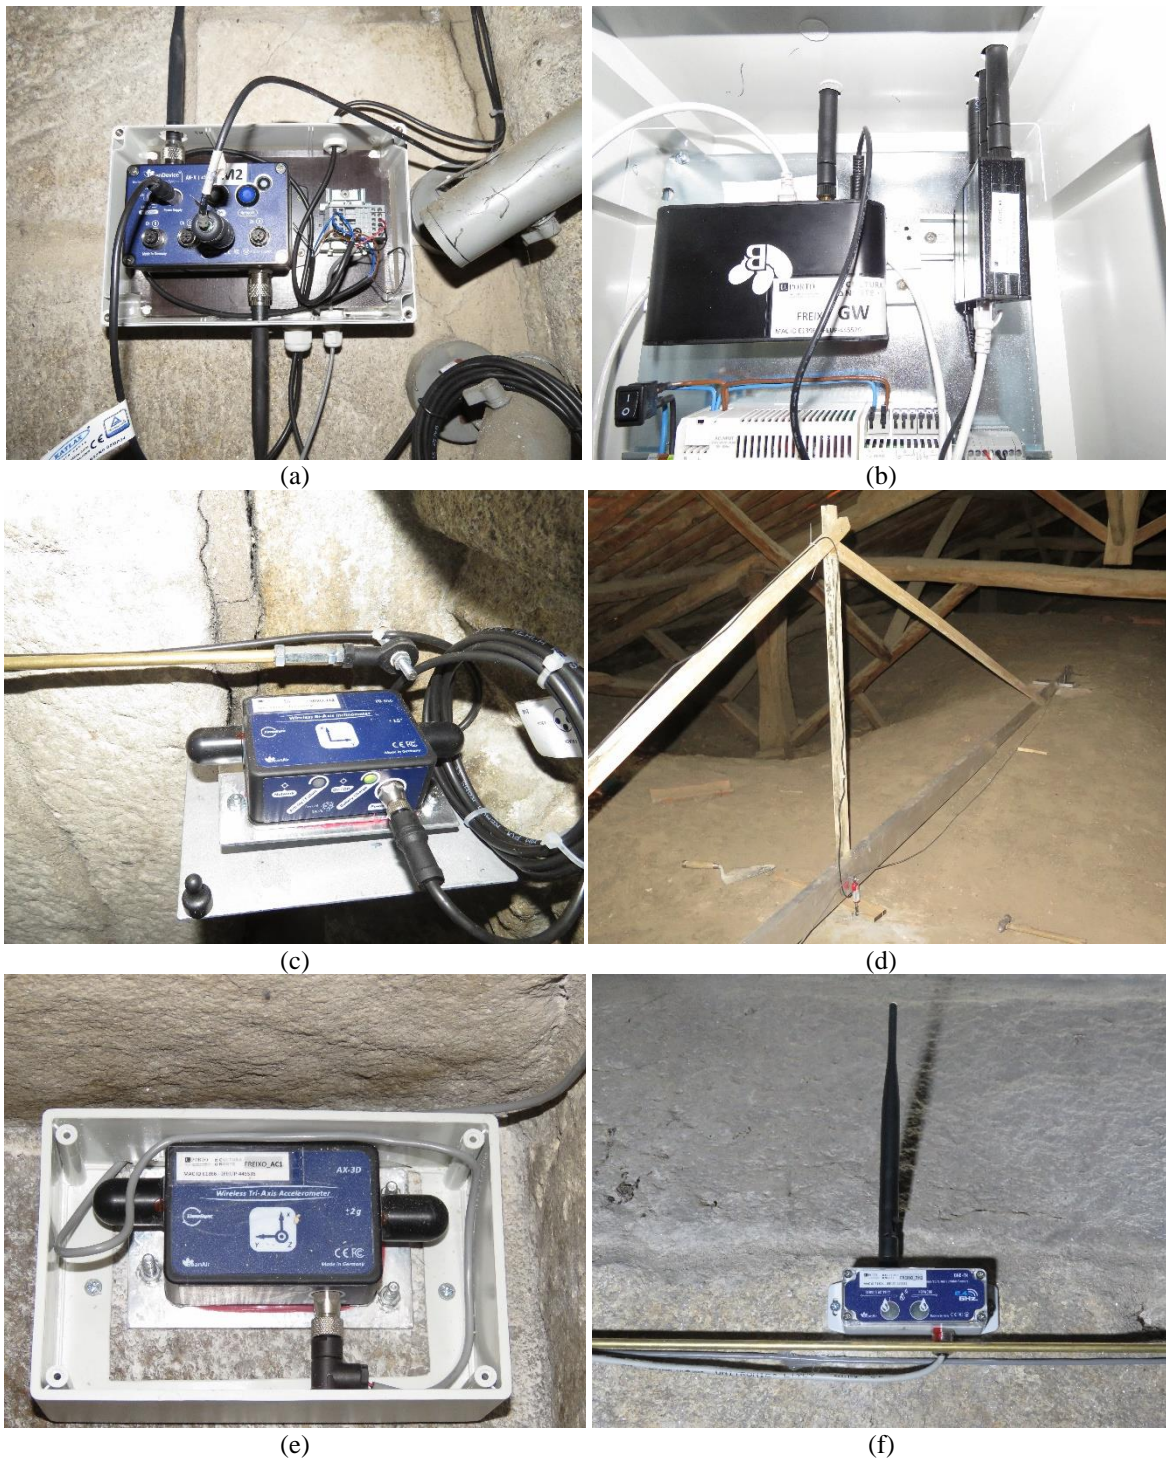
Figure 5. Monitoring system installed: (a) acquisition module M2; (b) gateway; (c) tiltmeter (CL2) and extremity of crackmeter FS3; (d) crackmeter FS7 installed on the extrados of the vault; (e) accelerometer (AC1); (f) temperature sensor TH1 and the extension rod of the crackmeter FS2 [source: authors].

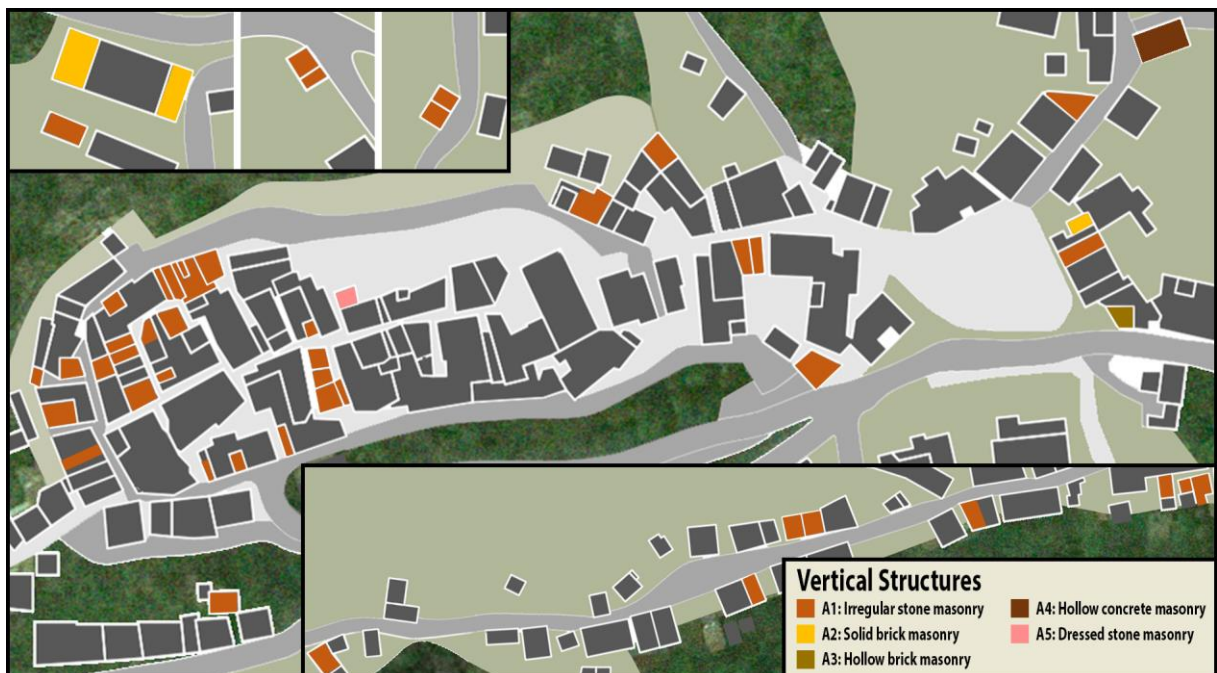
Figure 5. Mapping of vertical structures identified in the 51 building units. The colour represents the prevailing type found in the exterior walls, but more than one material is often present in the same unit – 2022 © Carlo Costantino
